Gad Hill School

Repairs to Parapet Wall - Emergency Works

West Elevation
Parapet Wall
As Proposed
A226

Project No.	Dwg. No.	Rev.
5516	D-01

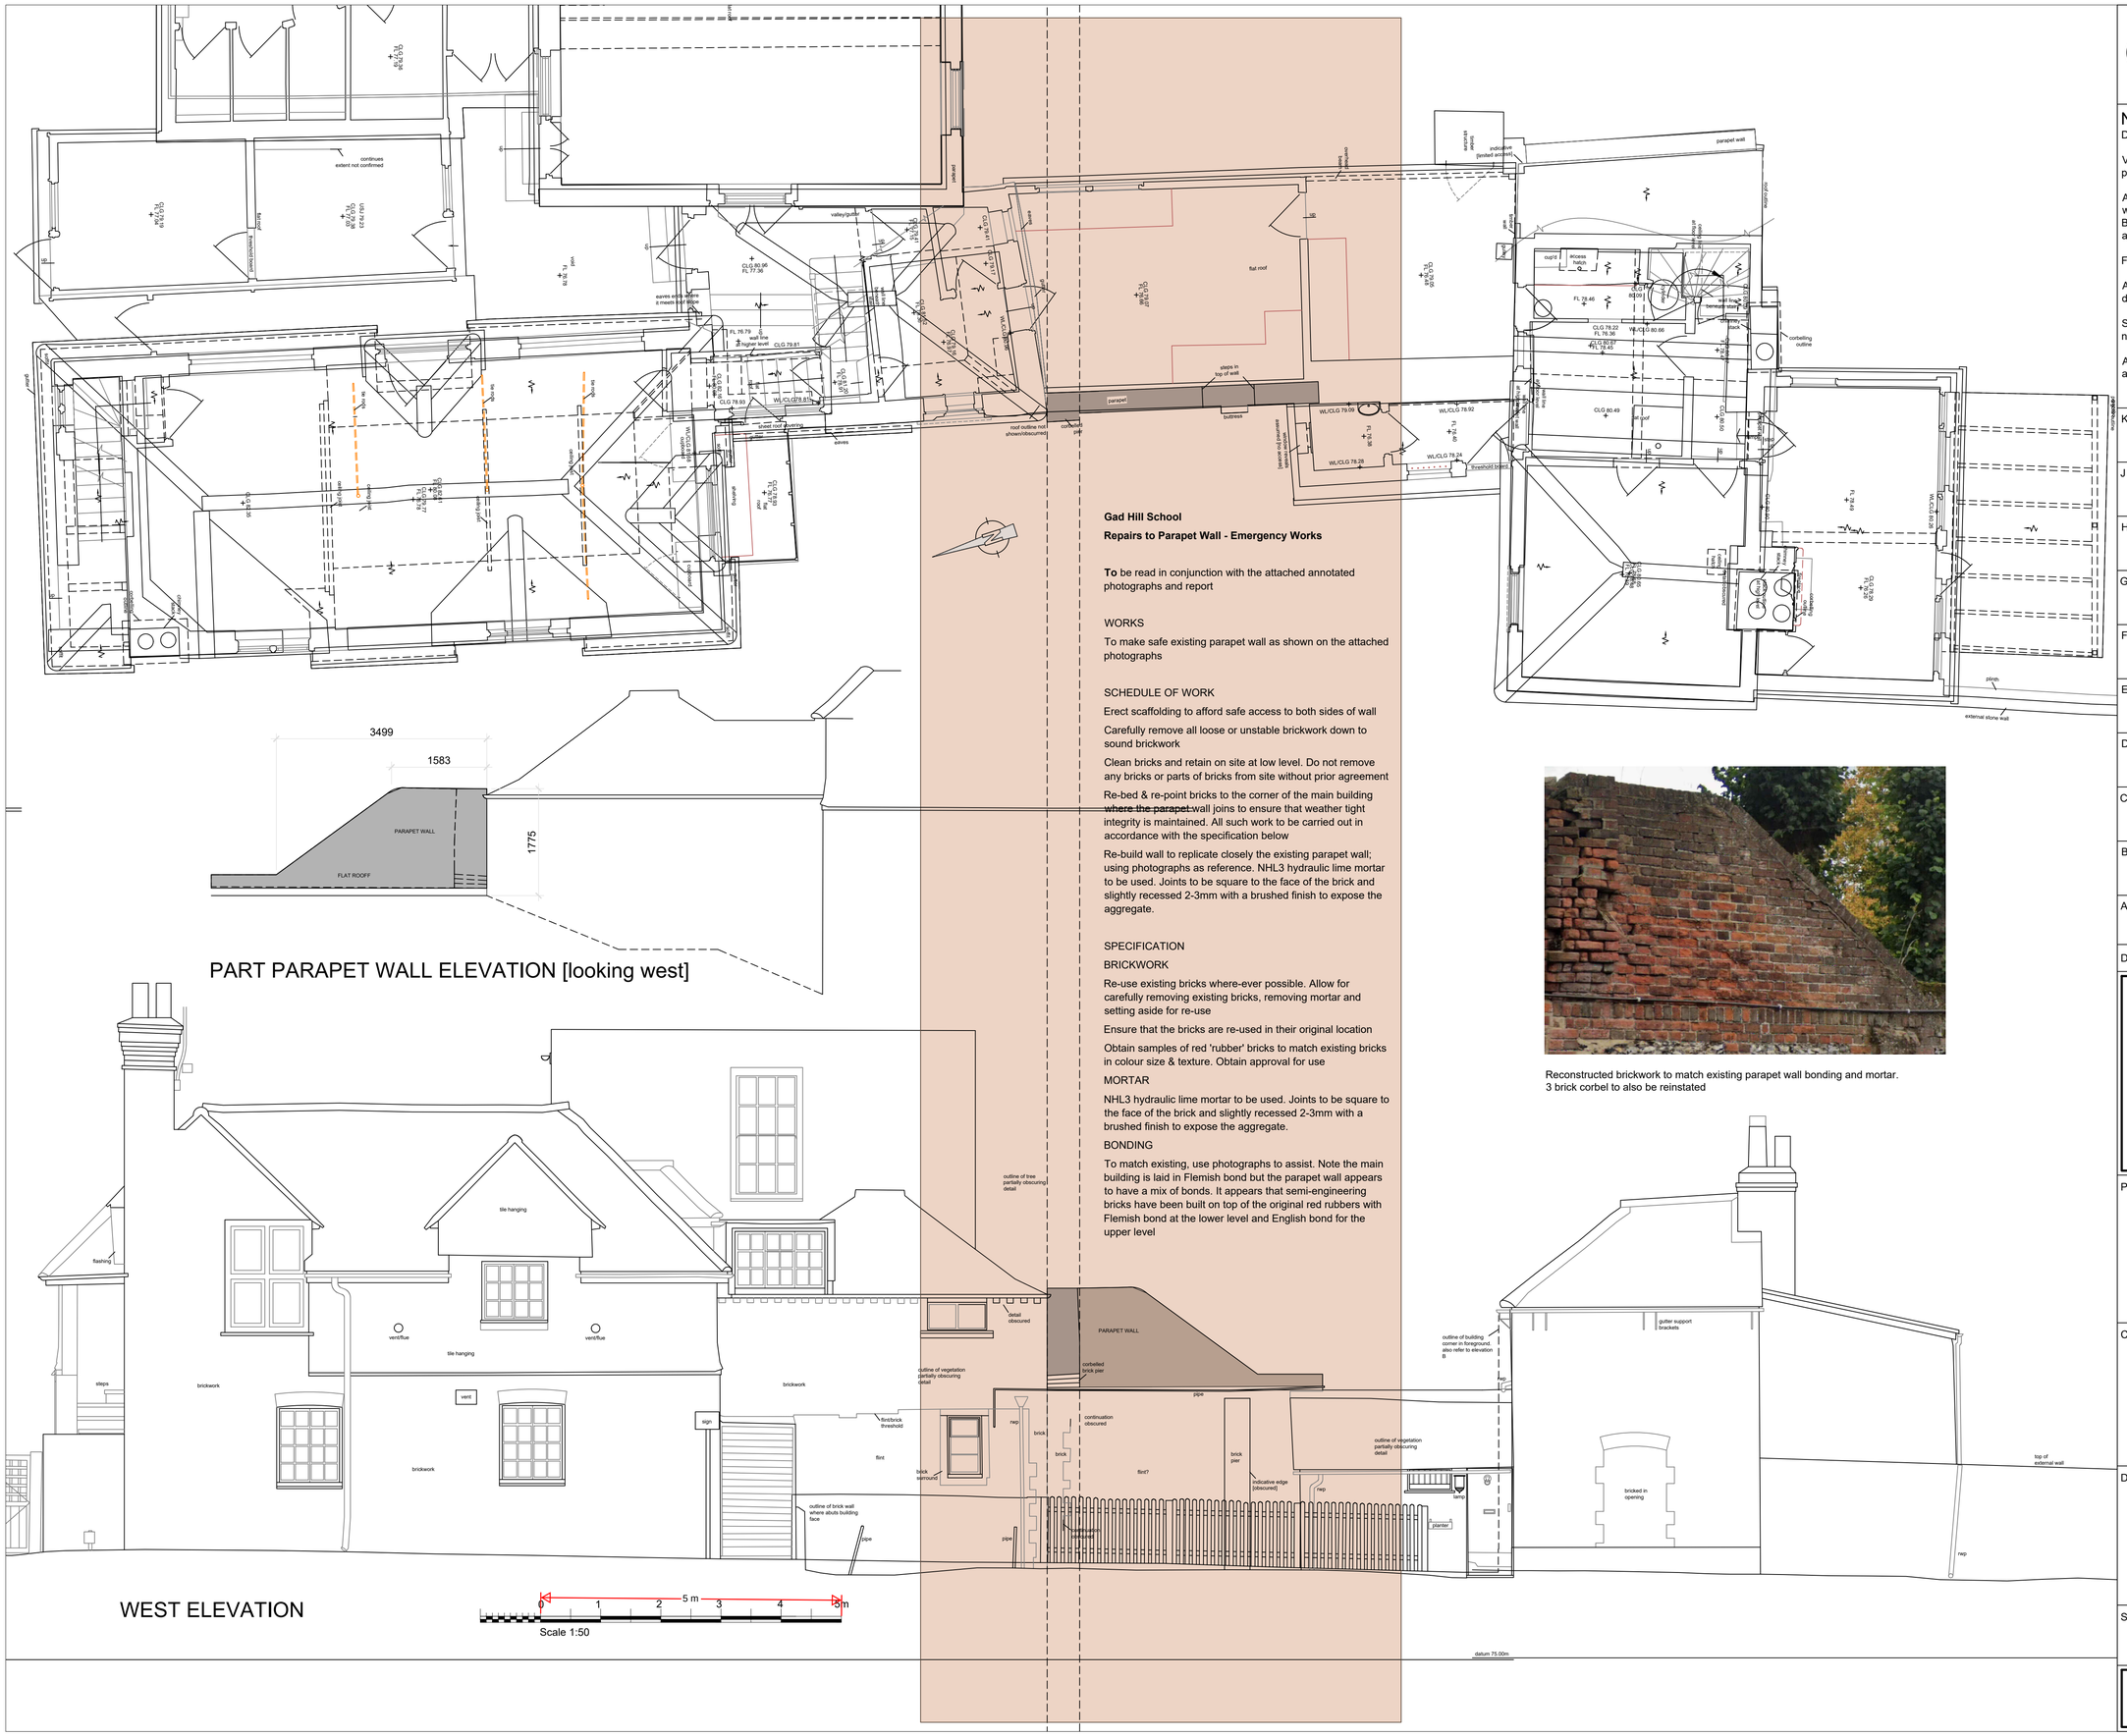
To make safe existing parapet wall as shown on the attached photographs

To match existing, use photographs to assist. Note the main building is laid in Flemish bond but the parapet wall appears to have a mix of bonds. It appears that semi-engineering bricks have been built on top of the original red rubbers with Flemish bond at the lower level and English bond for the upper level

Erect scaffolding to afford safe access to both sides of wall

Carefully remove all loose or unstable brickwork down to sound brickwork

Re-bed & re-point bricks to the corner of the main building where the parapet wall joins to ensure that weather tight integrity is maintained. All such work to be carried out in accordance with the specification below

Re-build wall to replicate closely the existing parapet wall; using photographs as reference. NHL3 hydraulic lime mortar to be used. Joints to be square to the face of the brick and slightly recessed 2-3mm with a brushed finish to expose the aggregate.

Reconstructed brickwork to match existing parapet wall bonding and mortar.
3 brick corbel to also be reinstated
