# STRUCTURAL REPORT

Barn at  
Green Farm  
Shorne

Job 16462

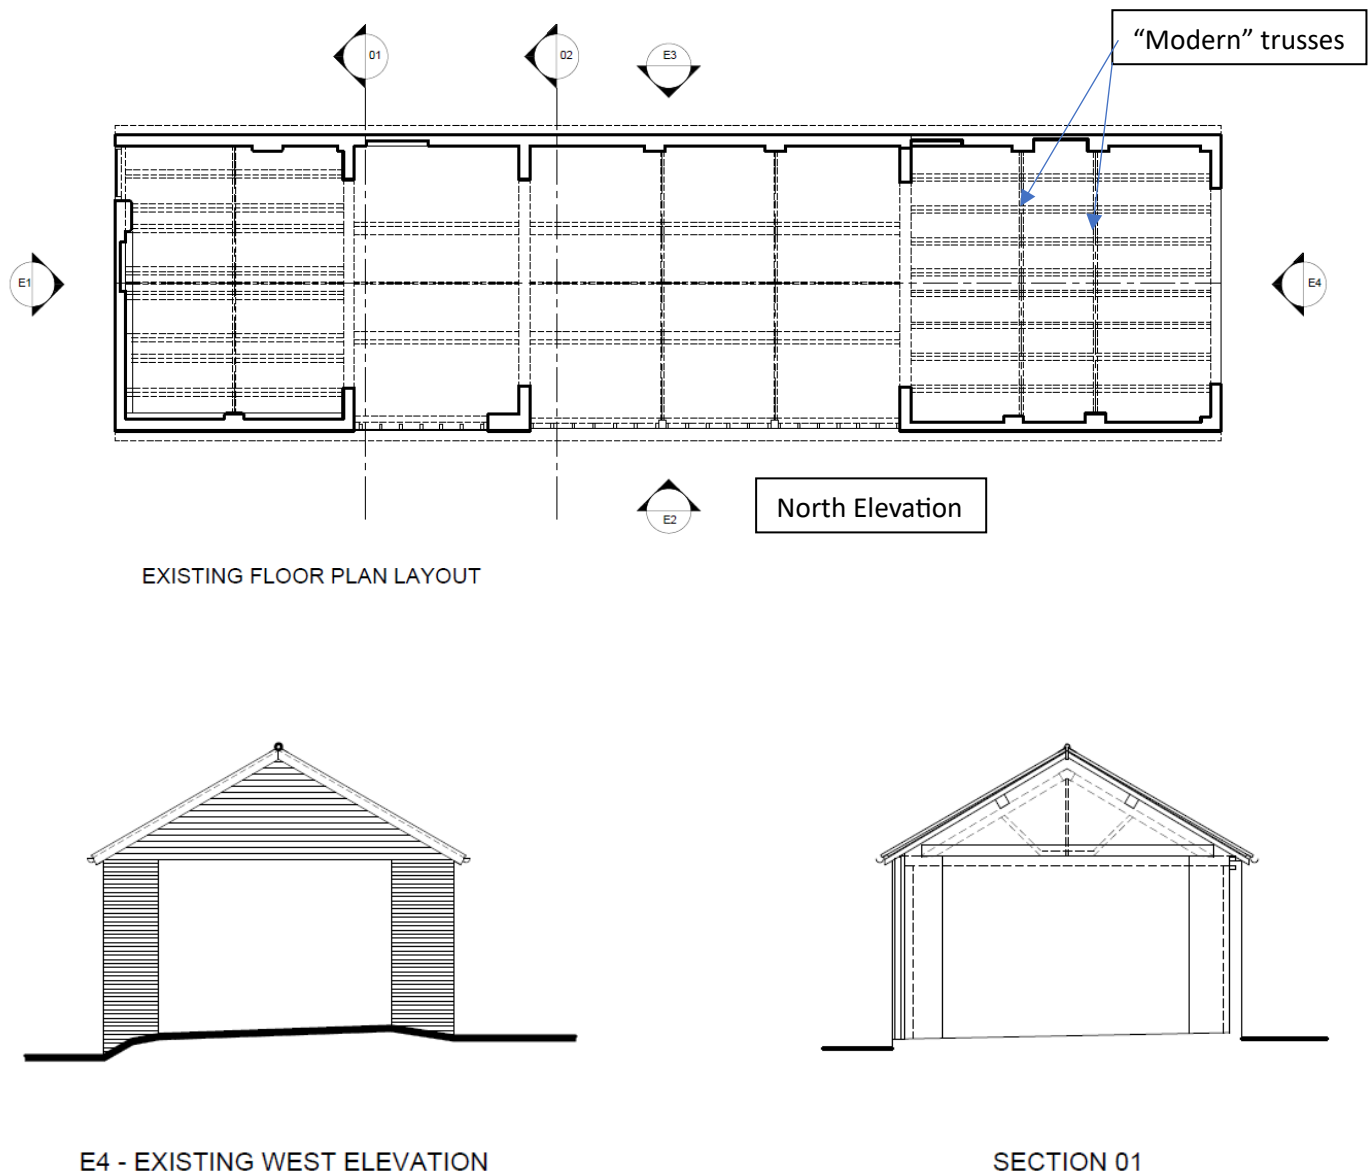
*Figure 4: Excerpt from dwg 2421-P-01 by JJB Architects*

2.4 Annotated excerpts from planning drawings by JJB Architects are shown below:
