JAMES CLAGUE  
ARCHITECTS

THE OLD FORGE

WROTHAM ROAD,  
MEOPHAM,  
GRAVESEND,  
KENT  
DA13 0JE

REPAIR SCHEDULE  
REV 0

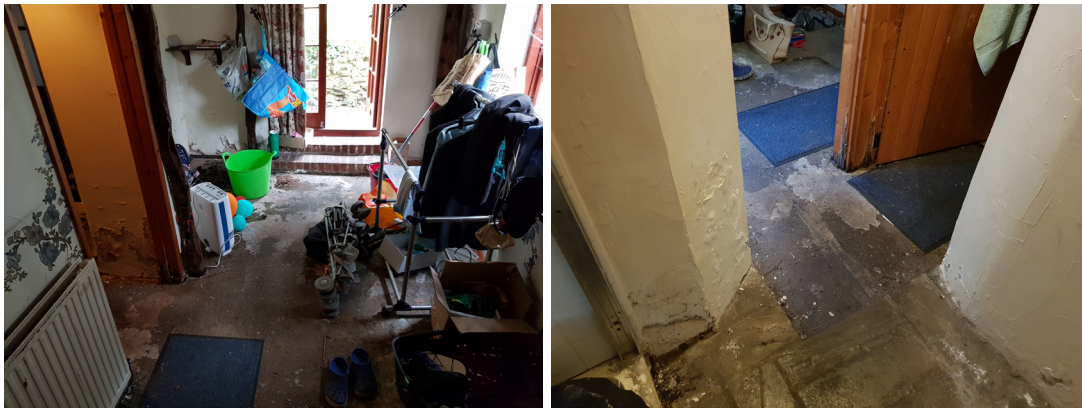
Fig. 17 - Photos of the existing cellar.

The existing ground floor to the proposed Utility area is of concrete construction, which shows

signs of dampness and has damaged the bottom of the walls in the area. A damp proof membrane is to be installed above the existing concrete slab before laying the underfloor heating system and new flooring. The moisture can be driven into the walls, hence, it is important to have the floor's damp proof membrane and wall's damp proof course lapping over each other.
