**LISTED BUILDING APPLICATION ref PP-12034428 (C1332):**  
**Partial discharge of conditions 3.2 and 4.3**  
**Cupola repairs at Gad’s Hill School, Rochester**

Cupola condition discharge

# Brief report outlining the process to arrive at the final approach to cupola repairs

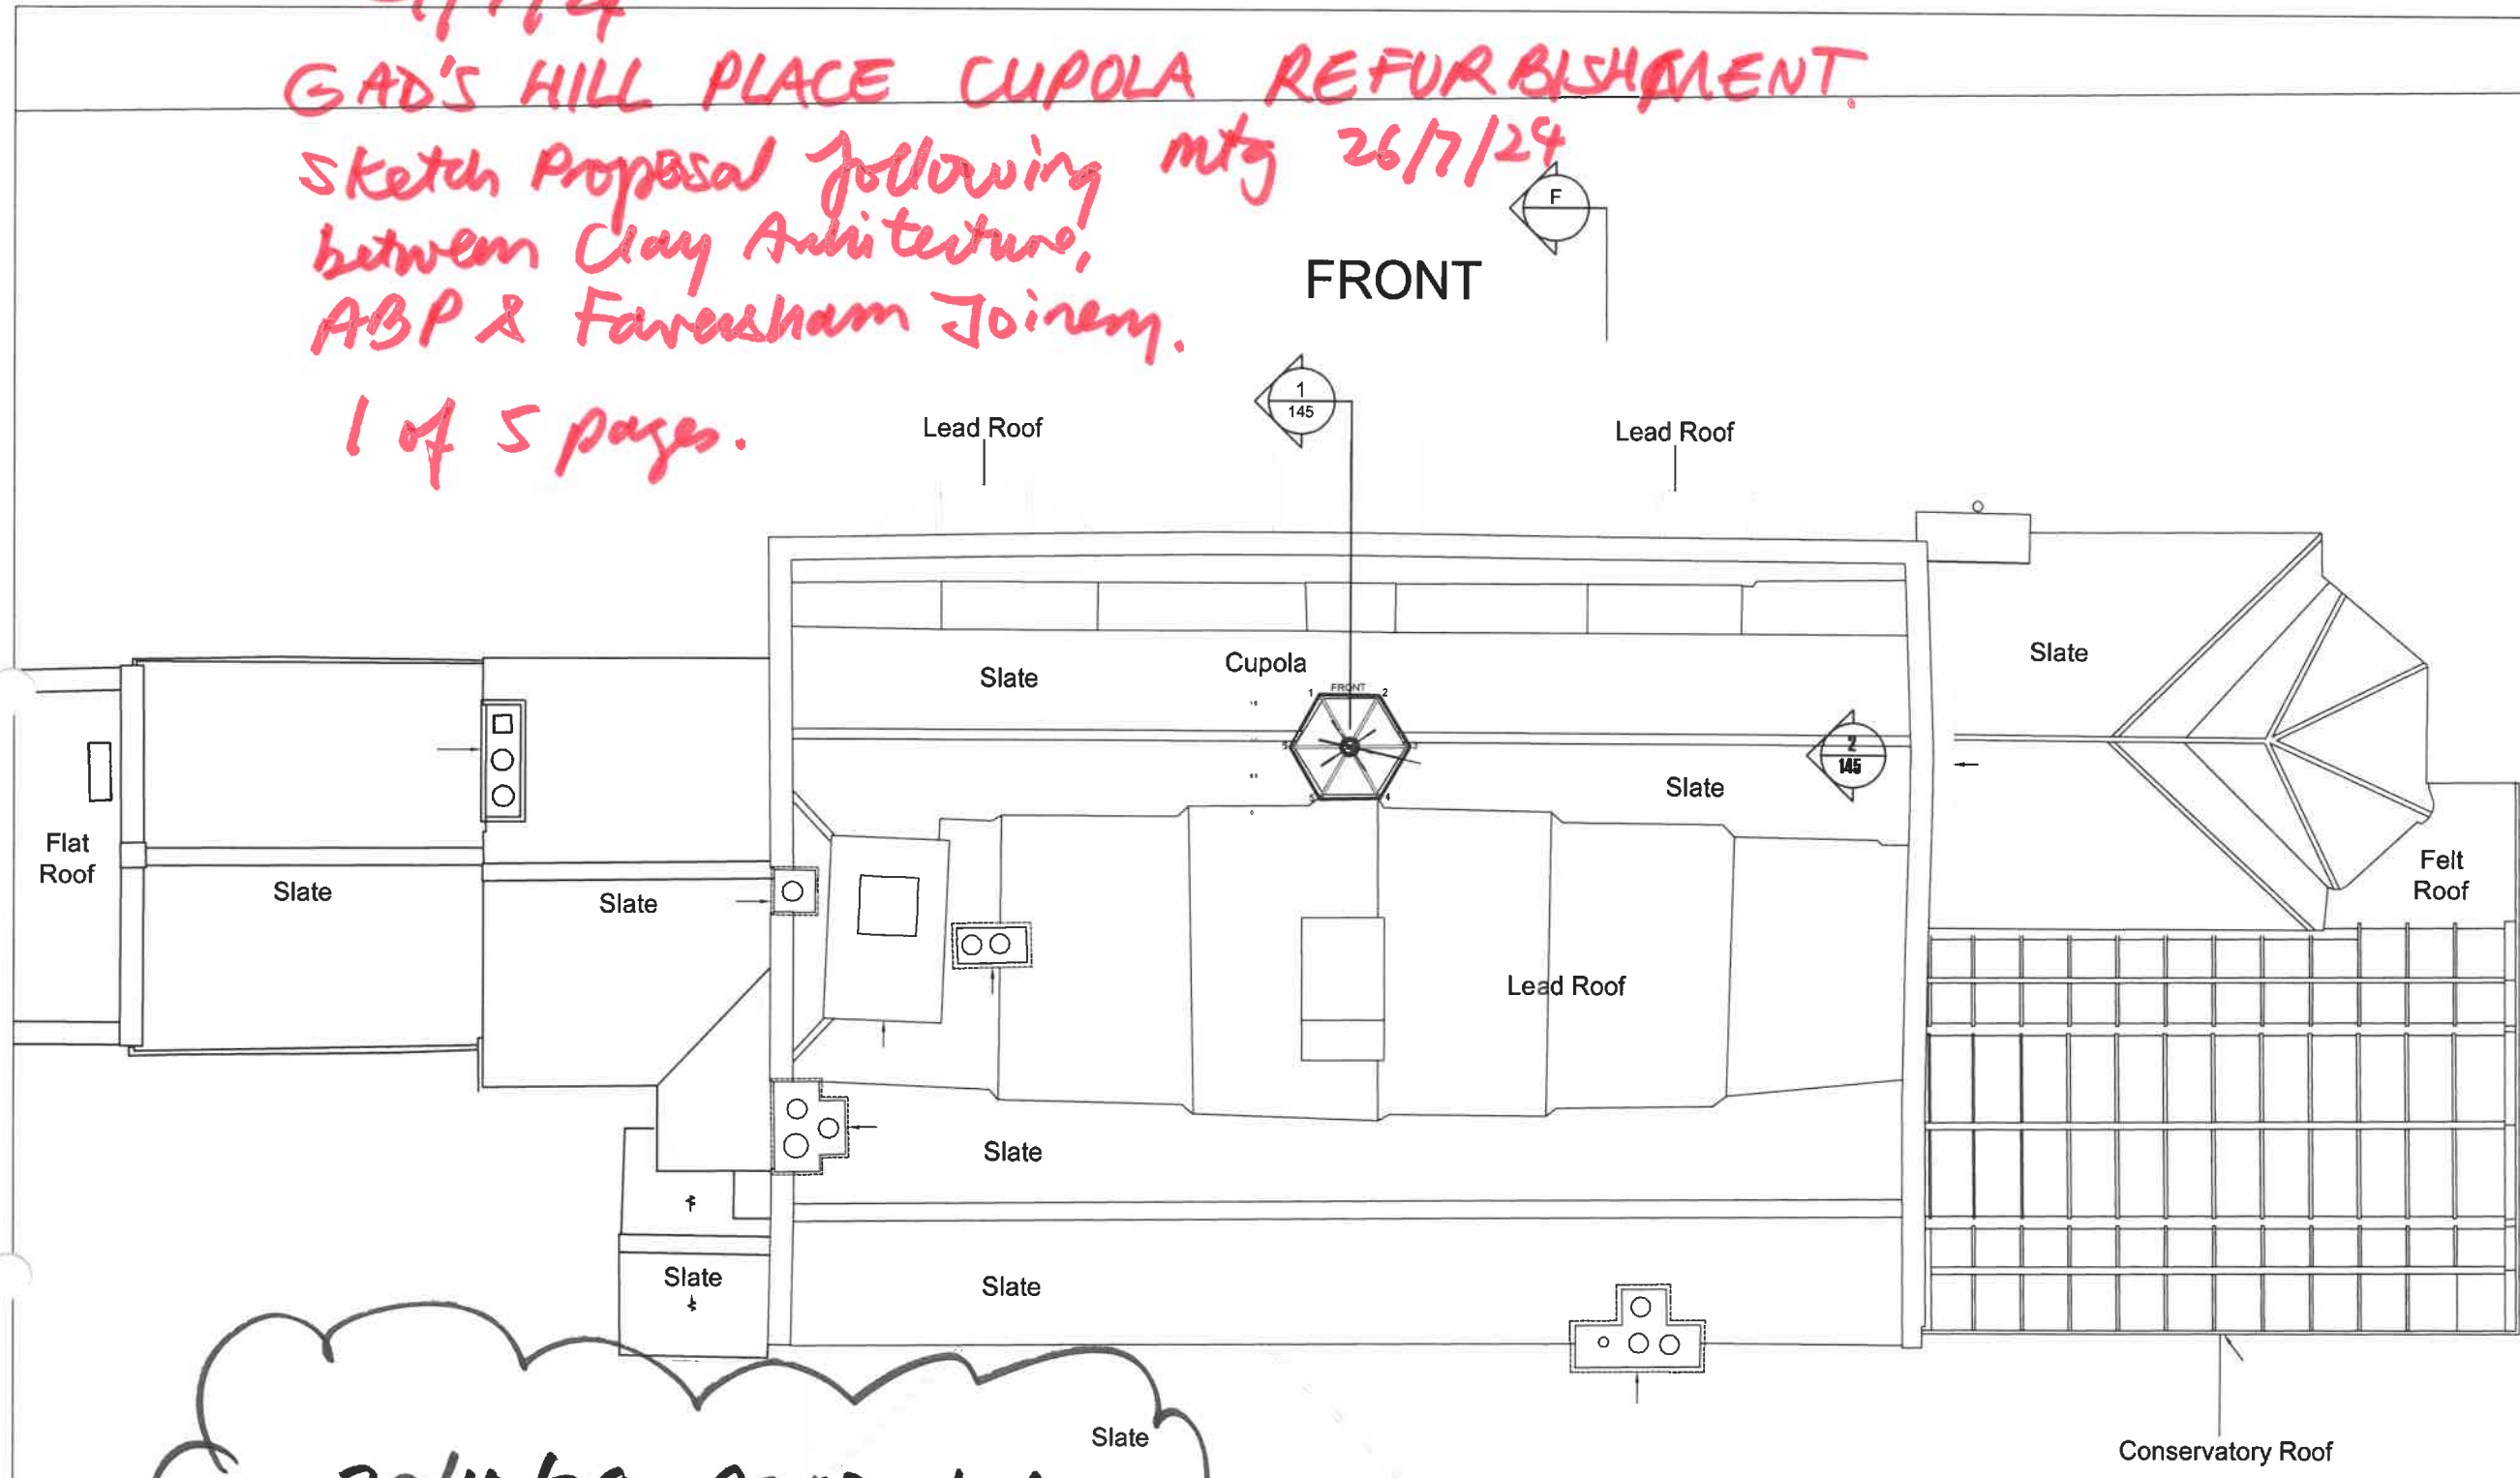
29/7/24  
 GAD'S HILL PLACE CUPOLA REFURBISHMENT.  
 Sketch Proposal following mtg 26/7/24  
 between Clay Architecture,  
 ABP & Fareham Joinery.  
 1 of 5 pages.

DAMAGED STRUT  
TO BE REPLACED  
BY CAP CON LTD.

REPLACEMENT BASE  
FRAME TO REST ON...  
HISTORIC BASE  
FRAME SUPPORTED  
ON...  
EXISTING CEILING  
JOIST

29/10/24 REVISION A.  
 KEY COORDINATING DIMENSIONS  
 ADDED AFTER SITE VISIT &  
 INVESTIGATION 29/10/24.

ARCHED FASCIA  
BOARD DIMS TO  
ENGINEER'S  
RECOMMENDATIONS

REPLACEMENT  
'TAPERED' POSTS
