# STAC architecture

## Roof Works - Maintenance & Repair Statement

**Project:** Repair and maintenance of roof

**Location:** The Mill House, Mill Hill Lane, Shorne. Gravesend. DA12 3HA

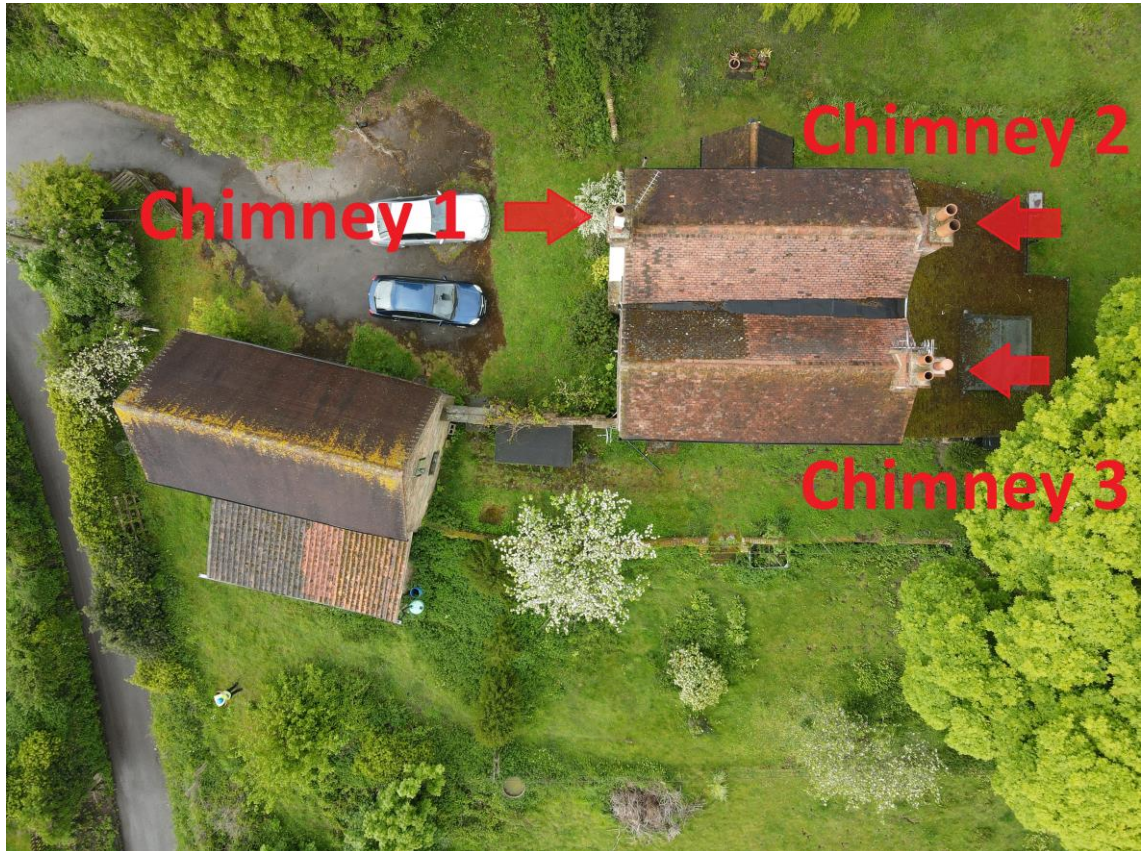
2.14 The Mill House from above with the three chimneys numbered

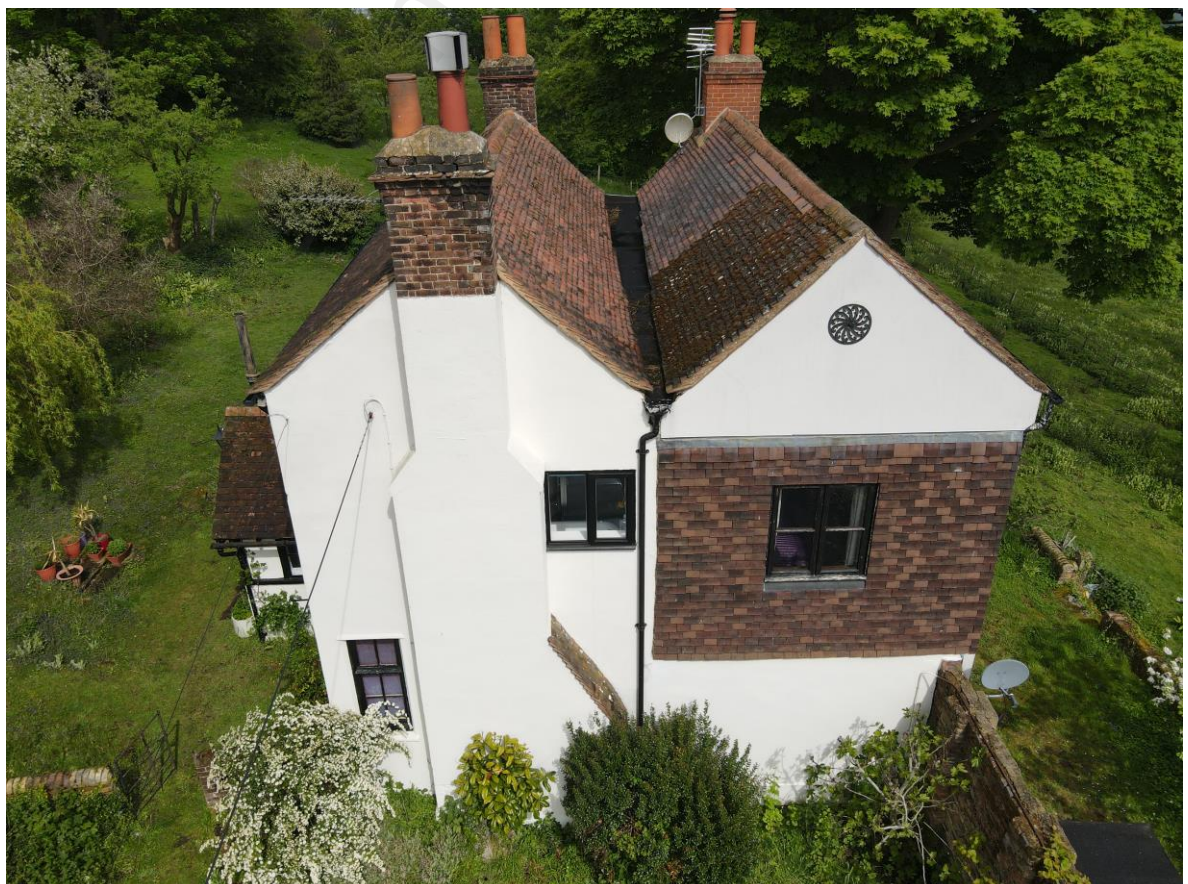
2.14 The Mill House (looking North-West) to elevation facing Mill Hill Lane. Chimney 1 in foreground, Chimney 2 rear left and Chimney 3 rear right
