## Subsidence Overview Report

Mrs Audrey Osborne  
1 Kent Terrace  
Church Street  
Rochester  
Kent  
ME3 7LF

# Factual Report

## SITE INVESTIGATION AND DRAINAGE REPORT CONTENT

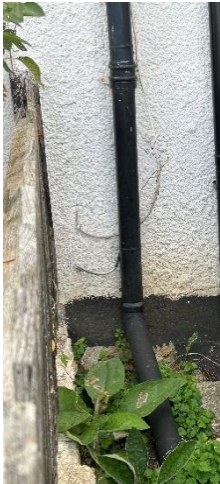
**RWP1**

**Invert depth:** NA

RWP1 & 2 both discharge to surface within the zone of influence. There is insufficient space to install a soakaway. We therefore recommend the insurers diverts them, above ground, away from the zone of influence or installs a water butt.
