**Ref: 3825/20**

**PROPOSED REDEVELOPMENT AT  
THE YARD, LOWER RANGE ROAD,  
GRAVESEND, KENT DA12 2QL**

**PHASE 1 GEO ENVIRONMENTAL DESK STUDY AND  
PHASE 2 REPORT ON SUBSOIL INVESTIGATIONS**

**December 2020**

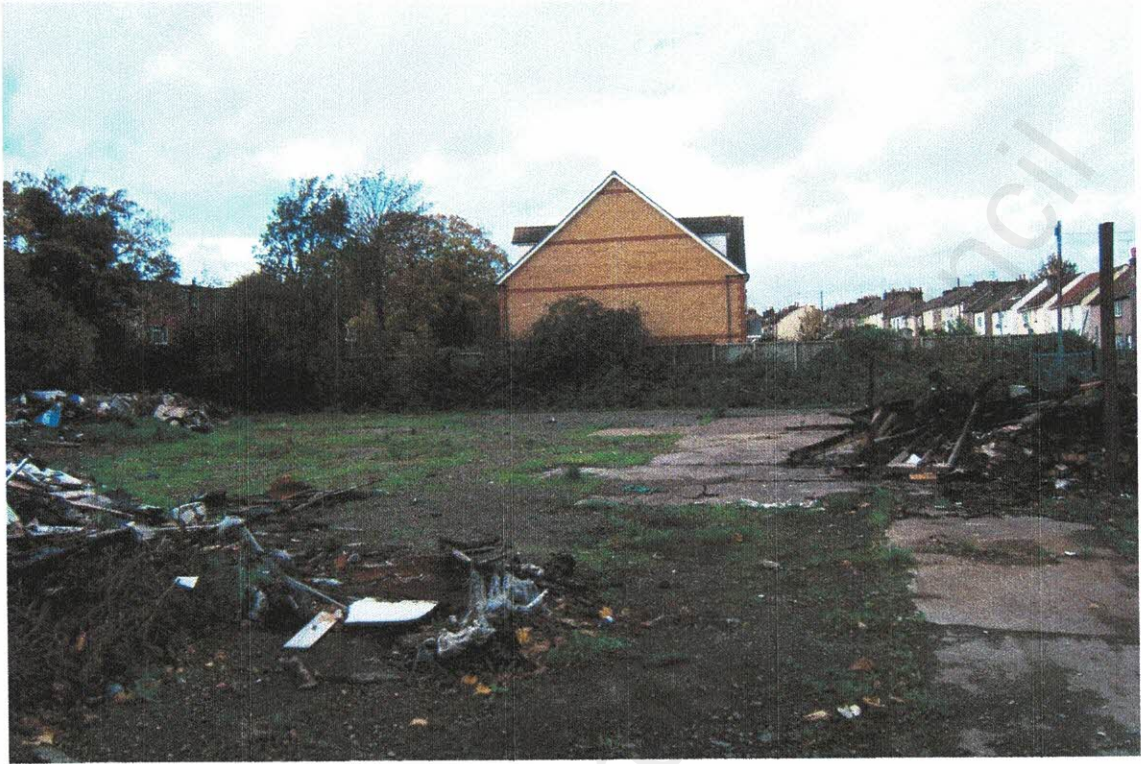
**Plate 7**

- 7.6 A steel incinerator was situated alongside the east boundary of the site (Plate 6).
- 7.7 Deciduous trees and bushes surrounded the east, south and west sides of the site, houses of relatively recent construction being present within the adjacent site to the west (Plate 7). A block of apartments occupied neighbouring land to the south.

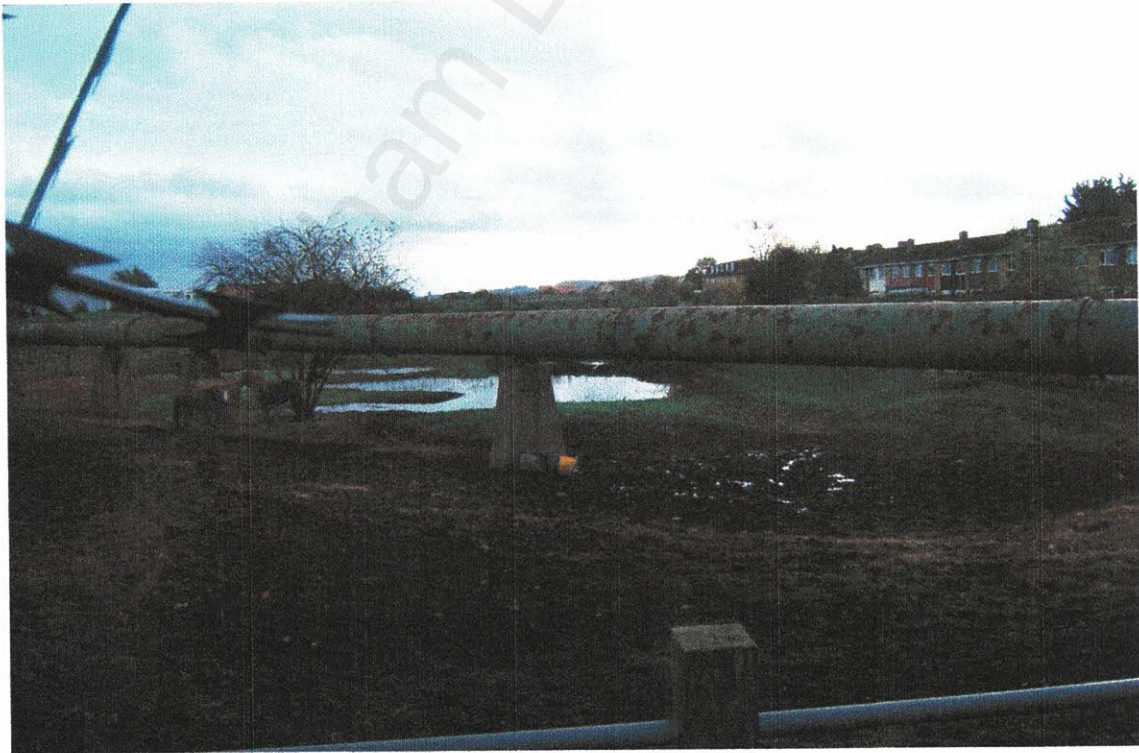
**Plate 8**

- 7.8 Enclosed grazing land containing two horses was located beyond the east side of the site, two ponds of a temporary appearance being in evidence approximately 50m from the site boundary (Plate 8). An above-ground pipeline supported on concrete piers passed through the enclosure, in close proximity to the southeast corner of the
