# Photographic Schedule of Condition

Reference: HC1636

Unit 23, Apex  
Business Park  
Queens Farm Road,  
Shorne  
Gravesend  
Kent  
DA12 3HU

**January  
5th 2024**

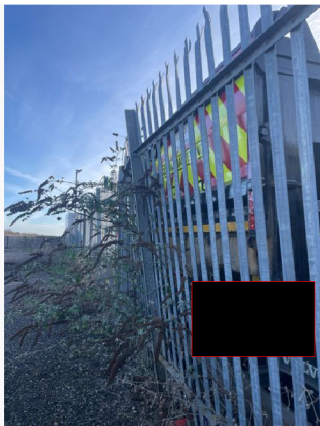
Ref # 1.2

| 1. SOUTH WEST QUADRANT | | | |
|---|---|---|---|
| 1.2 | Boundaries | <p>The south and west boundaries are of palisade fencing.</p> <p>There is also a palisade entrance gate in the south corner.</p> | <p>Fencing is in fair condition overall save for the following defects:</p> <ul style="list-style-type: none"> <li>- Numerous isolated areas impact damage;</li> <li>- Particularly notable impact damage to the south boundary of the 6th and 7th fence panels from the entrance gate. A large vehicle in the neighbouring yard was parked against the fence, causing the fence to lean inwards towards the site during the inspection;</li> <li>- Several fence pales are bent/deformed at the top and bottom;</li> <li>- Occasional vegetation growth through the fencing.</li> </ul> <p>The gate is in fair condition save for:</p> <ul style="list-style-type: none"> <li>- Occasional areas of rust (particularly to the lock area and hinges);</li> <li>- 1 no. gate binds on the ground. There is minor bending to the base of the gate where it binds.</li> </ul> |

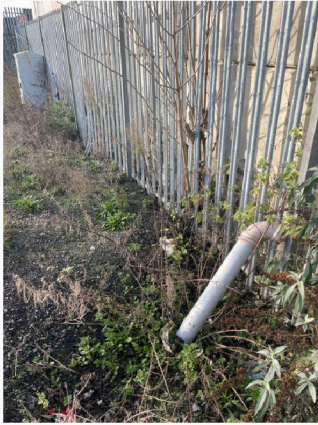
Ref # 1.3

| 1. SOUTH WEST QUADRANT | | | |
|---|---|---|---|
| 1.3 | Miscellaneous | <p>South west corner:</p> <ul style="list-style-type: none"> <li>- Metal pole/column with audio and security camera fit out items;</li> <li>- Metal electrical box.</li> </ul> <p>- Telephone pole approximately central near the west boundary;</p> <p>- Drainage pipe protruding the ground (south end of west boundary);</p> <p>- Previous tenant chattels.</p> | <p>The metal pole/column (with fitout) and electrical box appear to be in fair condition overall. A large electrical cable protrudes from the box and wraps around the perimeter fence loosely before going into the ground near the pole. No electrical items were tested as part of this inspection.</p> <p>No notable defects to the telephone pole save for age related weathering.</p> <p>The piping is in poor condition. It appears to be disconnected and is loosely fitted near the ground.</p> <p>The previous tenant's chattels remain including a rack of canisters and several large cement blocks/ barricades.</p> |

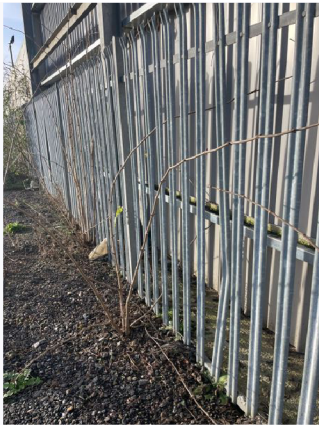
Ref # 2.2

| Ref | Name | Description | Condition |
|---|---|---|---|
| 2.2 | Boundaries | <p>The west boundary is palisade fencing.</p> <p>The north boundary is constructed with a combination of scaffold poles and boards, cement blocks within steel beam fence posts and corrugated metal sheets.</p> | <p>The palisade fencing is in fair condition overall, save for the following defects:</p> <ul style="list-style-type: none"> <li>- Occasional impact damage;</li> <li>- Several fence pales are bent/deformed at the top and bottom;</li> <li>- 1 no. fence pale detached;</li> <li>- Occasional vegetation growth through the fencing.</li> </ul> <p>The north boundary fence is in poor condition overall with the following defects:</p> <ul style="list-style-type: none"> <li>- Several scaffold boards and poles are displaced, damaged or missing;</li> <li>- Scaffold fixings are heavily rusted;</li> <li>- Steel fence posts and fixings to concrete infills are heavily corroded;</li> <li>- Several concrete inserts are displaced or damaged;</li> <li>- Several of the metal corrugated sheets are damaged or corroded.</li> </ul> |

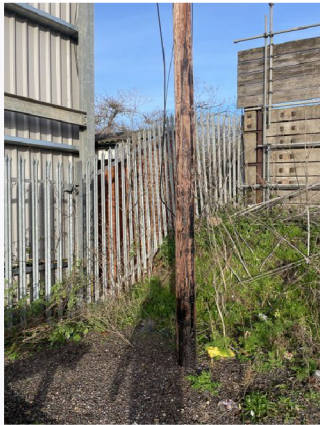
Ref # 2.3

| Ref | Name | Description | Condition |
|---|---|---|---|
| 2.3 | Miscellaneous | <ul style="list-style-type: none"> <li>- Previous tenant chattels;</li> <li>- Telephone pole in the north west corner.</li> </ul> | <p>The previous tenant's chattels remain including a picnic table, truck trailer and pallets of materials.</p> <p>No notable defects to the telephone pole.</p> |
