# CCTV Drainage Survey Report

Former St Johns Ambulance Site,  
Armoury Drive,  
Gravesend,  
Kent DA12 1CT

## u07467 Gravesend - CCTV Survey Report : 16/03/22

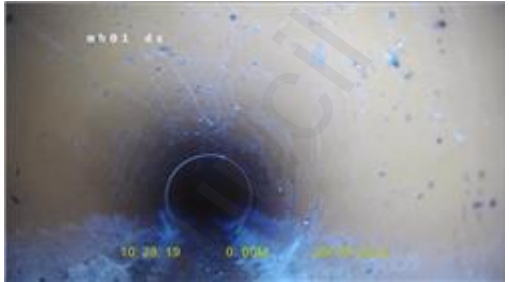
| Pos | Video Ref | Code | Cont. | Description | Image |
|---|---|---|---|---|---|
| 00.0m | 0:00:00 | MH | | Start node type, manhole, reference mh01 ds<br>mh01 ds | Image Provided - Ref: 0_0<br> |

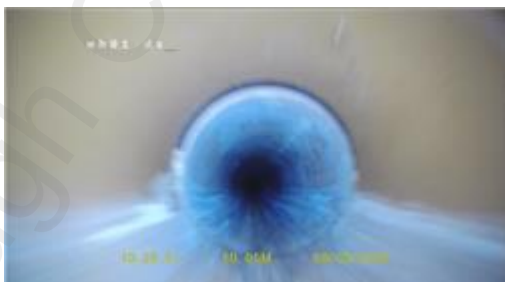
| Pos | Video Ref | Code | Cont. | Description | Image |
|---|---|---|---|---|---|
| 10.1m | 0:00:32 | MC | S1 | 10.1m - 18.3m Material of pipe changes to Vitrified Clay (i.e. all clayware) from 12 o'clock to 12 o'clock | Image Provided - Ref: 0_1<br> |

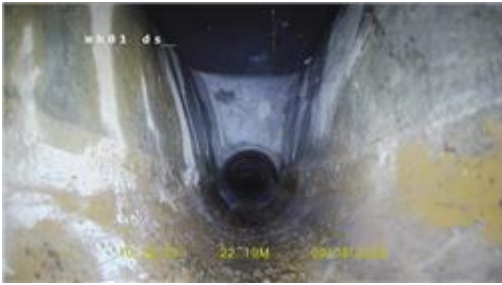
| Pos | Video Ref | Code | Cont. | Description | Image |
|---|---|---|---|---|---|
| 22.2m | | MHF | | Finish node type, manhole, reference mh04 | Image Provided - Ref: 0_9999<br> |

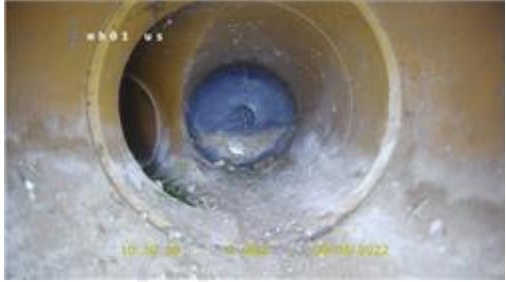
| Pos | Video Ref | Code | Cont. | Description | Image |
|---|---|---|---|---|---|
| 00.0m | 0:00:00 | MH | | Start node type, manhole, reference mh01 us | Image Provided - Ref: 1_0<br> |

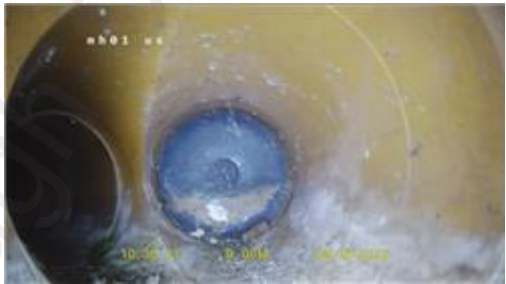
| Pos | Video Ref | Code | Cont. | Description | Image |
|---|---|---|---|---|---|
| 00.2m | 0:00:01 | JN | | Junction at 09 o'clock: 100mm Diameter | Image Provided - Ref: 1_1<br> |

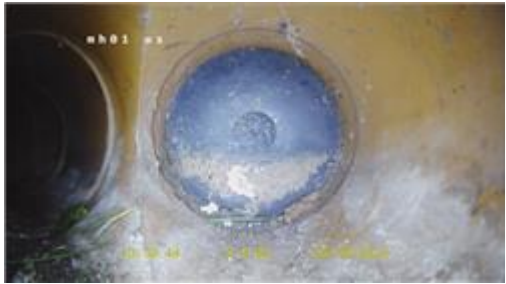
| Pos | Video Ref | Code | Cont. | Description | Image |
|---|---|---|---|---|---|
| 00.4m | | SA | | Survey abandoned<br>Survey Abandoned - Capped Off | Image Provided - Ref: 1_9999<br> |

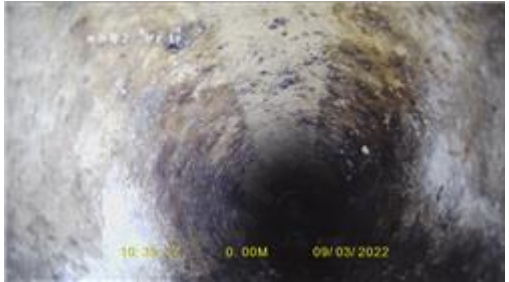
| Pos | Video Ref | Code | Cont. | Description | Image |
|---|---|---|---|---|---|
| 00.0m | 0:00:00 | MH | | Start node type, manhole, reference mh02 br1 | Image Provided - Ref: 2_0<br> |

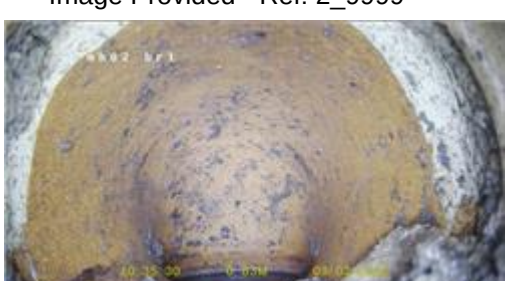
| Pos | Video Ref | Code | Cont. | Description | Image |
|---|---|---|---|---|---|
| 00.9m | | GYF | | Finish node type Gully, reference gully gully | Image Provided - Ref: 2_9999<br> |

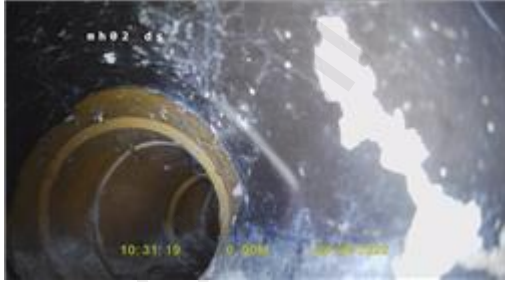
| Pos | Video Ref | Code | Cont. | Description | Image |
|---|---|---|---|---|---|
| 00.0m | 0:00:00 | MH | | Start node type, manhole, reference mh02 ds | Image Provided - Ref: 3_0<br> |

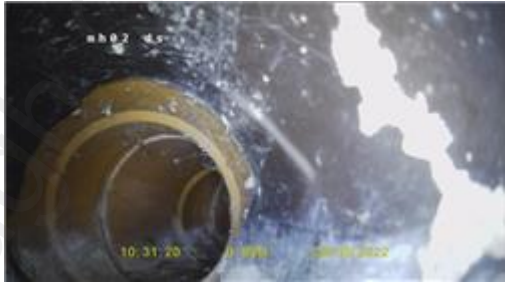
| Pos | Video Ref | Code | Cont. | Description | Image |
|---|---|---|---|---|---|
| 00.3m | 0:00:01 | LR | | Line of drain/sewer deviates right | Image Provided - Ref: 3_1<br> |

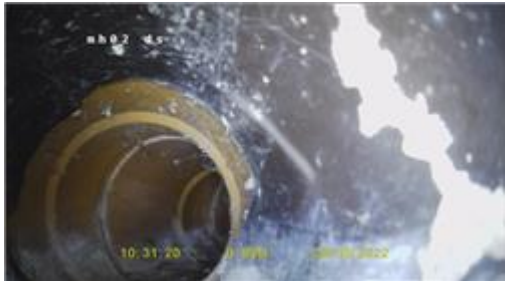
| Pos | Video Ref | Code | Cont. | Description | Image |
|---|---|---|---|---|---|
| 00.3m | 0:00:01 | MC | | Material of pipe changes to Polyethylene from 12 o'clock to 12 o'clock | Image Provided - Ref: 3_2<br> |

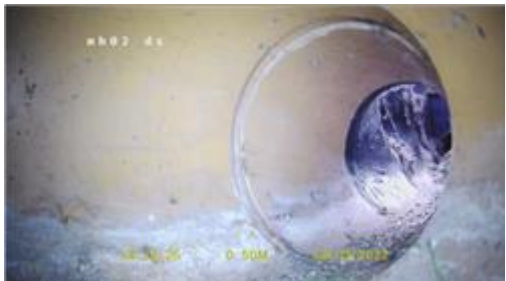
| Pos | Video Ref | Code | Cont. | Description | Image |
|---|---|---|---|---|---|
| 00.6m | | BRF | | Finish node type, major connection without manhole, reference connection connection | Image Provided - Ref: 3_9999<br> |

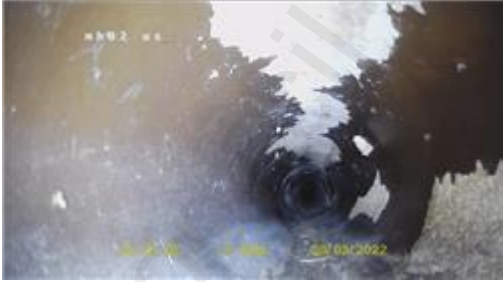
| Pos | Video Ref | Code | Cont. | Description | Image |
|---|---|---|---|---|---|
| 00.0m | 0:00:00 | MH | | Start node type, manhole, reference mh02 us | Image Provided - Ref: 4_0<br> |

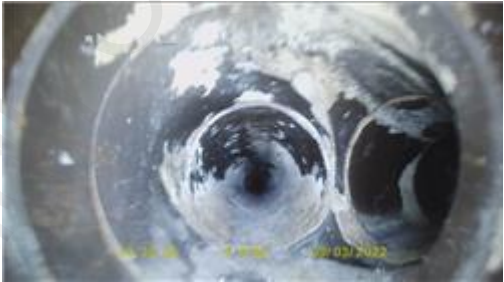
| Pos | Video Ref | Code | Cont. | Description | Image |
|---|---|---|---|---|---|
| 00.5m | 0:00:06 | JN | | Junction at 03 o'clock: 100mm Diameter | Image Provided - Ref: 4_1<br> |

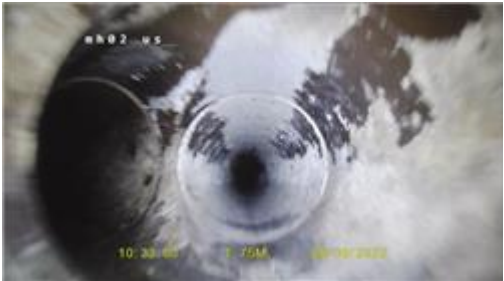
| Pos | Video Ref | Code | Cont. | Description | Image |
|---|---|---|---|---|---|
| 01.9m | 0:00:14 | JN | | Junction at 09 o'clock: 100mm Diameter | Image Provided - Ref: 4_2<br> |

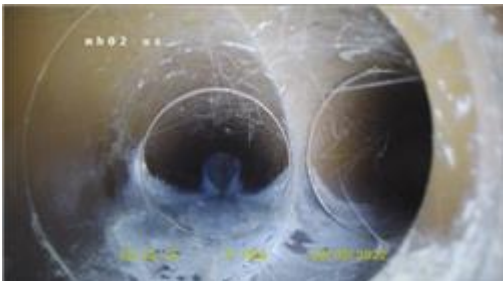
| Pos | Video Ref | Code | Cont. | Description | Image |
|---|---|---|---|---|---|
| 03.9m | 0:00:26 | JN | | Junction at 03 o'clock: 100mm Diameter | Image Provided - Ref: 4_3<br> |

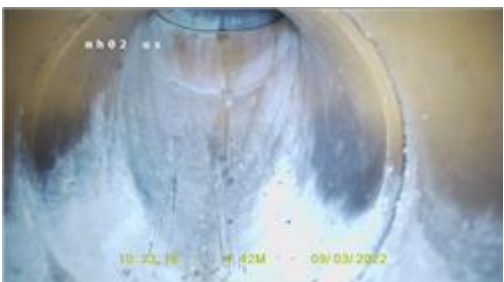
| Pos | Video Ref | Code | Cont. | Description | Image |
|---|---|---|---|---|---|
| 04.6m | 0:00:29 | LU | | Line of drain/sewer deviates up | Image Provided - Ref: 4_4<br> |

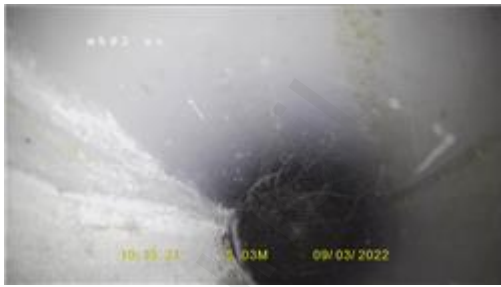
| Pos | Video Ref | Code | Cont. | Description | Image |
|---|---|---|---|---|---|
| 05.0m | | BRF | | Finish node type, major connection without manhole, reference downpipe downpipe | <p>Image Provided - Ref: 4_9999</p> |

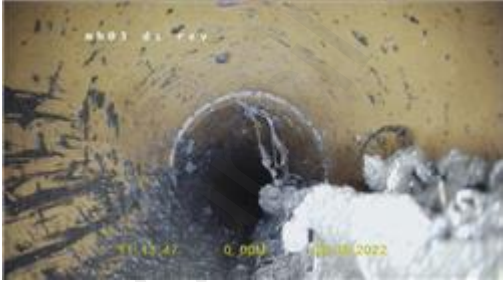
| Pos | Video Ref | Code | Cont. | Description | Image |
|---|---|---|---|---|---|
| 00.0m | 0:02:41 | MH | | Start node type, manhole, reference mh03 ds<br>mh03 ds | Image Provided - Ref: 5_0<br> |

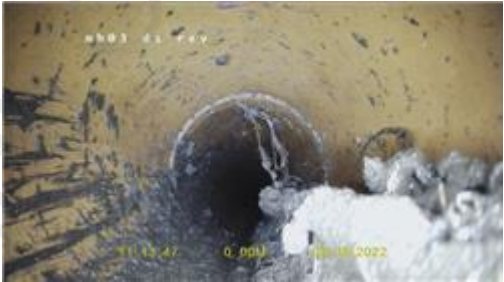
| Pos | Video Ref | Code | Cont. | Description | Image |
|---|---|---|---|---|---|
| 00.0m | 0:02:41 | DES | | Settled deposits fine: 10% cross-sectional area loss - Severity 2 | Image Provided - Ref: 5_3<br> |

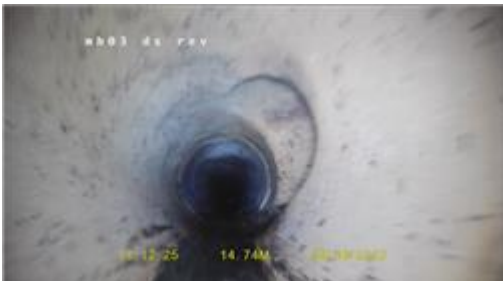
| Pos | Video Ref | Code | Cont. | Description | Image |
|---|---|---|---|---|---|
| 15.0m | 0:01:19 | JN | | Junction at 03 o'clock: 100mm Diameter | Image Provided - Ref: 5_2<br> |

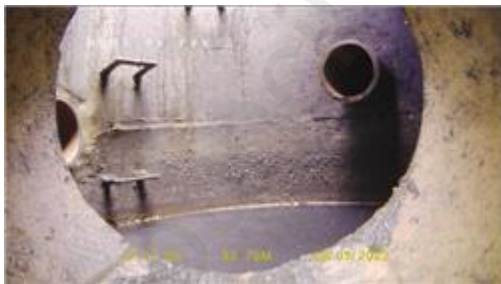
| Pos | Video Ref | Code | Cont. | Description | Image |
|---|---|---|---|---|---|
| 32.8m | | MHF | | Finish node type, manhole, reference mh05 | <p>Image Provided - Ref: 5_9999</p> |

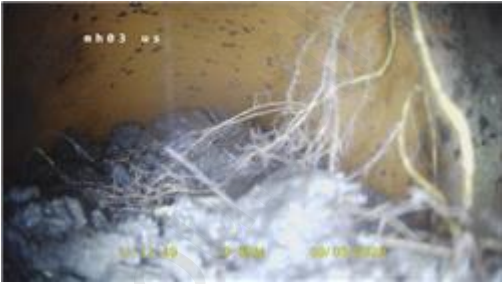
| Pos | Video Ref | Code | Cont. | Description | Image |
|---|---|---|---|---|---|
| 00.0m | 0:00:00 | MH | | Start node type, manhole, reference mh03 us<br>mh03 us | Image Provided - Ref: 6_0<br> |

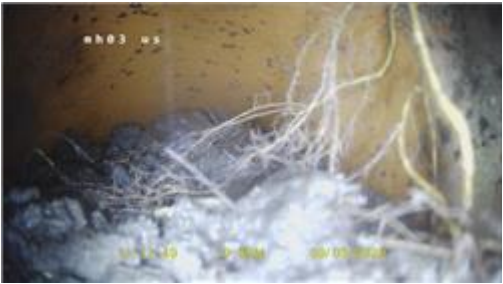
| Pos | Video Ref | Code | Cont. | Description | Image |
|---|---|---|---|---|---|
| 00.0m | | SA | | Survey abandoned<br>Survey Abandoned - Capped Off | Image Provided - Ref: 6_9999<br> |

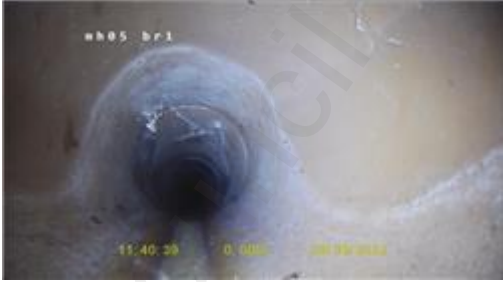
| Pos | Video Ref | Code | Cont. | Description | Image |
|---|---|---|---|---|---|
| 00.0m | 0:00:00 | MH | | Start node type, manhole, reference mh05 br1 | Image Provided - Ref: 8_0<br> |

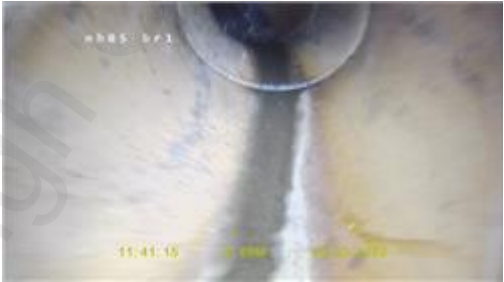
| Pos | Video Ref | Code | Cont. | Description | Image |
|---|---|---|---|---|---|
| 06.0m | 0:00:36 | LU | | Line of drain/sewer deviates up | Image Provided - Ref: 8_1<br> |

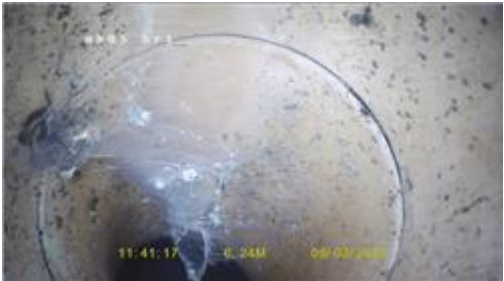
| Pos | Video Ref | Code | Cont. | Description | Image |
|---|---|---|---|---|---|
| 06.4m | 0:00:38 | LD | | Line of drain/sewer deviates down | Image Provided - Ref: 8_2<br> |

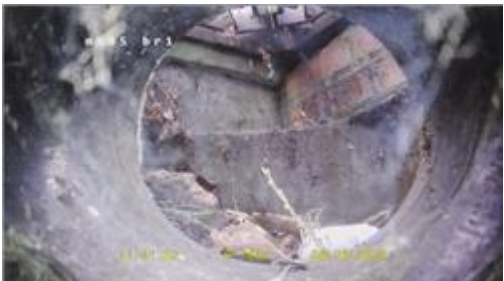
| Pos | Video Ref | Code | Cont. | Description | Image |
|---|---|---|---|---|---|
| 06.8m | | GYF | | Finish node type Gully, reference gully gully | Image Provided - Ref: 8_9999<br> |

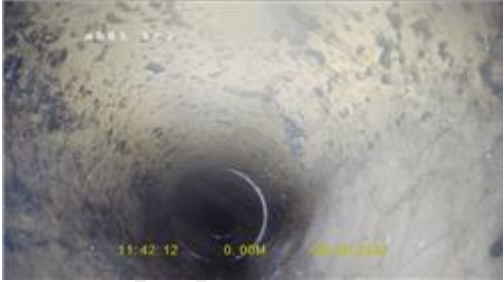
| Pos | Video Ref | Code | Cont. | Description | Image |
|---|---|---|---|---|---|
| 00.0m | 0:00:00 | MH | | Start node type, manhole, reference mh05 br2 | Image Provided - Ref: 9_0<br> |

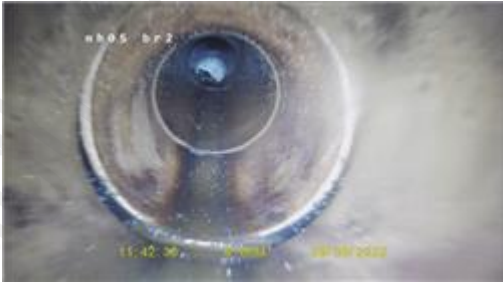
| Pos | Video Ref | Code | Cont. | Description | Image |
|---|---|---|---|---|---|
| 04.7m | 0:00:20 | OJM | | Open joint medium - Severity 2 | Image Provided - Ref: 9_1<br> |

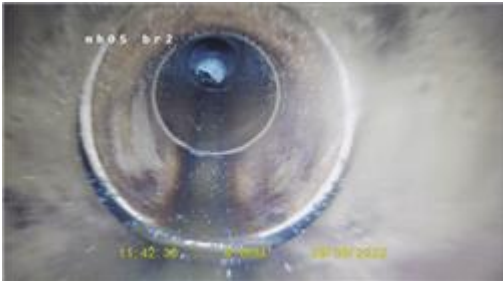
| Pos | Video Ref | Code | Cont. | Description | Image |
|---|---|---|---|---|---|
| 04.8m | 0:00:20 | LU | | Line of drain/sewer deviates up | Image Provided - Ref: 9_2<br> |

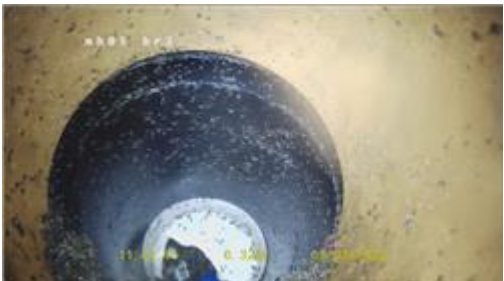
| Pos | Video Ref | Code | Cont. | Description | Image |
|---|---|---|---|---|---|
| 06.4m | 0:00:28 | LD | | Line of drain/sewer deviates down | Image Provided - Ref: 9_3<br> |

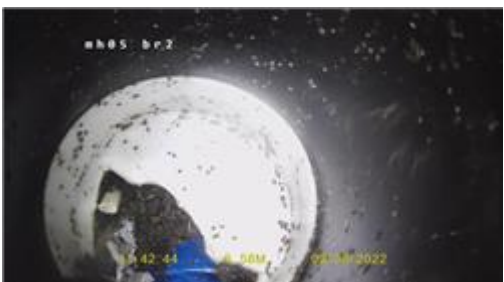
| Pos | Video Ref | Code | Cont. | Description | Image |
|---|---|---|---|---|---|
| 06.6m | | GYF | | Finish node type Gully, reference gully gully | Image Provided - Ref: 9_9999<br> |

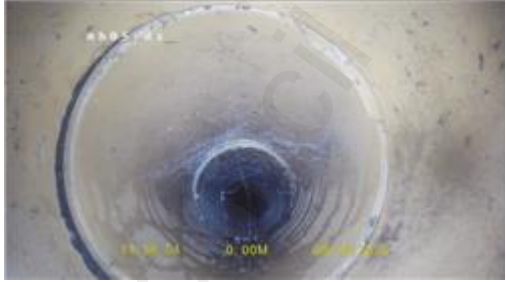
| Pos | Video Ref | Code | Cont. | Description | Image |
|---|---|---|---|---|---|
| 00.0m | 0:00:00 | MH | | Start node type, manhole, reference mh05 ds<br>mh05 ds | Image Provided - Ref: 10_0<br> |

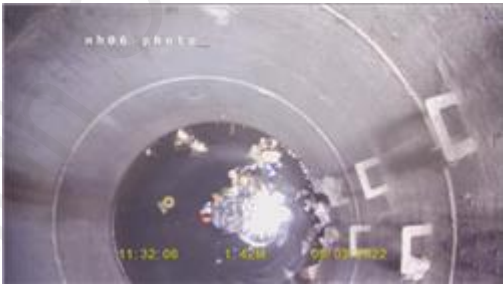
| Pos | Video Ref | Code | Cont. | Description | Image |
|---|---|---|---|---|---|
| 00.0m | 0:00:11 | REM | | General remark Borehole Soakaway | Image Provided - Ref: 11_1<br> |

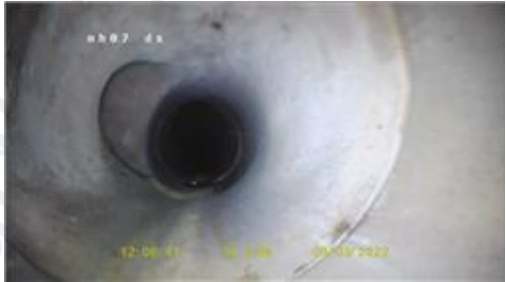
| Pos | Video Ref | Code | Cont. | Description | Image |
|---|---|---|---|---|---|
| 16.5m | 0:01:10 | JN | | Junction at 09 o'clock: 100mm Diameter | Image Provided - Ref: 12_1<br> |

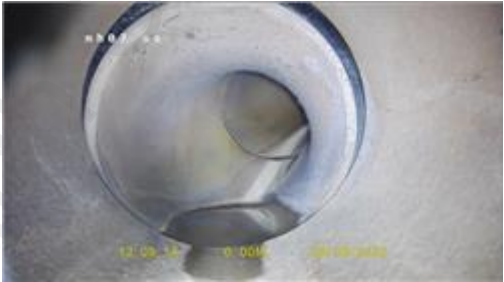
| Pos | Video Ref | Code | Cont. | Description | Image |
|---|---|---|---|---|---|
| 00.2m | 0:00:01 | JDM | | Joint displaced medium - Severity 2 | Image Provided - Ref: 13_1<br> |

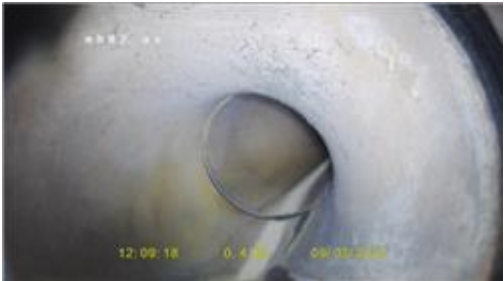
| Pos | Video Ref | Code | Cont. | Description | Image |
|---|---|---|---|---|---|
| 00.5m | 0:00:05 | LR | | Line of drain/sewer deviates right | Image Provided - Ref: 13_2<br> |

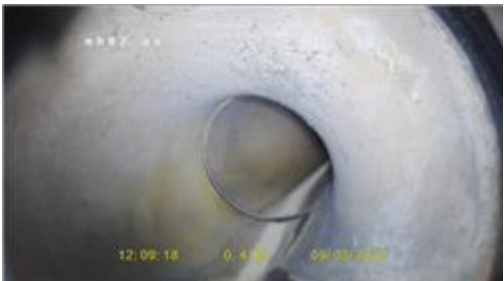
| Pos | Video Ref | Code | Cont. | Description | Image |
|---|---|---|---|---|---|
| 00.5m | 0:00:05 | LU | | Line of drain/sewer deviates up | Image Provided - Ref: 13_3<br> |

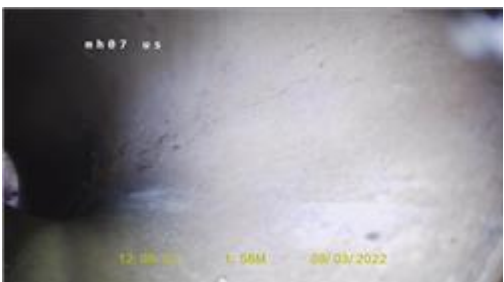
| Pos | Video Ref | Code | Cont. | Description | Image |
|---|---|---|---|---|---|
| 01.7m | 0:00:14 | LL | | Line of drain/sewer deviates left | Image Provided - Ref: 13_4<br> |

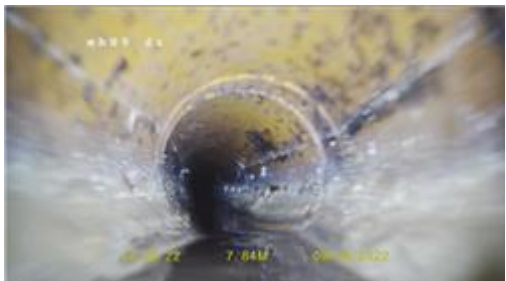
| Pos | Video Ref | Code | Cont. | Description | Image |
|---|---|---|---|---|---|
| 07.9m | 0:00:37 | LL | | Line of drain/sewer deviates left | Image Provided - Ref: 14_2<br> |

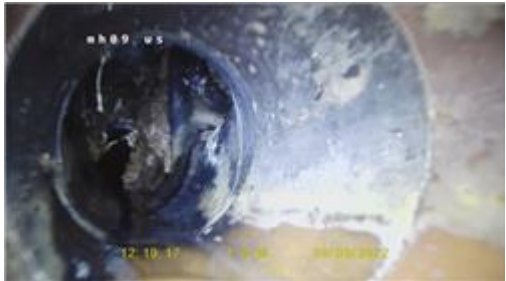
| Pos | Video Ref | Code | Cont. | Description | Image |
|---|---|---|---|---|---|
| 01.7m | 0:00:10 | LL | | Line of drain/sewer deviates left | Image Provided - Ref: 15_2<br> |

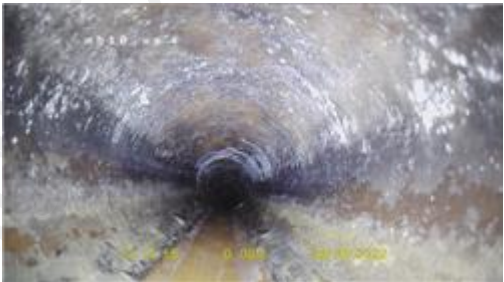
| Pos | Video Ref | Code | Cont. | Description | Image |
|---|---|---|---|---|---|
| 00.0m | 0:00:00 | DEF | S1 | Attached deposits, fouling 0m - 11.2m from 04 o'clock to 08 o'clock: 5% cross-sectional area loss - Severity 2 | Image Provided - Ref: 16_1<br> |

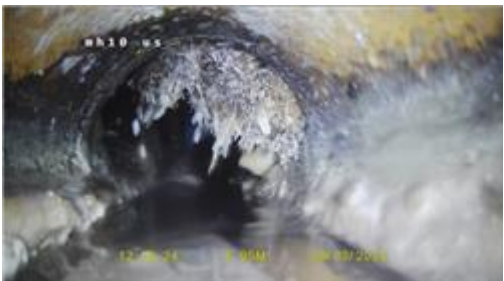
| Pos | Video Ref | Code | Cont. | Description | Image |
|---|---|---|---|---|---|
| 05.0m | 0:00:27 | RM | | Roots mass: 10% cross-sectional area loss - Severity 4 | Image Provided - Ref: 16_2<br> |

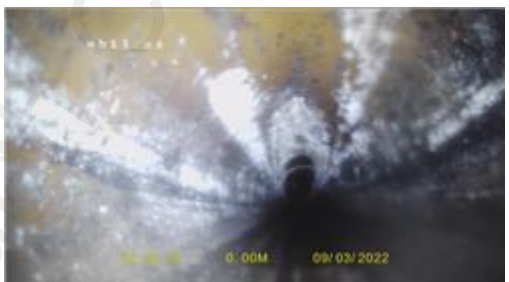
| Pos | Video Ref | Code | Cont. | Description | Image |
|---|---|---|---|---|---|
| 00.0m | 0:00:00 | DEF | S1 | Attached deposits, fouling 0m - 3m from 03 o'clock to 09 o'clock: 5% cross-sectional area loss - Severity 2 | Image Provided - Ref: 19_1<br> |

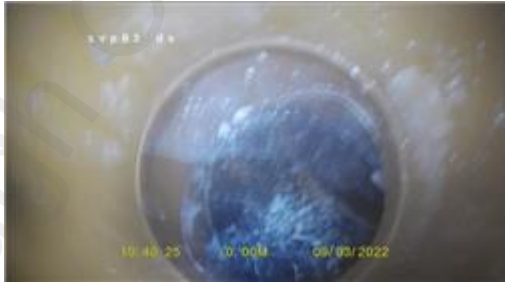
| Pos | Video Ref | Code | Cont. | Description | Image |
|---|---|---|---|---|---|
| 00.3m | 0:00:00 | LU | | Line of drain/sewer deviates up<br>Drain Lines Level | Image Provided - Ref: 20_1<br> |
