## 5.0 RECORD OF IMPLIMENTED WORK

5.0 RECORD OF IMPLEMENTED WORK

5.1 Appraisal of Exterior Materials & Finishes

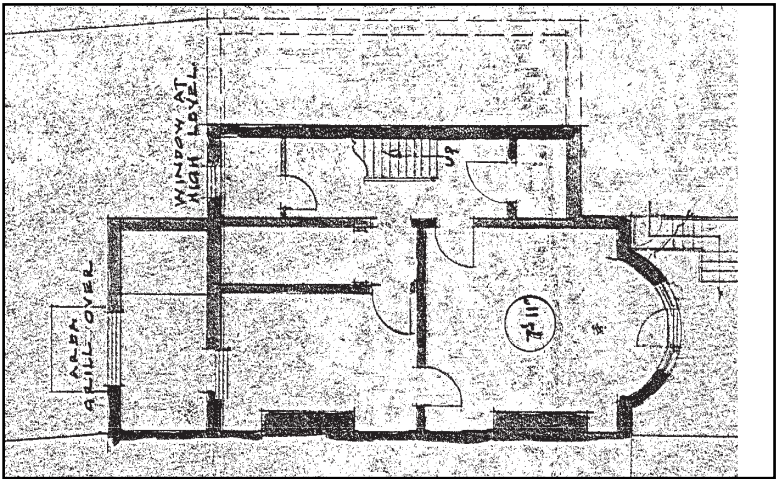
Fig. 20: Basement survey drawing by Direct Construction Surveyors & associated on site imagery 2025

- ✓ brick vaulted ceiling extant
- ✓ fire rated under-stairs cupboard
- ✓ stone slabs evident in situ
- ✓ previously in-filled door revealed, retained in situ
- ✗ area severed
- ✓ plasterboard lining removed
- ✓ later partition relocated
- ✓ lightwell area revealed
- ✗ door no longer evident
- ✓ hoist shaft removed
- ✗ rationale for new svp sought
- ✓ lifted stone slabs evident on site (stacked within rear yard)

general:  
✗ fenestration lost - possibly removed prior to un-lawful works when plasterboard was inserted internally to all walls.

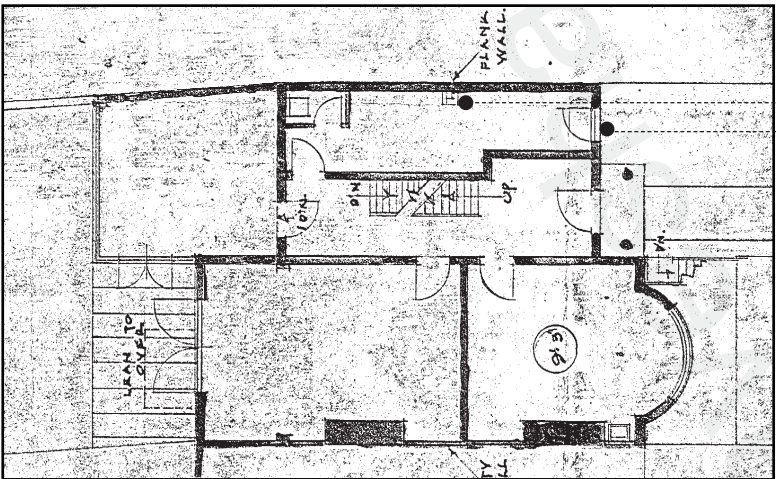
Fig. 21: GF survey drawing by Direct Construction Surveyors & associated on site imagery 2025

- ✓ utilities generally located in west wing, as such reliant on original svp location
- ✗ window aperture filled new svp from basement
- ✓ lgf lobby removed
- ✓ partition pulled forward to give greater clearance to staircase
- ✓ in-filled - door location evident
- ✓ utilises door apertures
- ✓ less detrimental room division better reading of plan form
- ✓ hoist lift removed
- ✓ general ability to read original plan form
- ✓ keeps utilities in later wing

evidence of floor board, skirting infill and replacement where removed lgf lobby was formed.

side wing front service access night safe infill evident

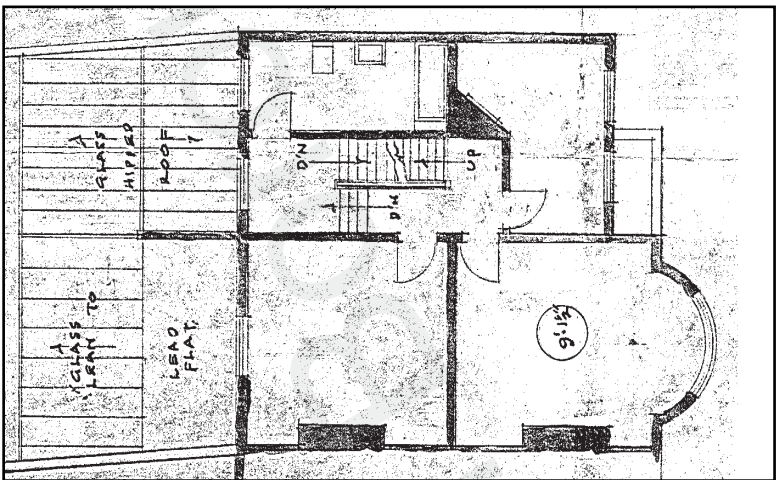
- ✗ partition installed (over steel-work below)
- ✓ wc partitions removed
- ✗ chimney removed
- ✓ door infill
- ✓ door infill
- ✓ lobby partition formed
- ✓ arch infill with shadow gap
- general:
  - ✓ arrangement retains original plan form
  - ✓ door infill's retain doors and decorative moulding features in situ
  - ✓ utilises existing openings for ventilation and flues

office wc's installed  
utilising residential  
bathroom

doors and apertures  
intact

dividing wall removed  
(nibs retained)

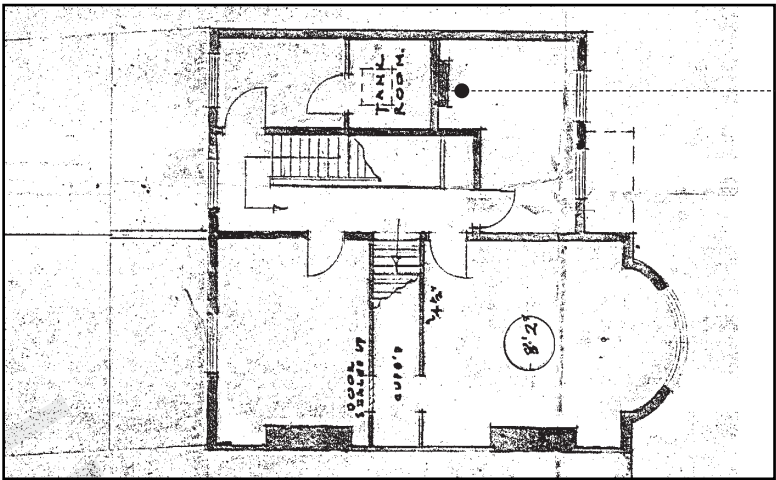
chimney breast evidenced

wc's located  
partition formed

original location of doors and apertures  
locations evident

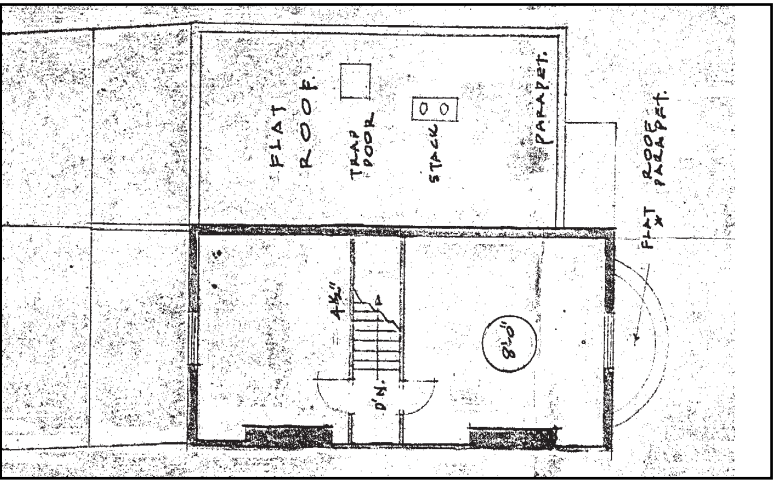
Fig. 24: 3F survey drawing by Direct Construction Surveyors & associated on site imagery 2025

✓ Original slate hipped roof to side wing with tile vents revealed in drone footage, stairwell window over

✗ partitions formed

general:  
minimal intervention; reversible partitions to wc & store

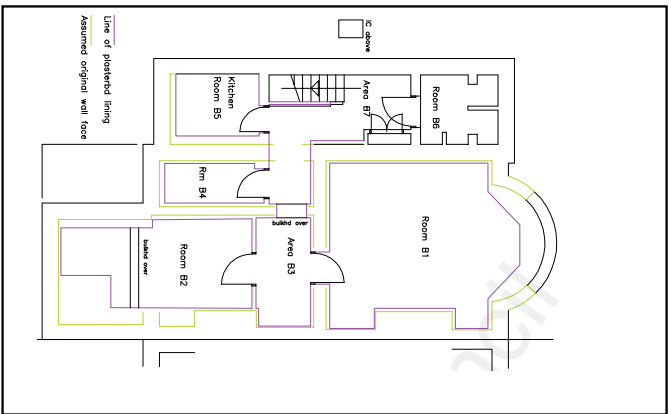
Fig. 25 LGF survey drawing by Direct Construction Surveyors & associated on site imagery 2025

Structural Engineer Inspection revealed no major movement or settle-ment was suspected, despite cracking through the stonework over the basement bay, brickwork was in reasonable conditions with no major cracking at low level and as such, However, the chimney revealed little or no foundation below and some vertical cracking was evident.

No cracking or movement was apparent to the front Bay brickwork internally
