# Drainage Report

**Kimberly Clark**  
**Northfleet Mill**  
**Gravesend**  
**Kent**  
**DA11 9AD**

## A60790 Kimberly Clark Northfleet Mill DA11 9AD - CCTV Survey Report : 28/07/23

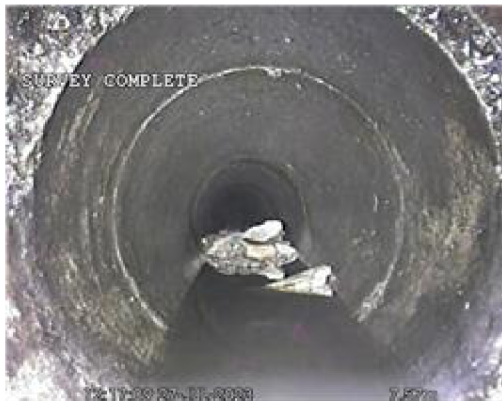
| Pos | Video Ref | Code | Description | Image |
|---|---|---|---|---|
| 07.57m | | MHF | Finish node type, manhole MH66 | <p>Image Provided - Ref: 1_9999</p> |

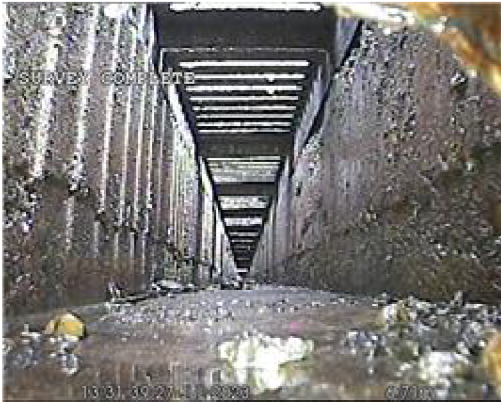
| <b>Section: 3</b><br><br><b>From: MH65</b><br><b>To: ACO</b> | <ul style="list-style-type: none"> <li>• Longitudinal crack at joint observed at 0.00m.</li> <li>• Circumferential crack observed @ 4.67m.</li> <li>• Pipe in extremely poor condition from 5.40m-6.70m with multiple cracks and open fractures observed. Risk of total collapse if line not repaired.</li> <li>• Recommend structural lining of 6.70m 225Ø pipe.</li> </ul> | <b>DRB Grade: C</b><br><b>Pipe Size: 225</b><br><b>Material: Vitrified Clay (i.e. all clayware)</b><br><b>Use: Surface Water</b> |

| Pos | Video Ref | Code | Description | Image |
|---|---|---|---|---|
| 06.71m | | GYF | Finish node type Gully ACO | <p>Image Provided - Ref: 2_9999</p> |

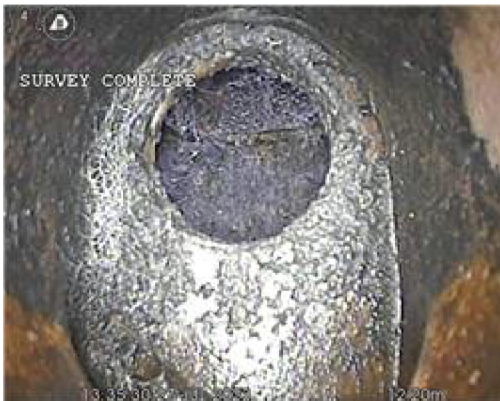
| Pos | Video Ref | Code | Description | Image |
|---|---|---|---|---|
| 12.20m | | GYF | Finish node type Gully G50 | <p>Image Provided - Ref: 3_9999</p> |

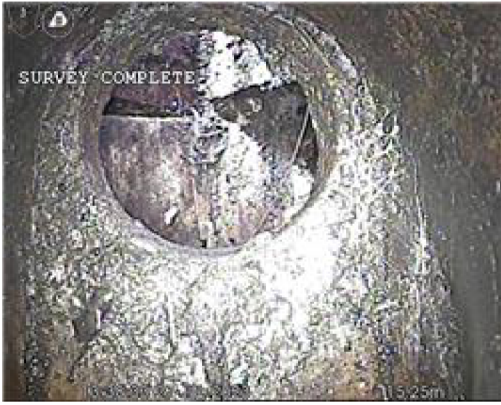
| Pos | Video Ref | Code | Description | Image |
|---|---|---|---|---|
| 15.25m | | GYF | Finish node type Gully G49 | <p>Image Provided - Ref: 4_9999</p> |

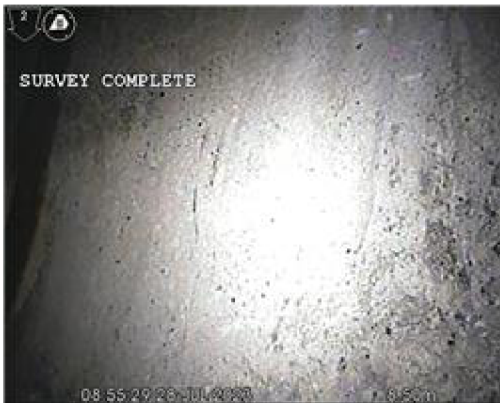
| Pos | Video Ref | Code | Description | Image |
|---|---|---|---|---|
| 08.50m | | MHF | Finish node type, manhole MH33 | <p>Image Provided - Ref: 5_9999</p> |

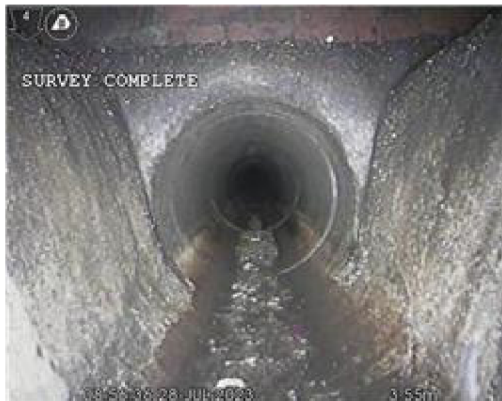
| Pos | Video Ref | Code | Description | Image |
|---|---|---|---|---|
| 03.55m | | MHF | Finish node type, manhole MH34 | <p>Image Provided - Ref: 6_9999</p> |

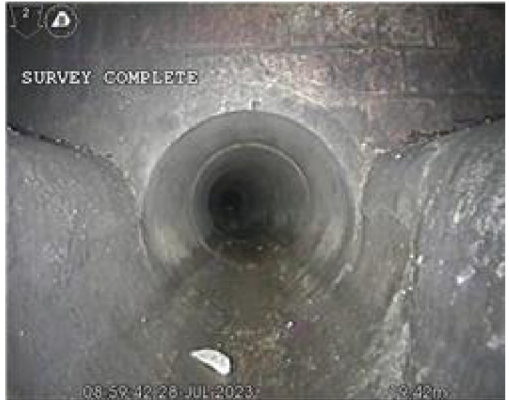
| Pos | Video Ref | Code | Description | Image |
|---|---|---|---|---|
| 19.42m | | MHF | Finish node type, manhole MH66 | <p>Image Provided - Ref: 7_9999</p> |

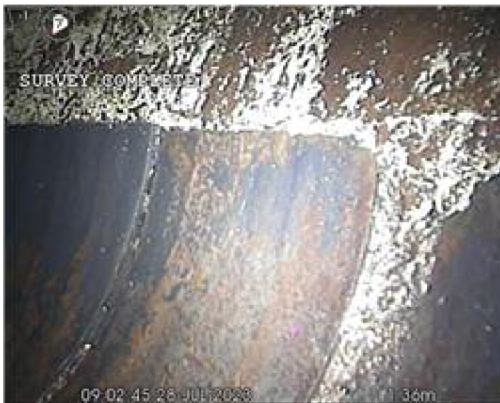
| Pos | Video Ref | Code | Description | Image |
|---|---|---|---|---|
| 01.36m | | MHF | Finish node type, manhole MH31 | <p>Image Provided - Ref: 8_9999</p> |

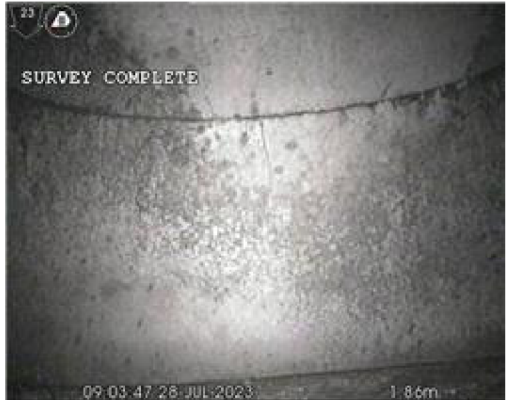
| Pos | Video Ref | Code | Description | Image |
|---|---|---|---|---|
| 01.86m | | MHF | Finish node type, manhole MH30 | <p>Image Provided - Ref: 9_9999</p> |

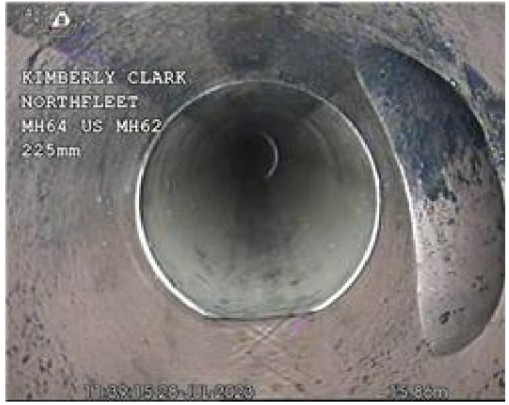
| Pos | Video Ref | Code | Description | Image |
|---|---|---|---|---|
| 15.86m | 0:01:25 | JN | Junction at 03 o'clock: 150mm Diameter | Image Provided - Ref: 10_2<br> |

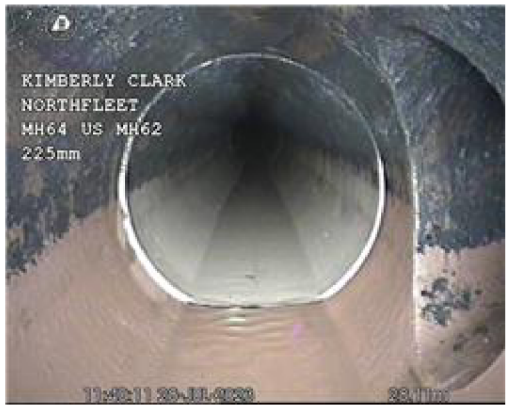
| Pos | Video Ref | Code | Description | Image |
|---|---|---|---|---|
| 28.11m | 0:02:22 | JN | Junction at 03 o'clock: 150mm Diameter | Image Provided - Ref: 10_3<br> |

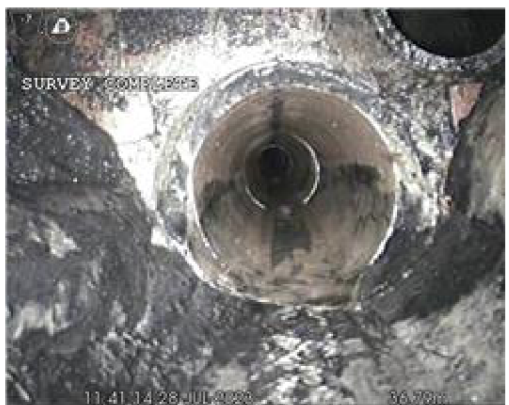
| Pos | Video Ref | Code | Description | Image |
|---|---|---|---|---|
| 36.79m | | MHF | Finish node type, manhole MH62 | Image Provided - Ref: 10_9999<br> |

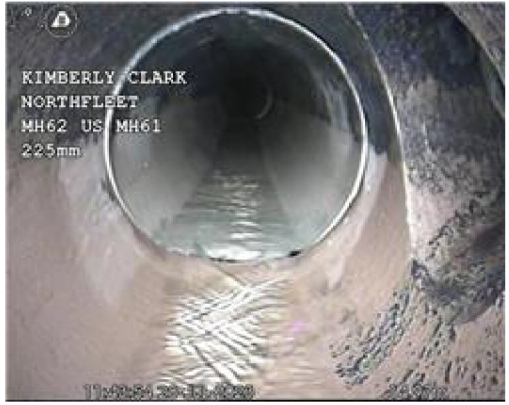
| Pos | Video Ref | Code | Description | Image |
|---|---|---|---|---|
| 14.97m | 0:01:17 | JN | Junction at 03 o'clock: 150mm Diameter | Image Provided - Ref: 11_2<br> |

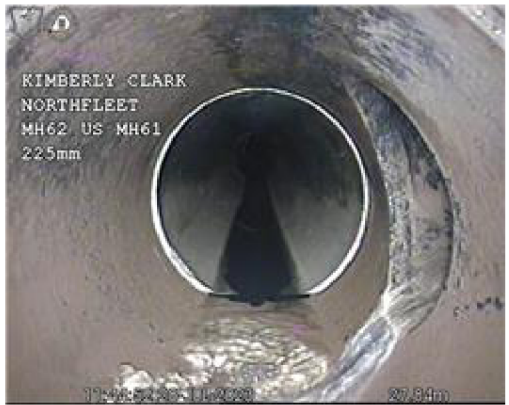
| Pos | Video Ref | Code | Description | Image |
|---|---|---|---|---|
| 27.84m | 0:02:15 | JN | Junction at 03 o'clock: 150mm Diameter | Image Provided - Ref: 11_3<br> |

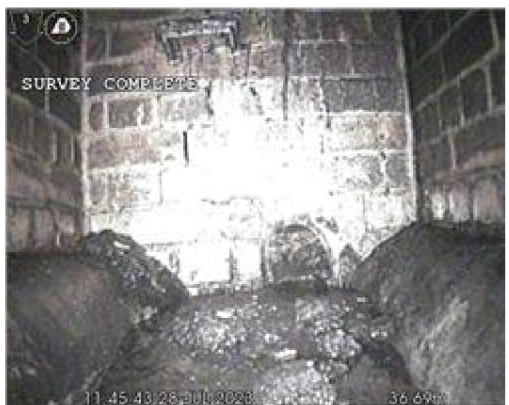
| Pos | Video Ref | Code | Description | Image |
|---|---|---|---|---|
| 36.69m | | MHF | Finish node type, manhole MH61 | Image Provided - Ref: 11_9999<br> |
