POTTING SHED DEFECTS:

| <b>PROJECT:</b><br>PROPOSED OUTBUILDINGS REPAIR / REPLACEMENT AT OWLETT'S MANSION, COBHAM | <b>CLIENT:</b><br>NATIONAL TRUST | <b>DRAWING TITLE:</b><br>EXISTING ELEVATIONS<br>POTTING SHED | <b>DRAWN BY:</b><br>NF | <b>SCALE:</b><br>1:50 @ A3 | <b>REV</b><br>P1 - 06.03.2026 -<br>Final issue | <b>DEFECTS KEY:</b><br>Cracks in masonry<br>Spalling or missing brickwork / mortar<br>Rotten or unstable timber structure | Improper mortar repairs<br>Areas covered by vegetation - to be further investigated<br>Water Damage, Damp, Mould |

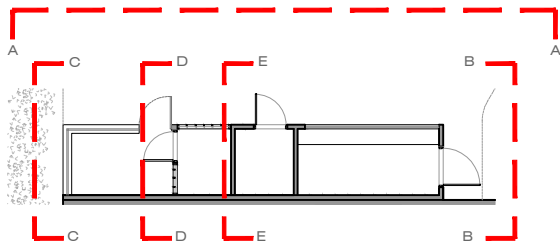
**Summary** - The Potting Shed is in an advanced state of deterioration, principally due to prolonged water ingress, timber decay and associated structural movement. The failure of the roof covering has allowed persistent moisture penetration, resulting in widespread wet rot and beetle infestation to the timber rafters. Loss of structural integrity at rafter bearings has led to roof spread and outward thrust on the masonry walls, causing displacement and cracking. Localised structural failure at the northwest corner, caused by decay of a supporting timber post, has resulted in differential movement between the end wall and the principal spine wall. The cumulative effect of timber decay, masonry cracking, and inappropriate past interventions has compromised both the structural stability and the material integrity of the building. The defects are interrelated, with moisture ingress acting as the primary driver of decay and structural movement.

The mono-pitch roof structure is beyond repair. The original softwood rafters (100 x 50mm at approximately 380mm centres) exhibit extensive wet rot and significant beetle infestation. The absence of a waterproof roof covering has left the timbers exposed, accelerating deterioration.

At the junction with the spine wall, rafter bearings have decayed, leading to loss of effective support. This has caused the roof to drop and exert lateral thrust on the supporting masonry. In several locations, rafters no longer adequately bear onto their supports due to geometric distortion caused by structural movement. The roof structure can no longer be considered structurally reliable.

The timber support conditions at the head of the masonry wall have failed due to prolonged moisture exposure. Decay at these interfaces has reduced load transfer capacity and contributed to roof spread. At the northwest corner, the end wall is supported in part by a timber post bearing onto a saddle stone. The base of this post has rotted, resulting in vertical displacement and differential settlement. This has caused separation between the end wall and the main brick wall.

The northwest end wall, constructed in half-brick thickness and largely reliant on a timber frame for stability, has dropped relative to the adjoining structure. A pronounced movement joint has opened between this wall and the spine wall as a result of settlement and timber decay.

Internally, a cross wall exhibits a significant vertical crack, approximately 20mm wide at its head and tapering toward its base. This is consistent with roof spread resulting from loss of bearing at the top of the main wall. The crack compromises both structural stability and weather resistance.

Localised brick deterioration is also present around the former flue opening, and areas of masonry require repointing.

The absence of a functioning roof covering has exposed the structure to prolonged moisture ingress. This has been the principal catalyst for timber rot, beetle infestation, and masonry movement. Persistent damp conditions have undermined the durability of both structural timber and brickwork, accelerating the rate of decay. Unless the source of water penetration is addressed, further deterioration will continue.
