# Owletts Mansion & Outbuildings: Heritage Statement

PROPOSED LISTED BUILDING CONSENT

FOR CONSERVATION REPAIRS TO OWLETTS MANSION & OUTBUILDINGS TO THE EAST AT THE STREET, COBHAM, KENT

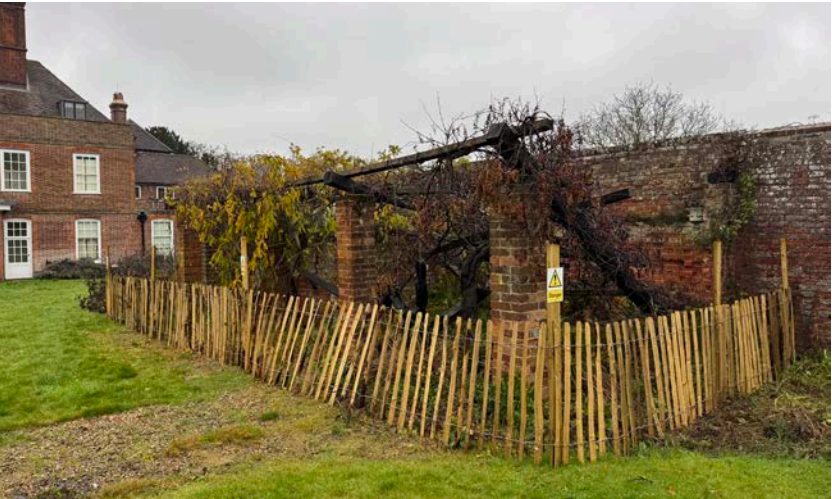
The loggia structure has experienced significant deterioration to the timber roof structure, primarily due to prolonged exposure to moisture and age-related decay. The existing primary timber beams are severely rotten and structurally compromised, resulting in partial collapse of the roof structure.

Associated defects include cracking within the masonry walls, likely resulting from historic movement and the loss of structural stability caused by the failing roof structure. In addition, areas of spalled brickwork, missing mortar joints and inappropriate historic repairs using hard cement-based mortars have been identified. Vegetation growth and the accumulation of leaves and debris within the loggia have further contributed to moisture retention and ongoing deterioration of the masonry fabric.

1. View of Loggia from south with Owletts Mansion behind

Structural repairs will be undertaken in accordance with the Structural Engineer’s report and drawings. The existing decayed timber beams will be replaced with six new 200 × 200mm D30 grade oak primary beams, improving structural stability while maintaining a traditional material appropriate to the structure.

In addition, seven timber slats positioned above the primary beams will be replaced with new 100mm × 75mm D30 oak members, matching the existing configuration and dimensions.

Cracked masonry will be stabilised using 6mm diameter Helifix stainless steel reinforcement bars, installed within the bed joints at every third course along the length of the cracks. The installation will involve carefully raking out bed joints to approximately 40mm depth, inserting the reinforcement bars in accordance with manufacturer’s specifications, and repointing the joints with a suitable lime mortar.

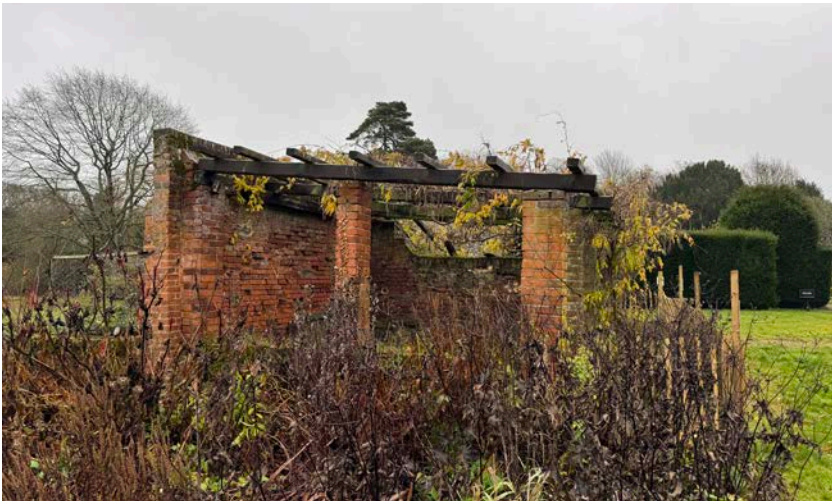
2. View of north west elevation of Loggia

Areas of missing or deteriorated mortar will be raked out and repointed using a lime mortar matched to the existing through analysis of samples taken from deep within the mortar joints.

Areas of spalled brickwork will be addressed through careful removal and turning of bricks to present a sound face where possible. Where bricks are too deteriorated to reuse, reclaimed bricks will be sourced to match the existing masonry.

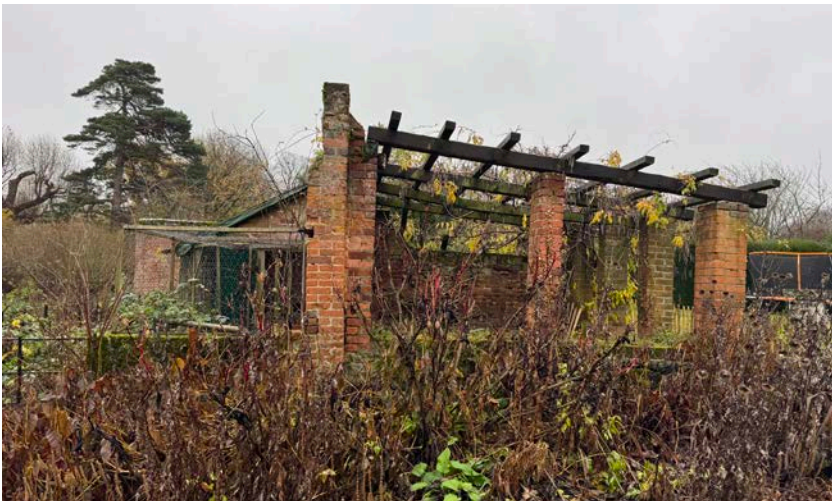
3. View of north west elevation of Loggia and Potting Shed

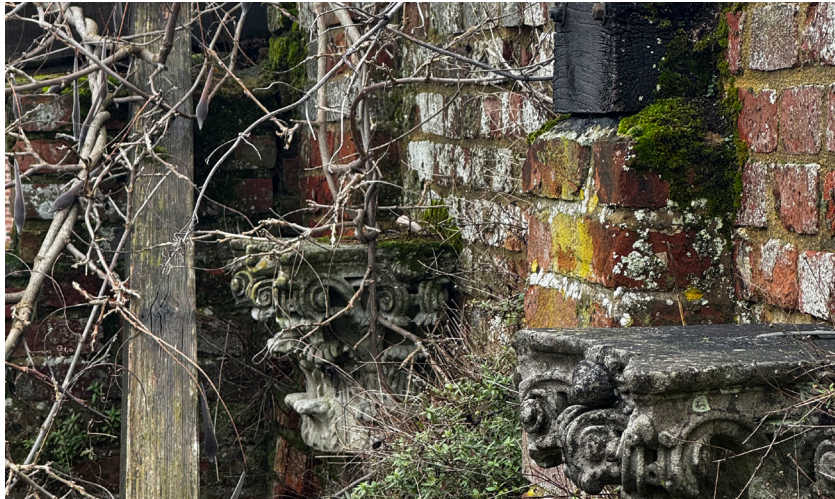
6. View of Loggia half brick ledge with corinthian decorations

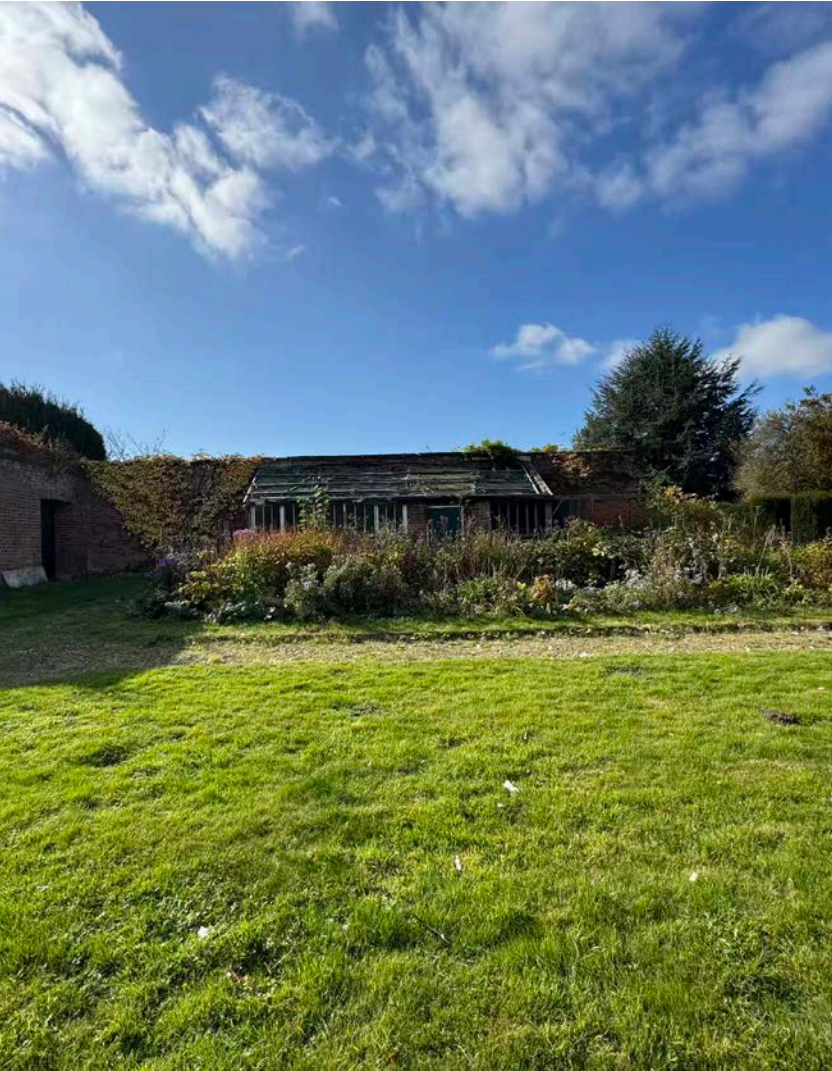
The potting shed roof structure has deteriorated due to prolonged exposure to moisture and age-related decay, resulting in significant deterioration of the existing timber rafters. The roof structure is no longer considered structurally reliable and requires replacement. The associated masonry has areas of missing and deteriorated mortar, which has allowed moisture penetration into the wall fabric.

1. North elevation of potting shed

The existing mono-pitch roof structure will be carefully dismantled and replaced, with the new structure replicating the original roof form, pitch and arrangement. New structural timbers will be installed to match the size and configuration of the original rafters, ensuring the visual and structural character of the building is maintained. Where possible, existing roof tiles will be retained and reused, preserving historic material fabric. Any additional tiles required will be sourced to match the originals. Areas of deteriorated mortar within the masonry will be carefully raked out and repointed using a lime mortar matched to the existing composition, based on samples taken from deep within the joints.

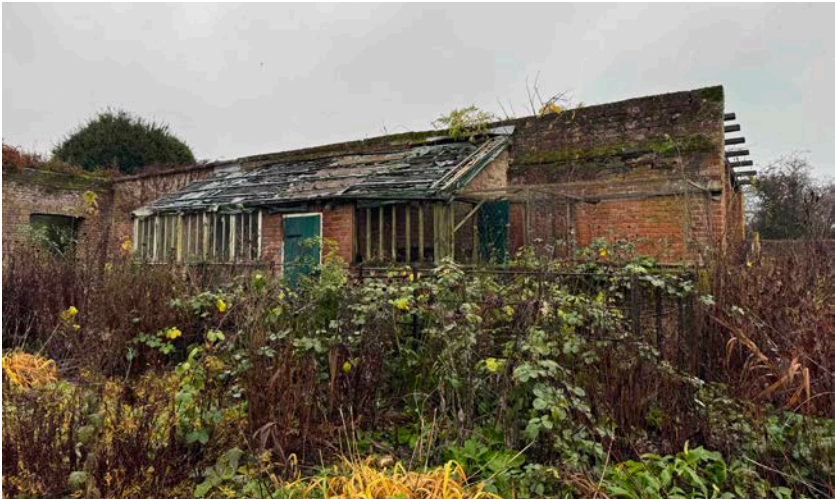
4. North west view of potting shed

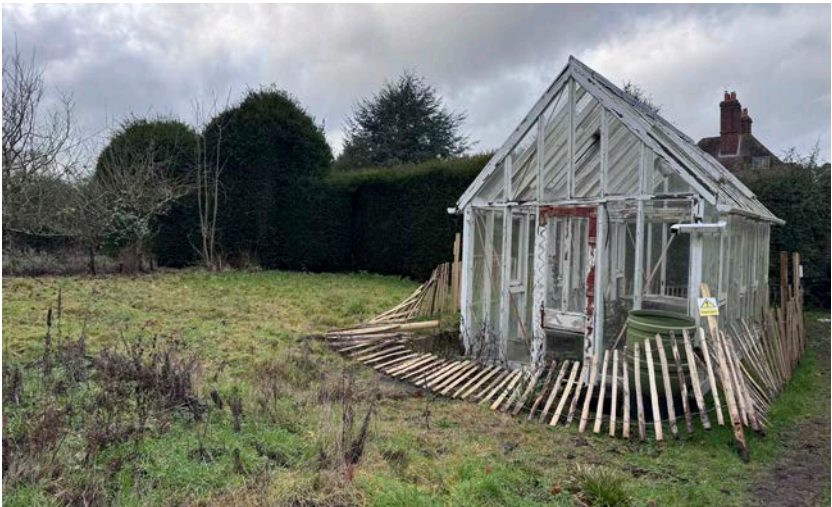
The existing greenhouse structure has experienced extensive decay to the timber framework, particularly at the base of the walls above the brick plinth and within elements of the roof structure adjacent to the guttering. This deterioration is primarily due to prolonged exposure to moisture and the close proximity of timber elements to ground level.

Due to the extent of decay, the timber structure is no longer capable of effective repair.

2. Rear view of greenhouse

The existing greenhouse structure will be carefully dismantled and replaced, with the new structure designed to match the architectural character, proportions, window rhythm and overall height of the existing building.

The brick plinth will be raised by several courses, increasing the separation between ground level and the timber structure to improve durability and reduce the risk of future moisture-related decay.

A new plinth detail will incorporate a timber cill positioned above a DPC / leaded brickwork, creating an improved moisture barrier between masonry and timber.

The replacement structure will be constructed from durable timber such as Accoya, chosen for its resistance to decay and long-term performance. The timber framework will be painted white to match the appearance of the existing greenhouse.

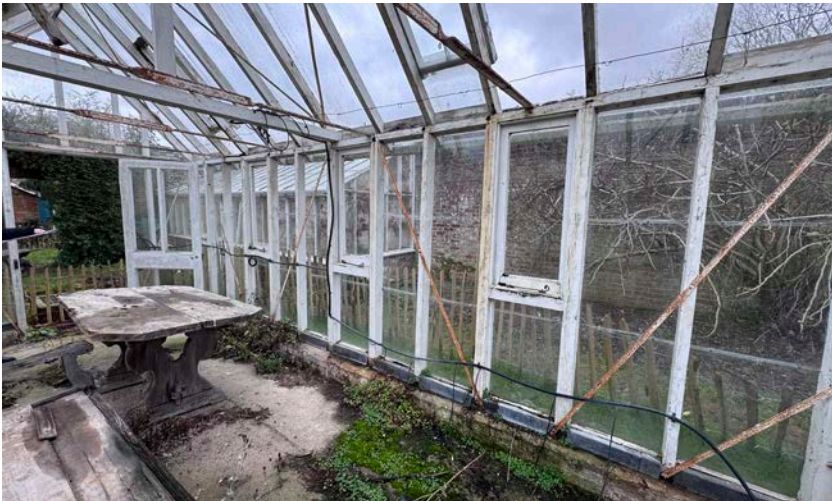
3. Internal view

Glazing will be replaced with reinforced or shatter-resistant safety glazing to improve durability and ensure visitor safety.

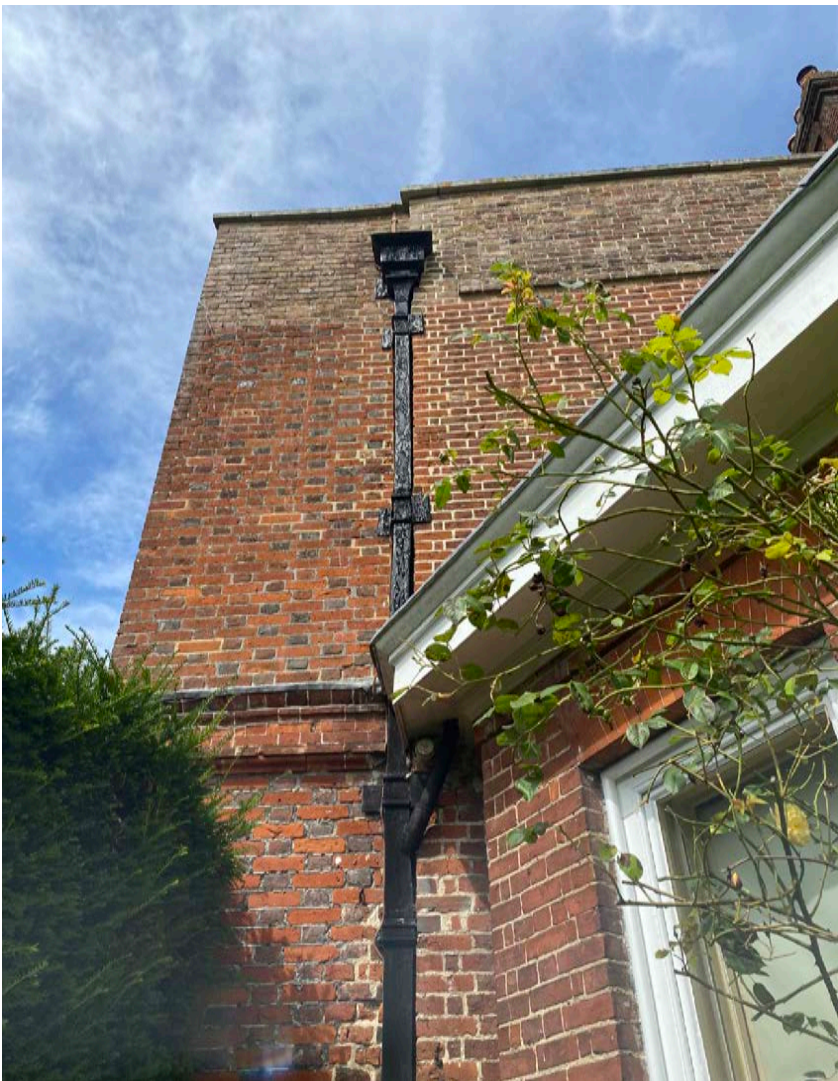
3. Close up of hopper and downpipe

In addition to the outbuilding repairs, minor works are proposed to the south-east elevation of the main house, where the existing gutter outlet through the parapet will be enlarged to improve rainwater discharge and reduce the risk of water overflow and moisture-related deterioration to the masonry below.
