# Clarence Place

## Masonry Façade Survey August 2023

REF 23108-PAYE-CPS-001

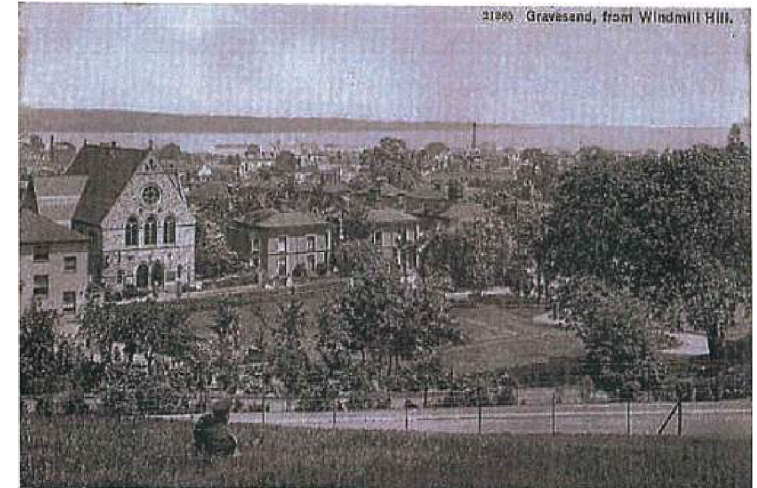
Fig.1 shows the building in its original built form constructed using Kent Rag stone walling and Bath stone dressings, copings, window and door surrounds, stringcourses. Use of Aberdeen granite for main entrance columns.

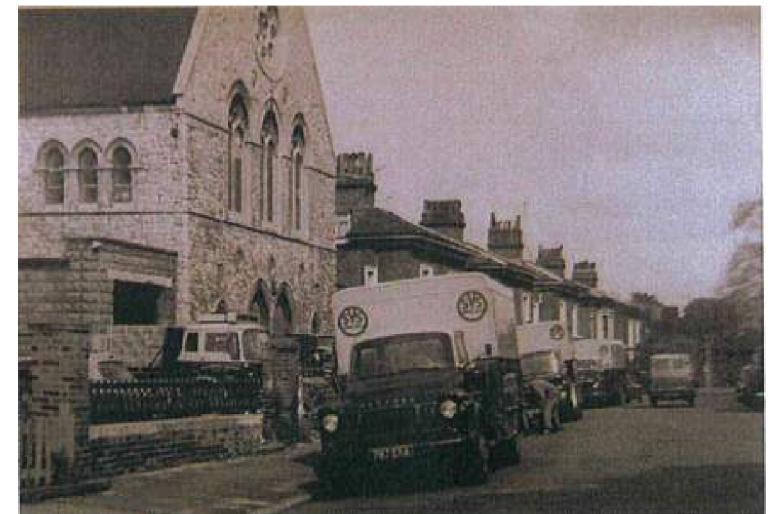
In 1955 it was bought by a commercial company and converted into a warehouse. Fig.2

During this phase extensions were added to the side and alterations carried out to entrances. The building was unrendered at this time.

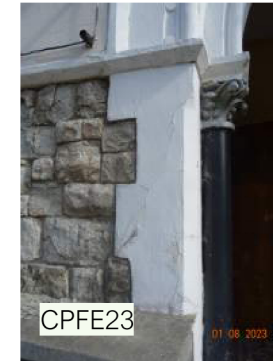
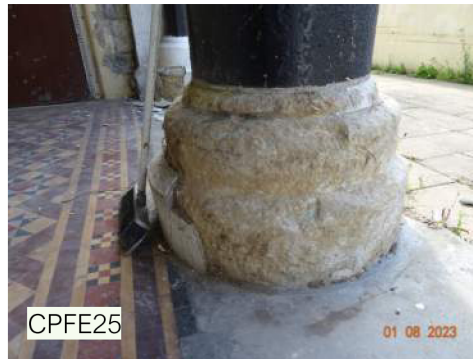
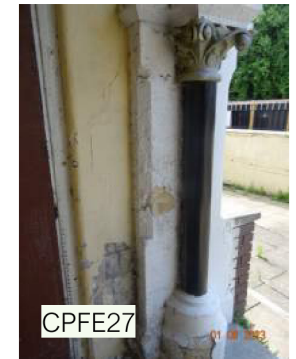
PHOTOS: CPFE22-27

RISK: AMBER/RED

Consideration given to removing render, repair and re-point Rag stone and leaving exposed.

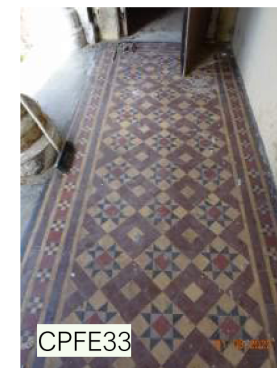
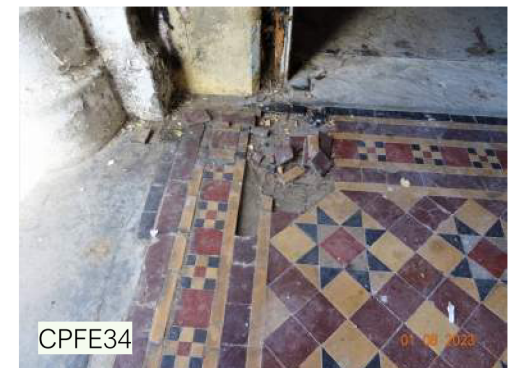
PHOTOS: CPFE33-34      RISK: AMBER

Encaustic tiles are in reasonable condition with minor damage. Consideration given to lifting, subject to adhesion, salvage and re-use.
