*Gad's Hill Place Cupola Repairs.*  
*Notes taken from*  
*meeting @ Fareham Joinery*  
*22/5/2024.*  
*1 of 14 pages.*

Project GAD'S HILL SCHOOL, HIGHAM  
GAD'S HILL PLACE REPAIRS

Title CUPOLA REPAIRS  
EXISTING SECTION AND SIDE ELEVATION

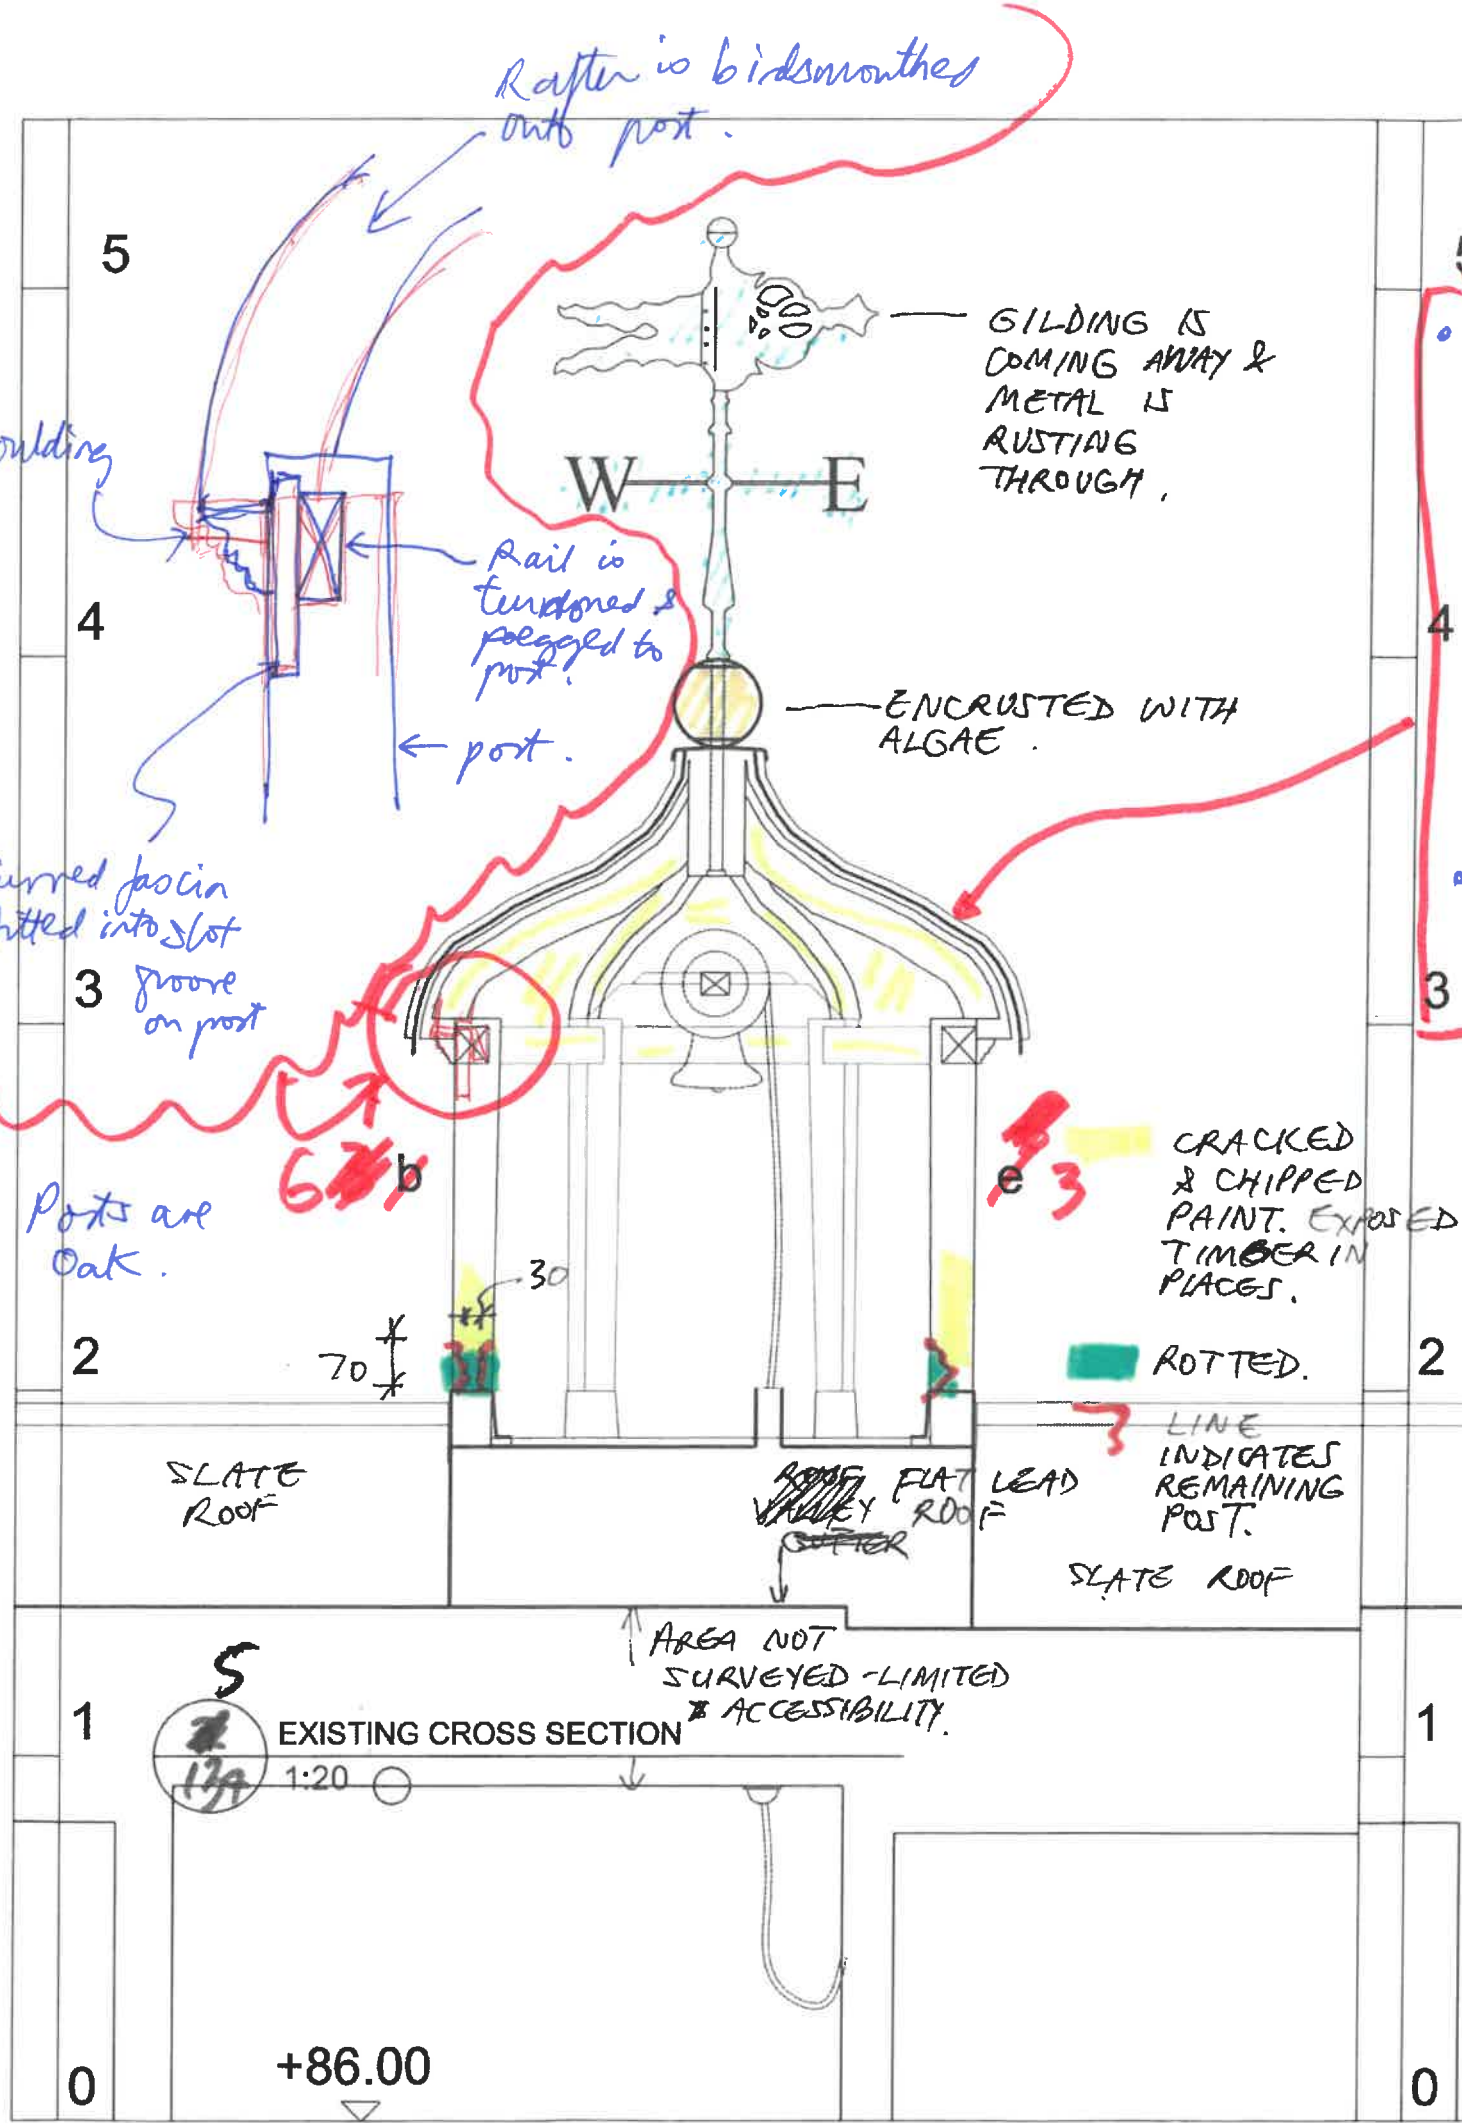
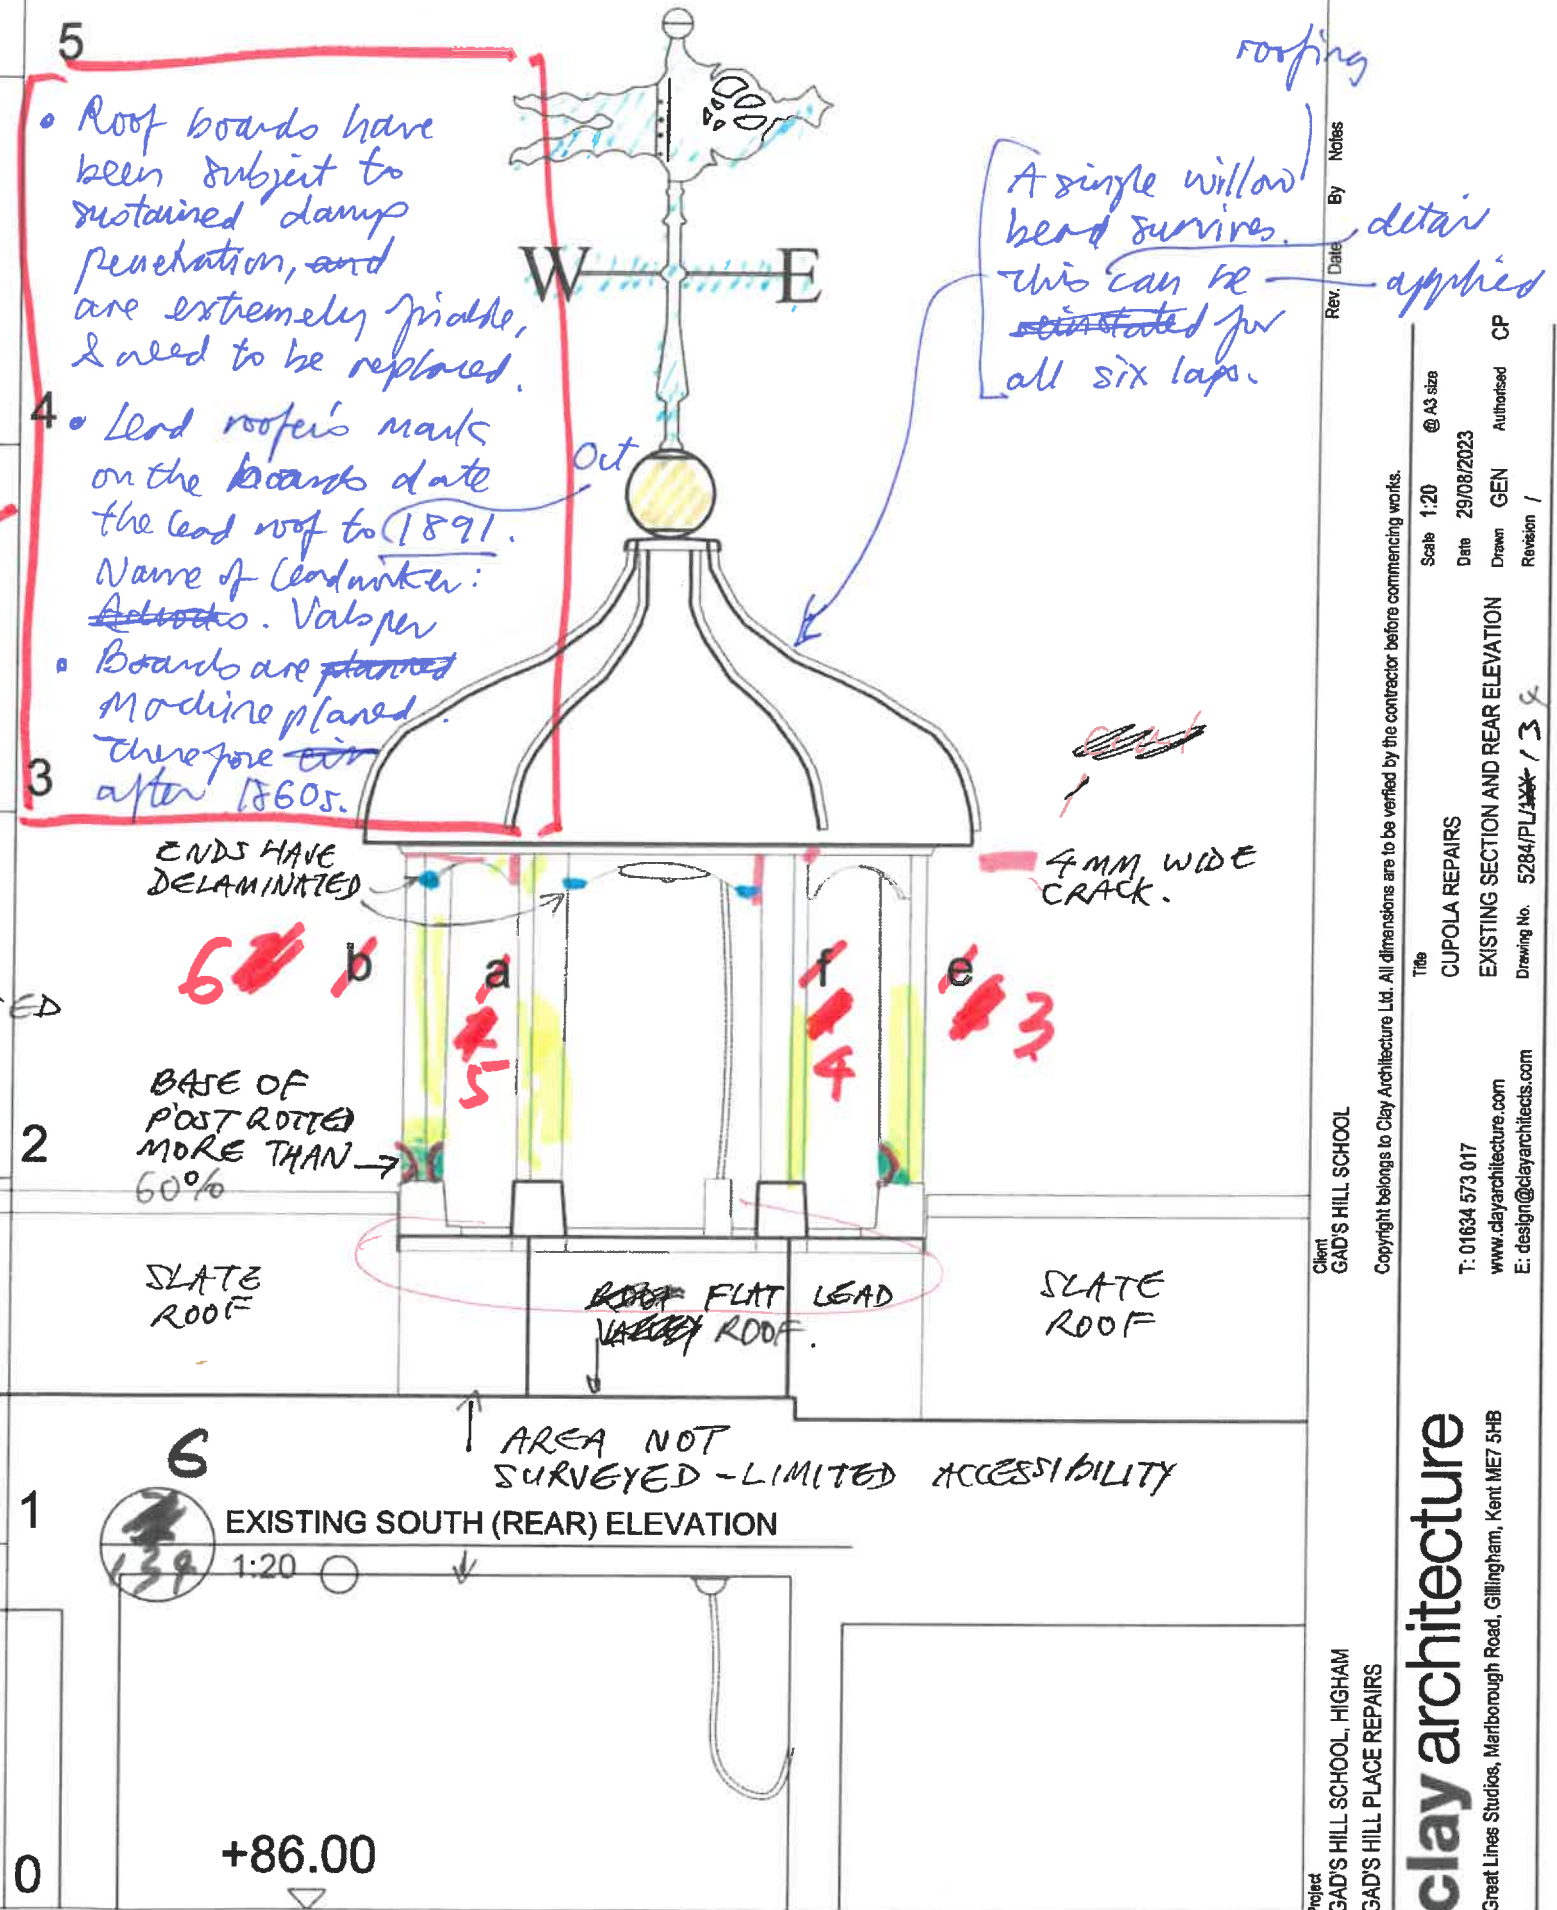
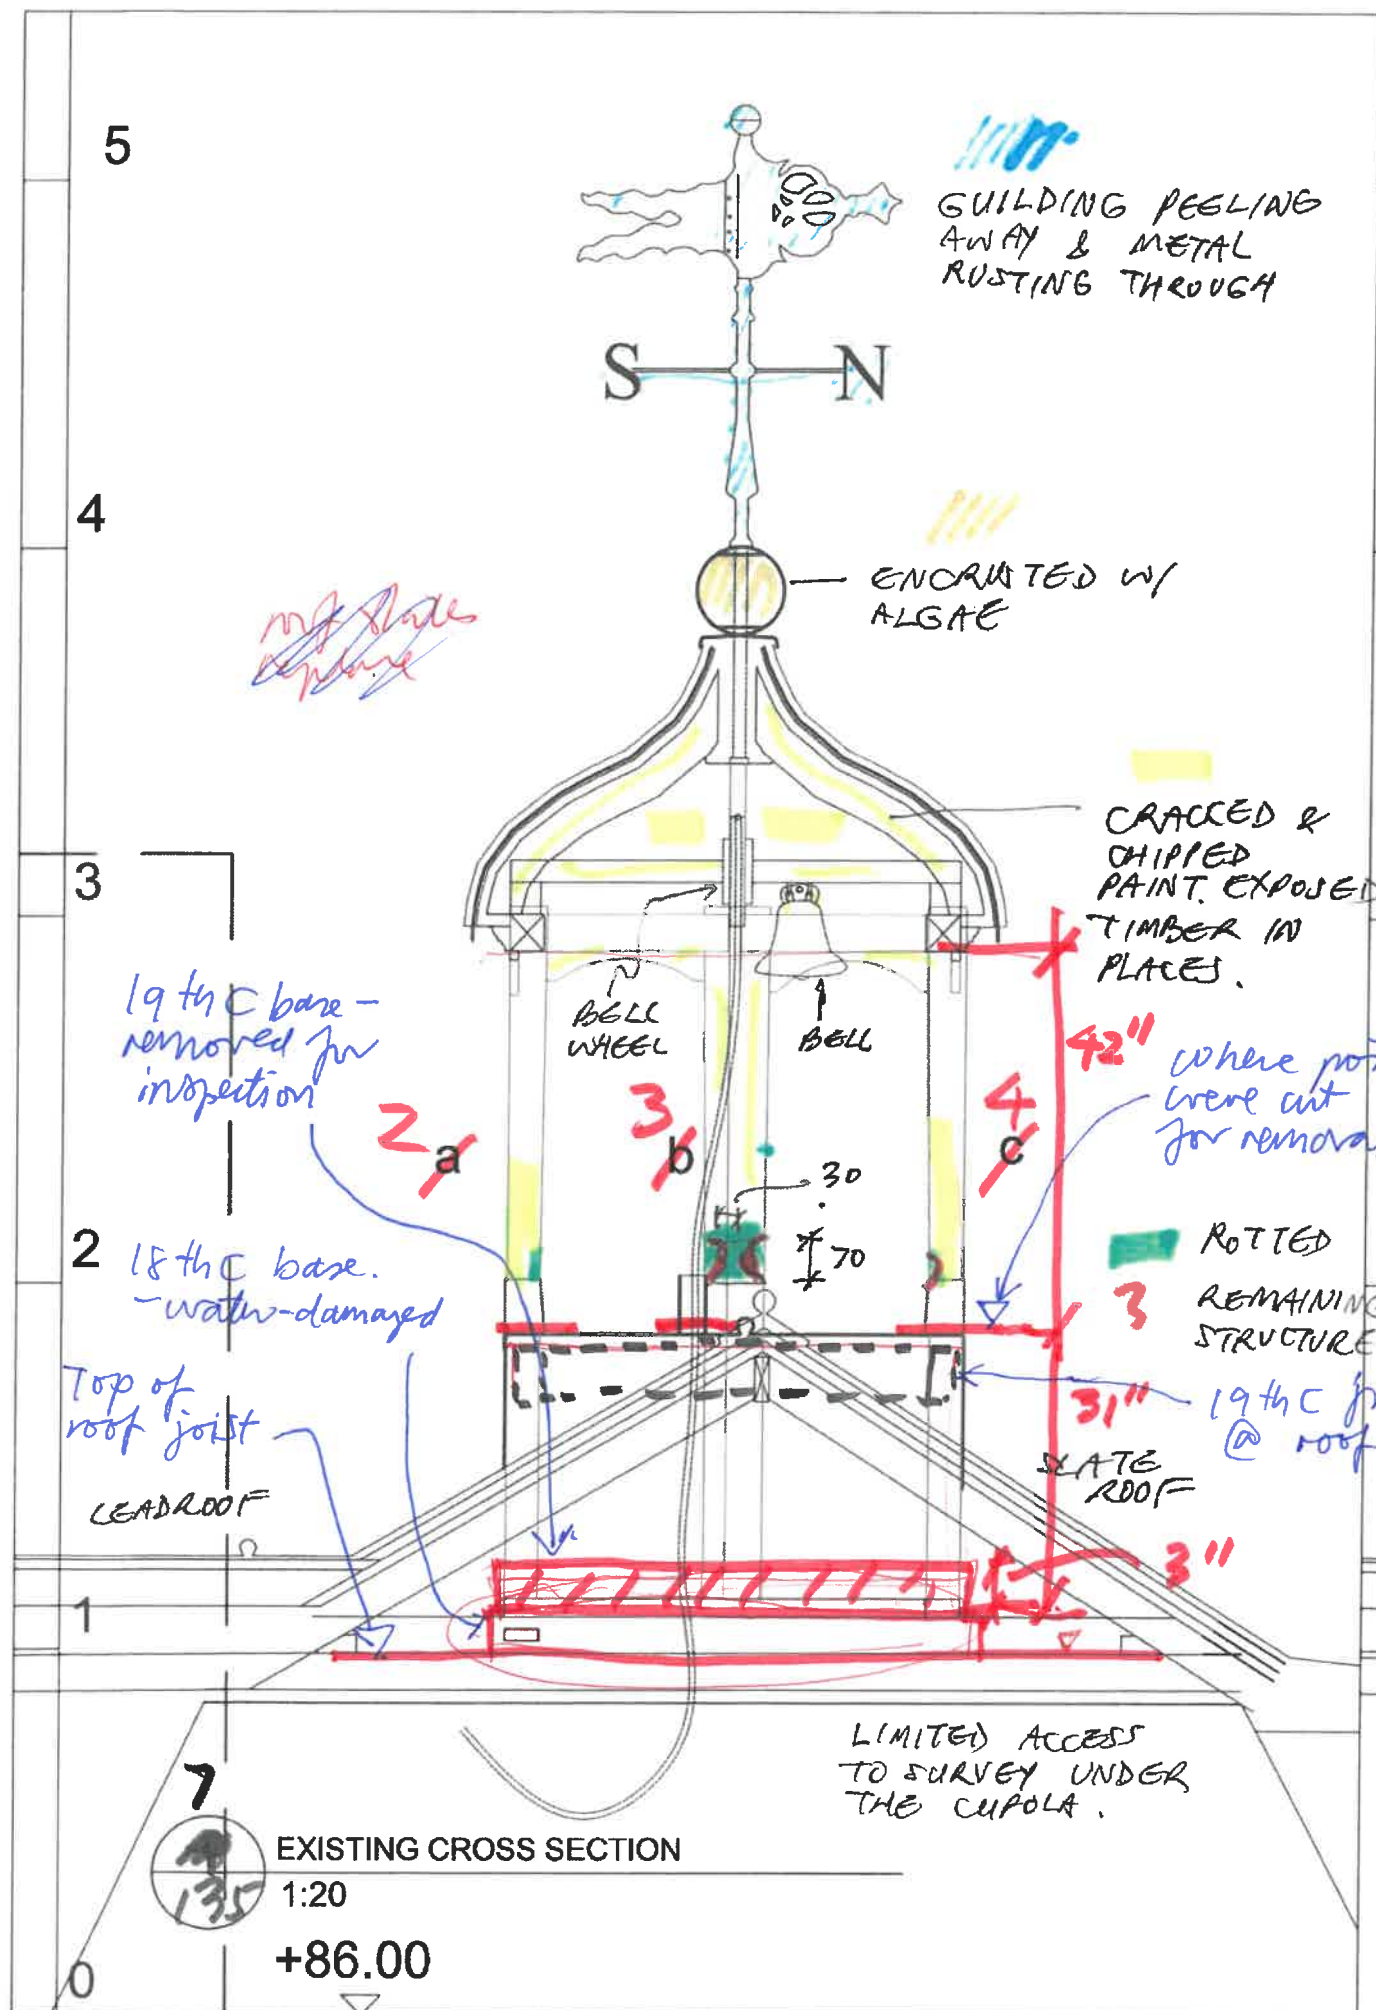
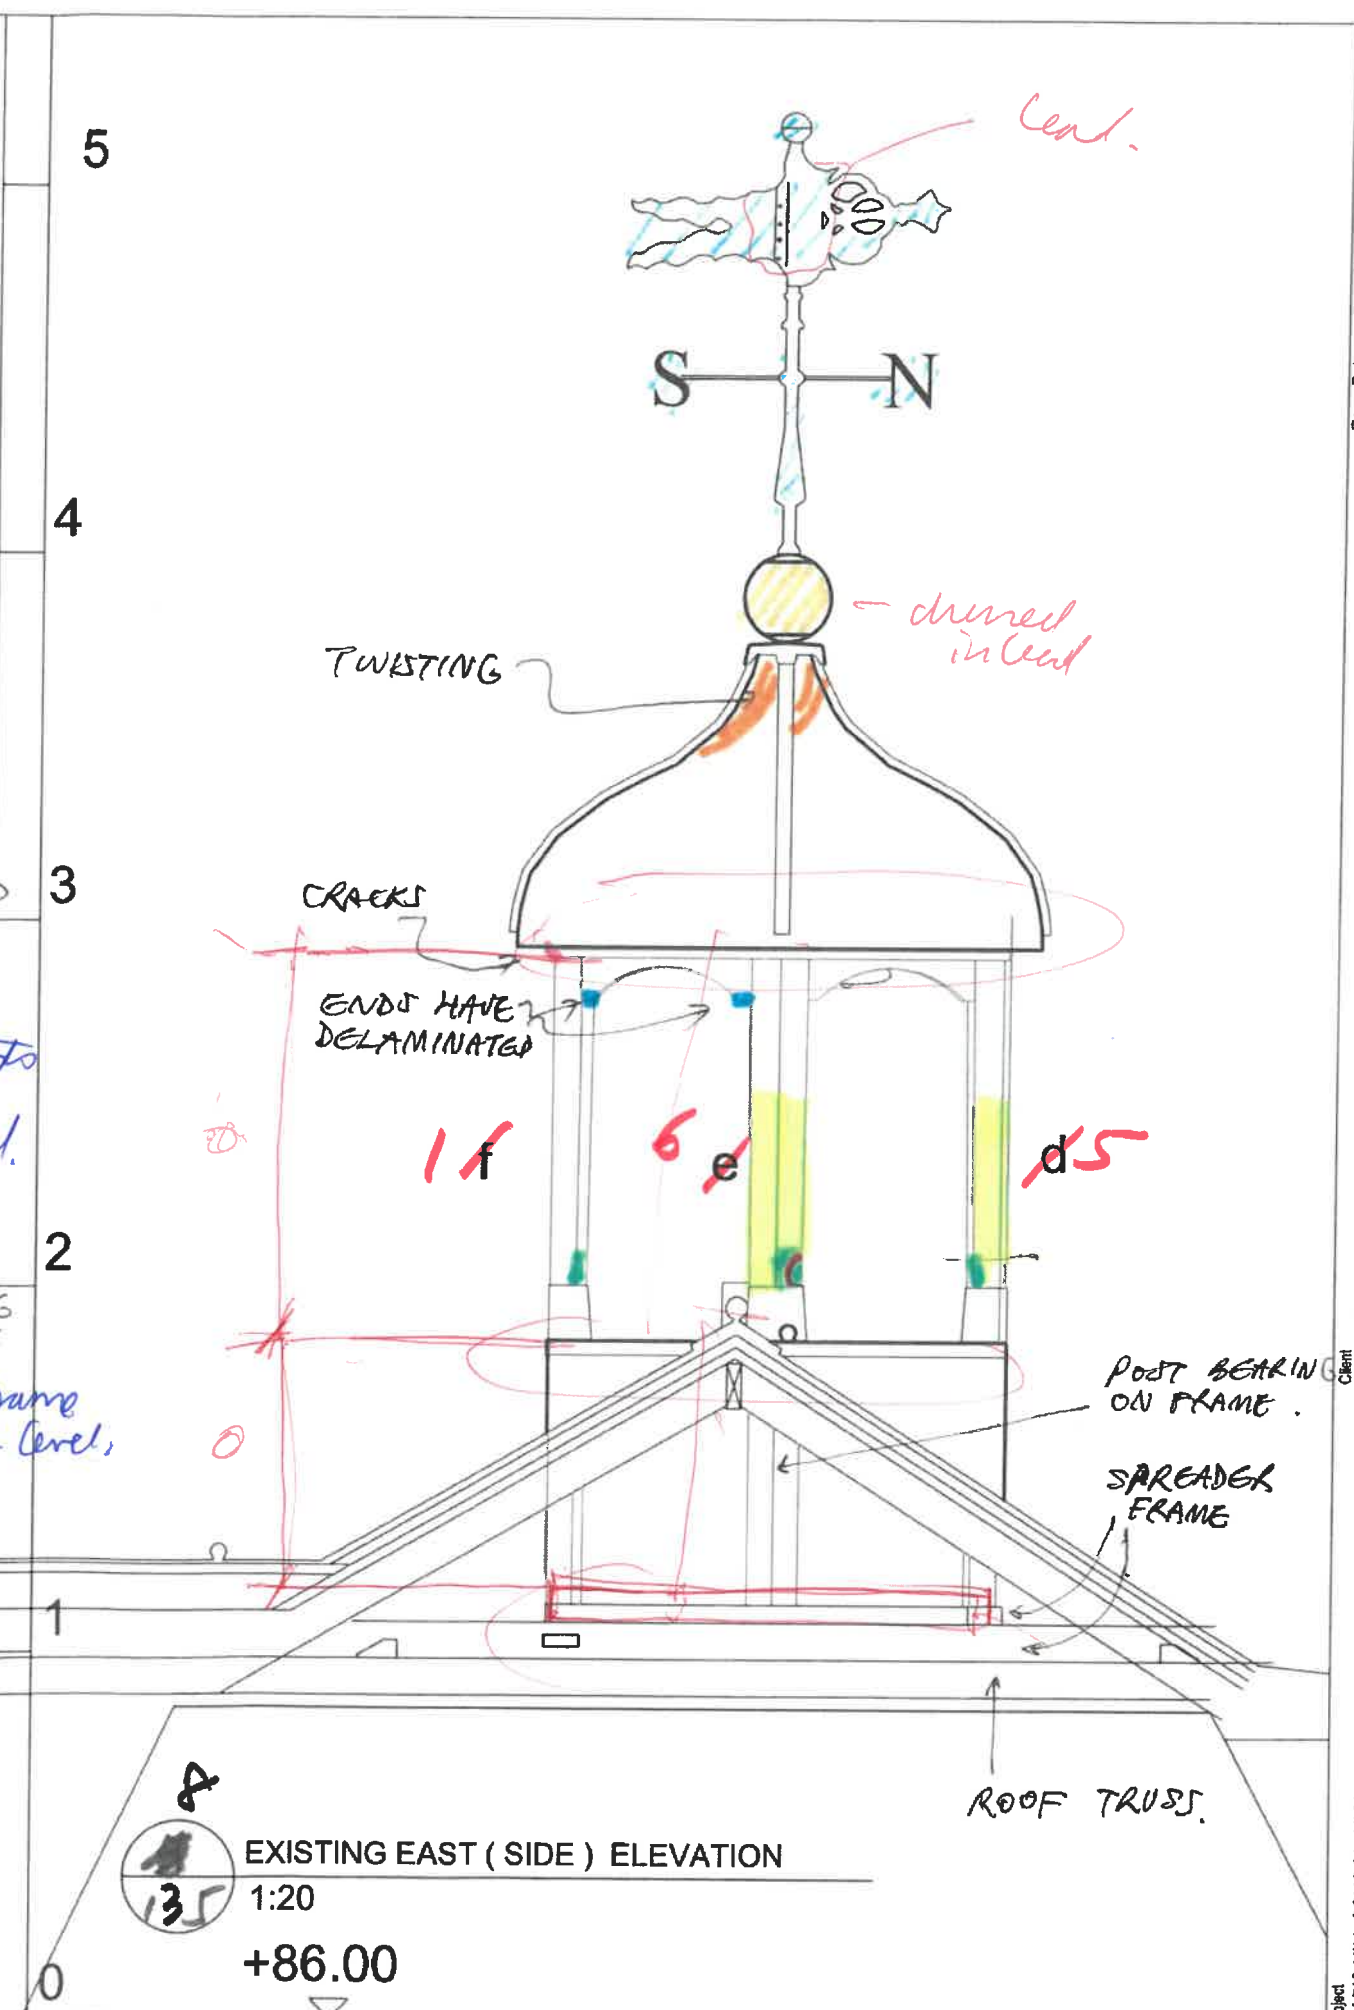
60% of weather vane is lead.  
 Gold leaf won't hold.  
 Prepare wire brush & repaint w/ gold.  
 coloured paint instead

SPLIT.

CRACKED & PEELING PAINT. EXPOSED TIMBER.

ROTTED

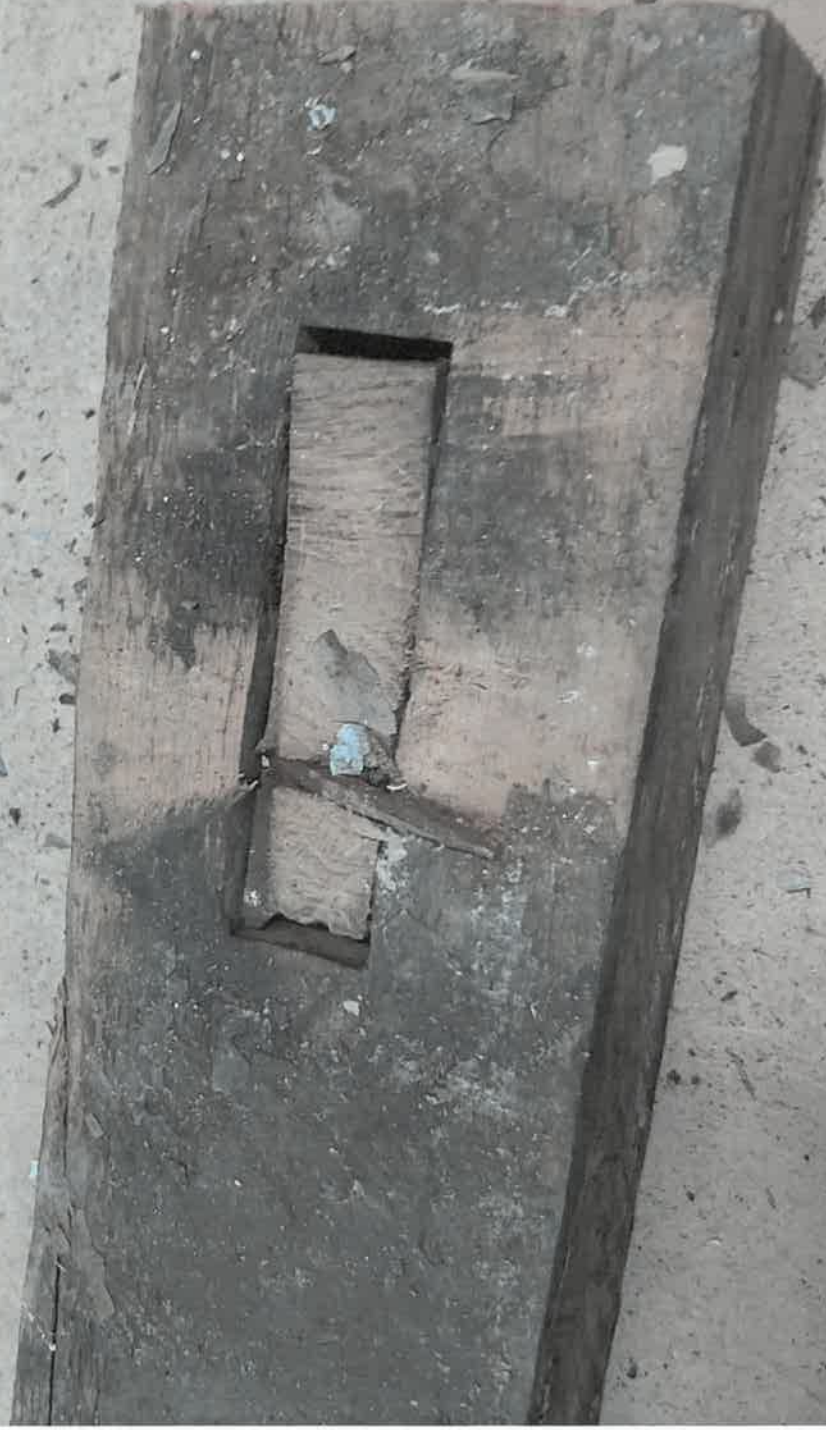
J. Valster - Thun  
Oct 1st 1841

Roofers mark dated 1871

19th base  
frame - Toth-pined  
tenon joint to post.

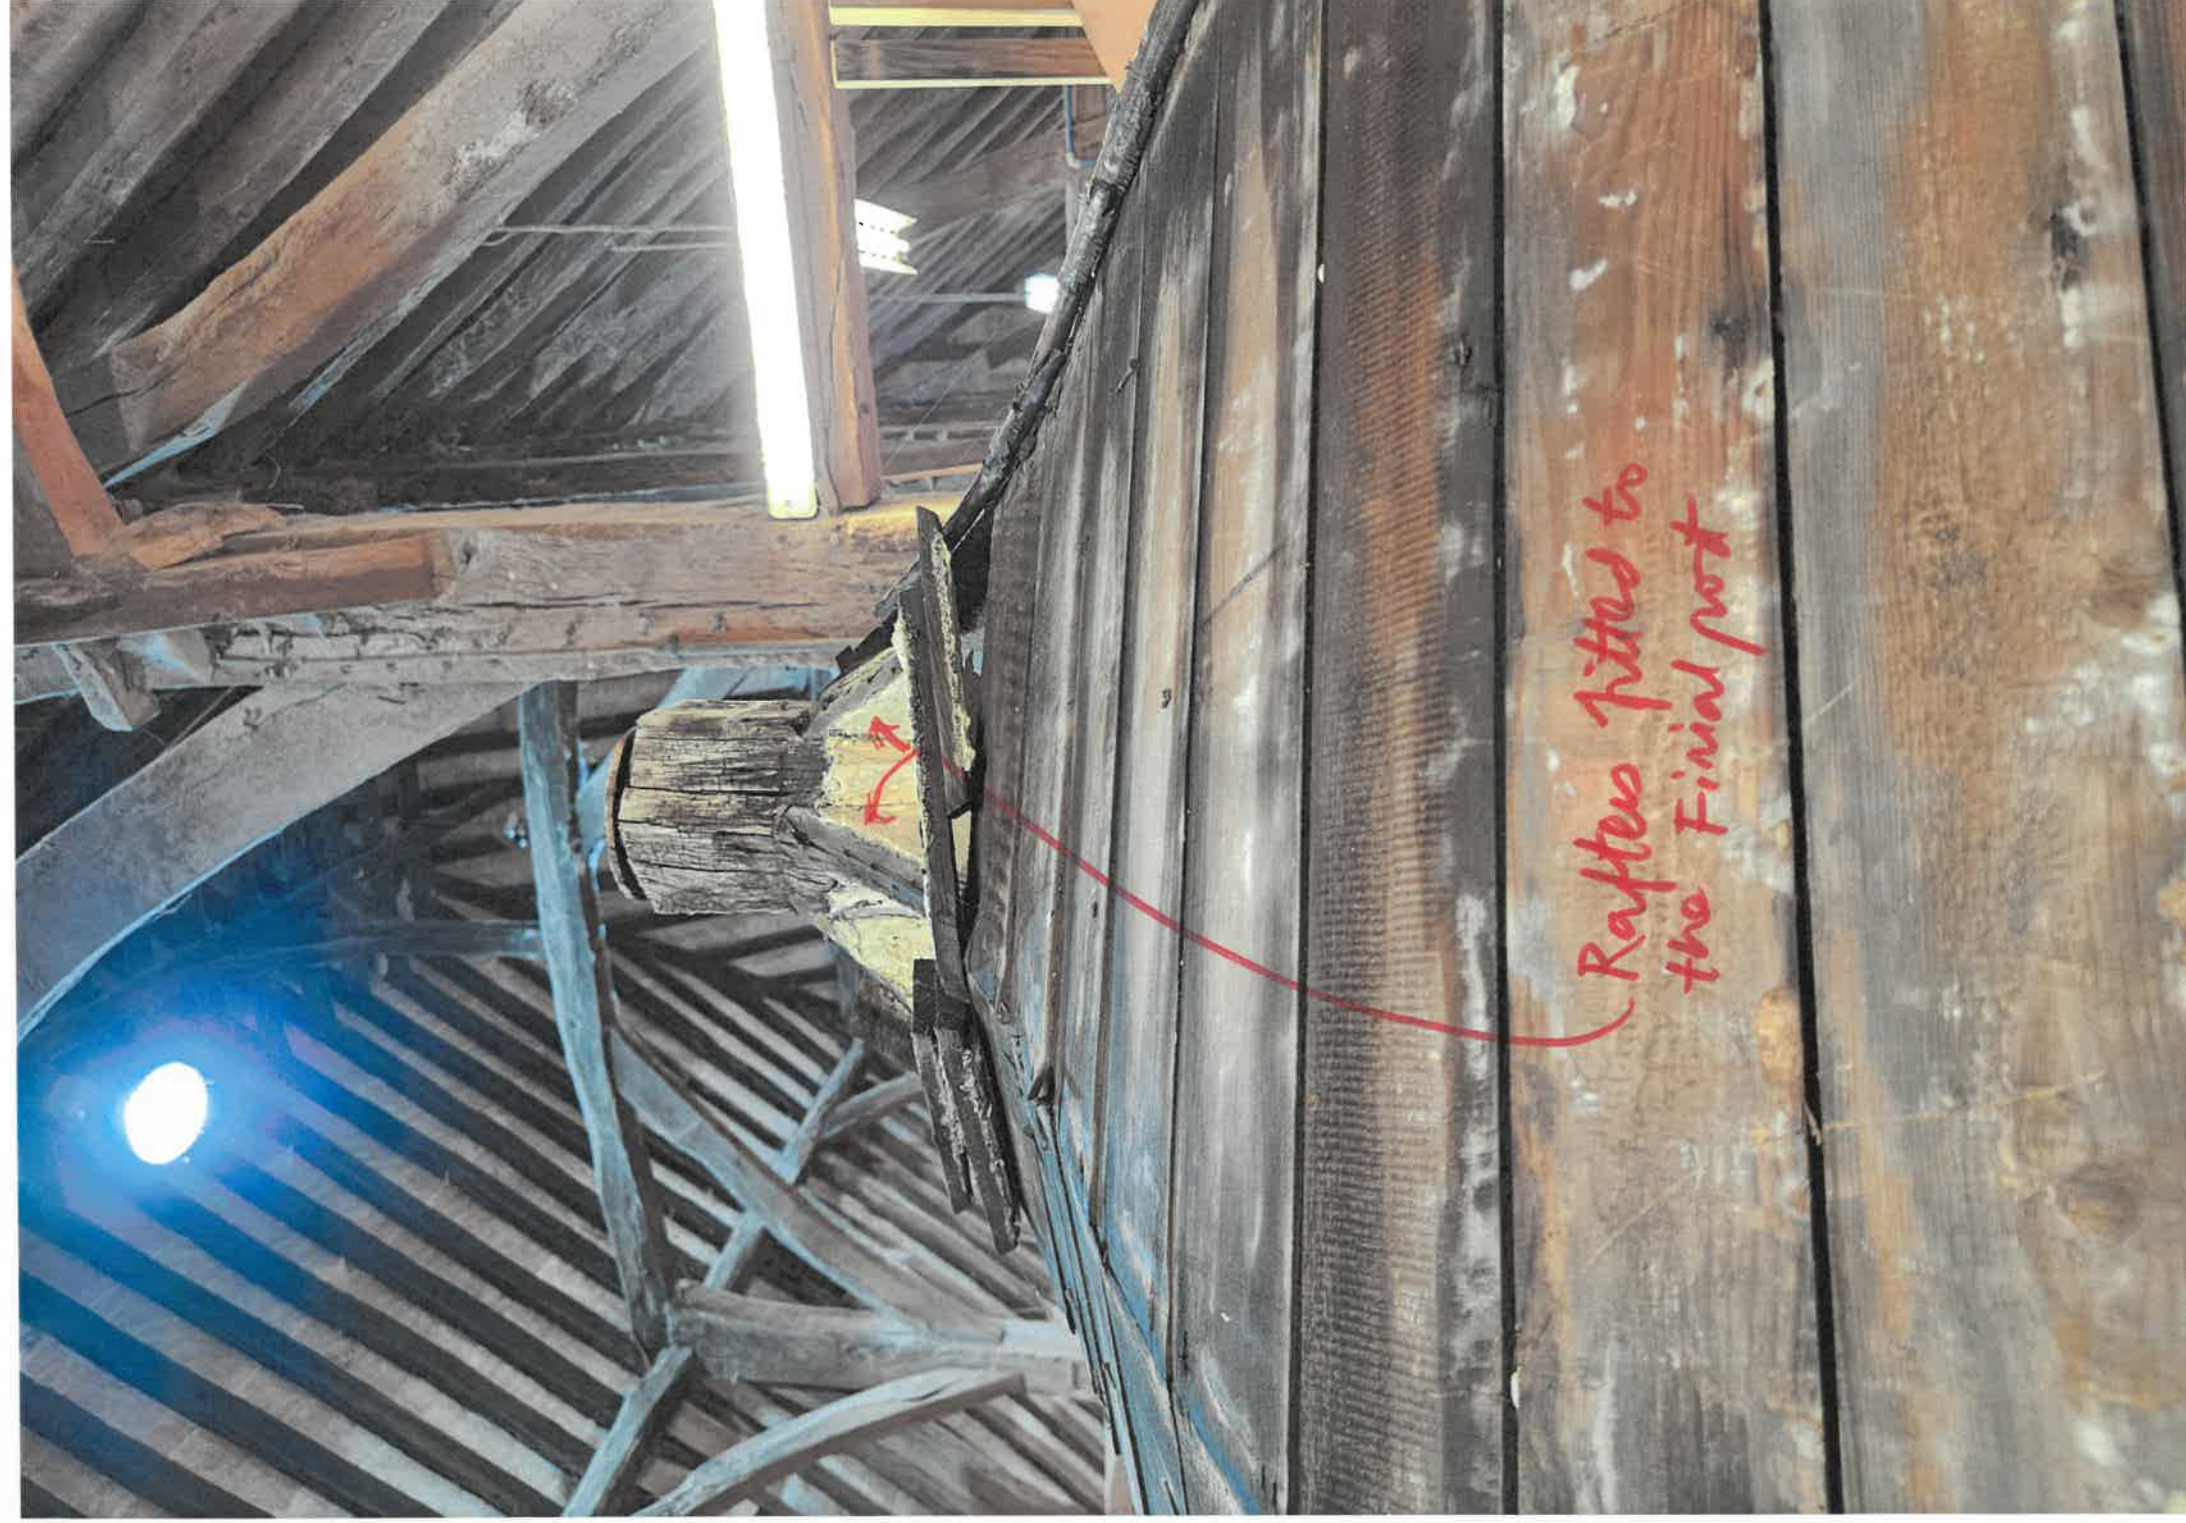
# Photographs

Some of the posts are rotten, paintwork has cracked allowing water ingress. Cupola has twisted.

Post is rotten and needs to be replaced.
