# STRUCTURAL INSPECTION REPORT

## Imperial Wharf Flood Defence Inspection

File Reference:  
317181-FCG-SW-XX-RP-C-3101-S2-P03

**ON:** IMPERIAL WHARF FLOOD DEFENCE INSPECTION  
**FOR:** FM CONWAY  
**FRANKHAM PROJECT NO.:** 317181

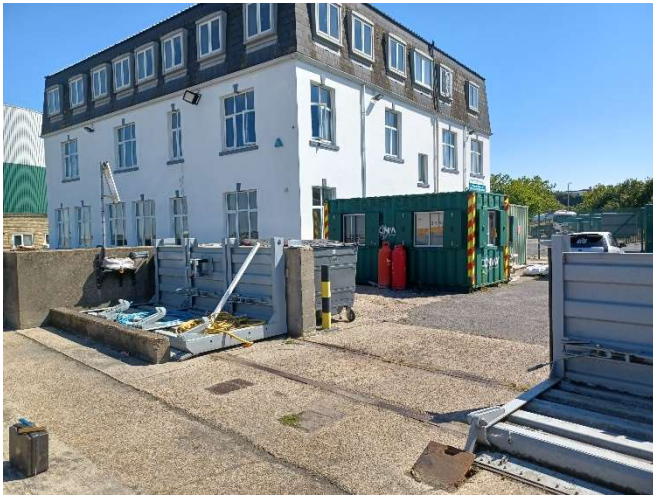
A steel flood gate of approximately 7 m in width is installed to allow traffic access to the jetty head and downriver deck ([Photo 7](#) - [Photo 10](#)). The gate is installed behind concrete walls of approximately 1300 mm height and 300 mm thickness.

**Photo 7 – General photo of flood gate**

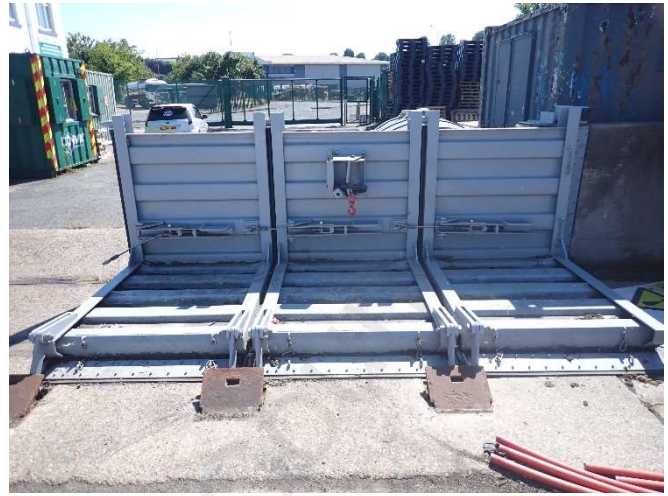
**Photo 8 – General view of upriver flood gate**

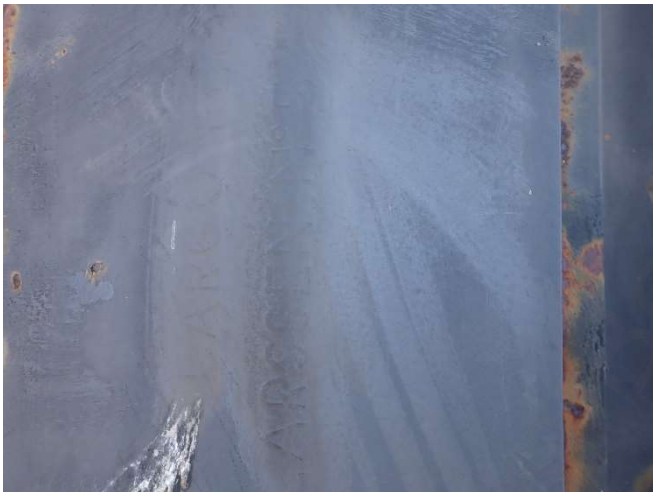
The upriver end of the inner wharf comprises Larssen N° 5 sheet piles with a 520 mm x 650 mm concrete capping beam ([Photo 9](#)).

**Photo 9 – Typical view of Larssen N°5 pile**

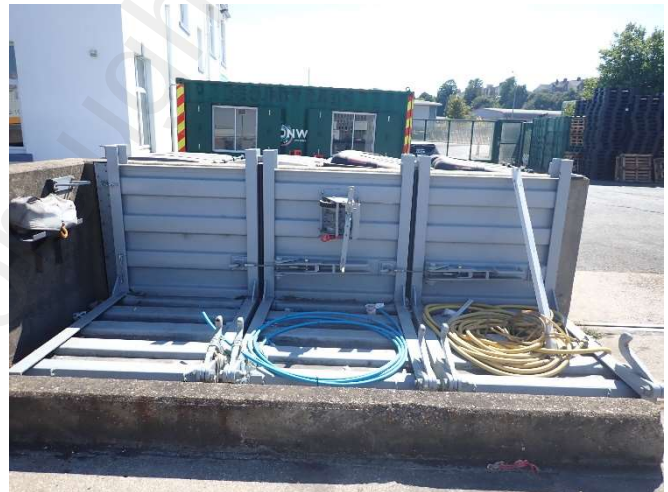
**Photo 10 – General view of downriver flood gate**

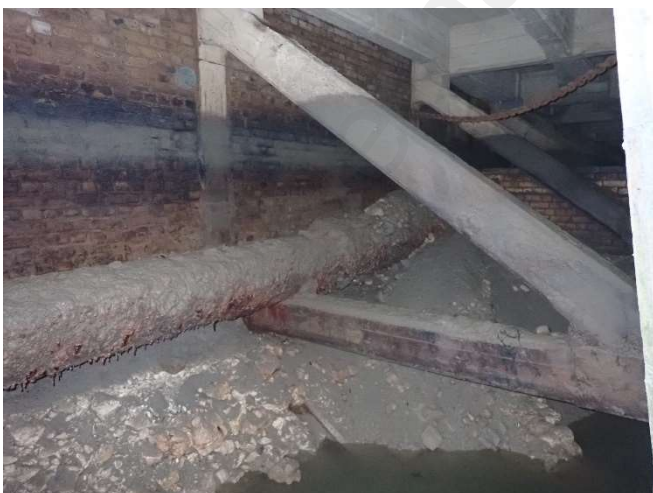
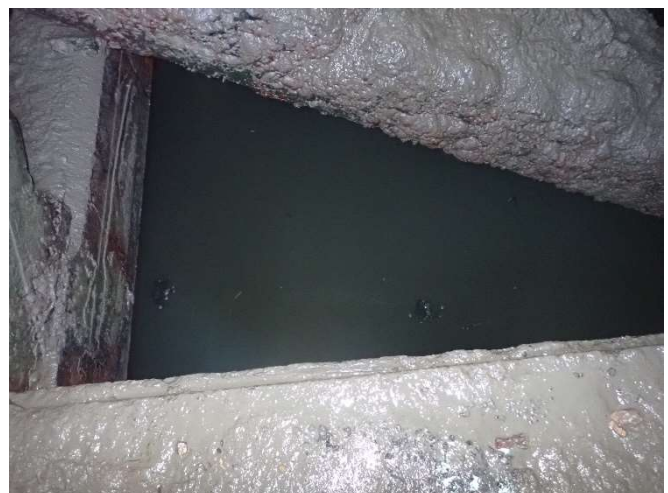
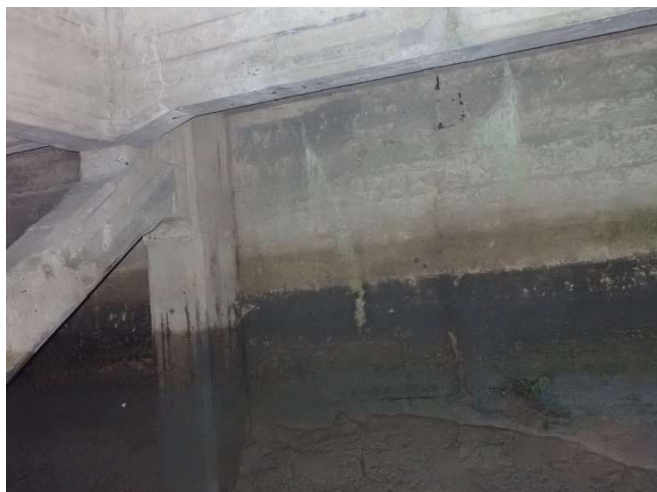
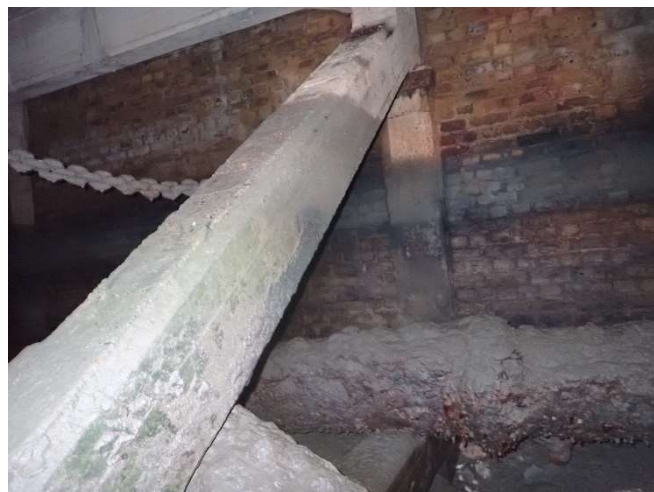
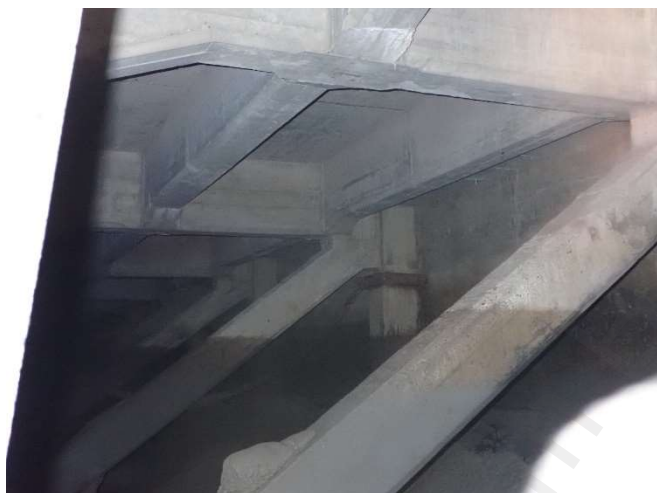
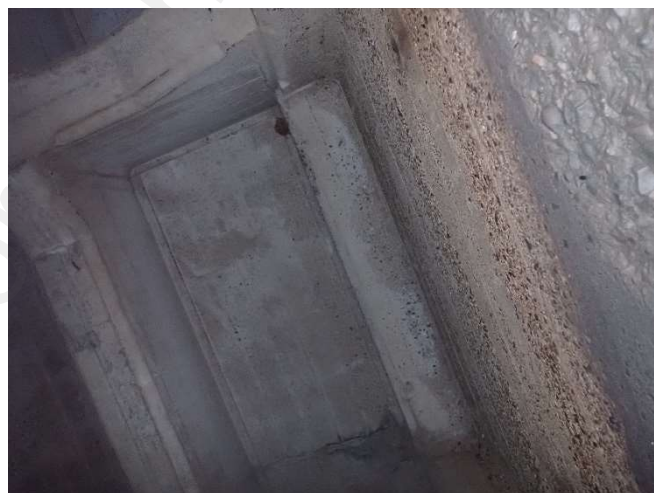
At the downriver end a concrete wall comprises the berthing line of the wharf. This concrete wall is approximately 300 mm thick and 8 m in height when measured from the riverbed depth. A visual inspection was undertaken to the structure below the downriver end deck through voids in the wall. A complex system of beams, struts and columns were visible, and it is believed that these comprise the supporting system of the downriver end wharf deck ([Photo 11](#) - [Photo 16](#)).

**Photo 11 – View of internal structure of wall 1**

**Photo 12 - View of internal structure of wall 1**

**Photo 13 - View of internal structure of wall 1**

**Photo 14 - View of internal structure of the masonry wall through wall 1**

**Photo 15 - View of internal structure showing the concrete beams and Masonry wall through wall 1**

**Photo 16 - View of internal structure of wall 1**

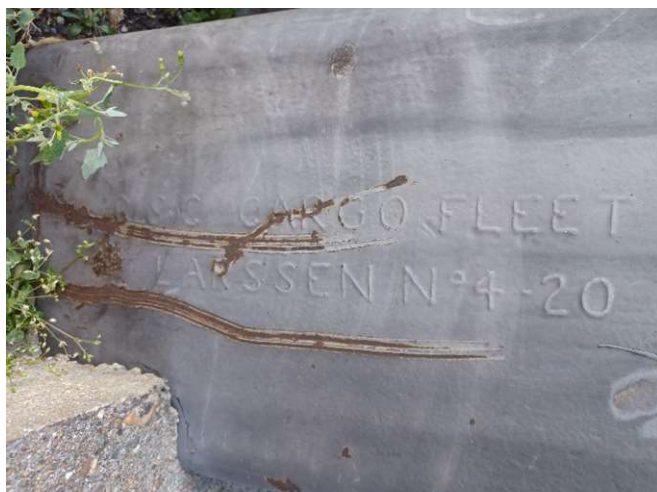
The downriver flood defence system comprises full section concrete walls at the very end of the wharf and Larssen N° 4 steel sheet piles with a 520 mm x 650 mm concrete capping beam in the areas at the downriver side of the flood gate ([Photo 17](#)).

**Photo 17 – Typical view of Larssen N°4-20 sheet**

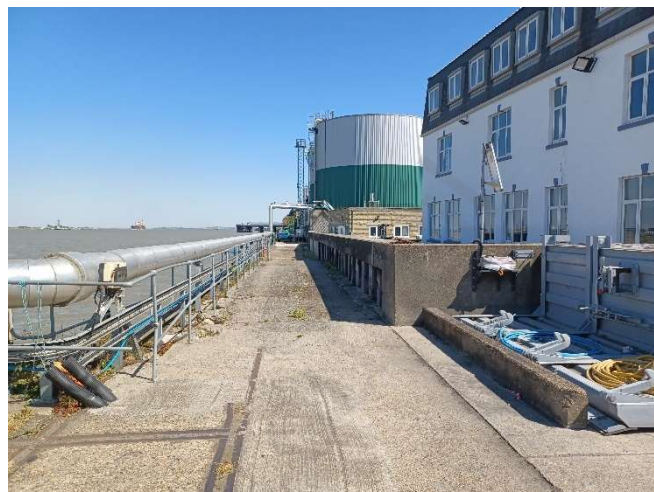
**Photo 18 – View of downriver flood defence wall from the floodgate**

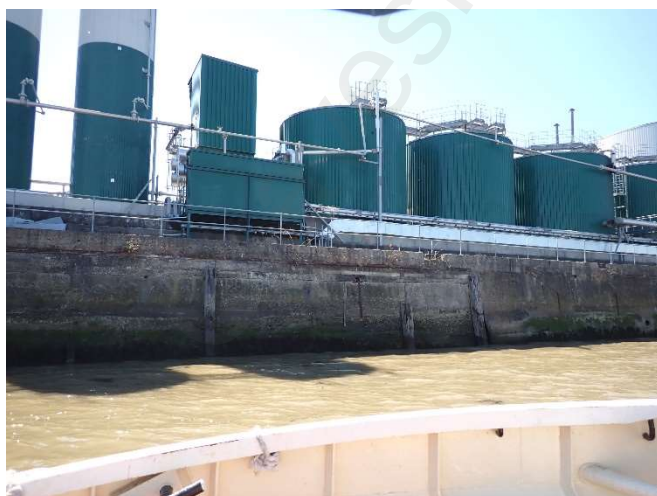
**Photo 21 – View of wall 1 fenders**

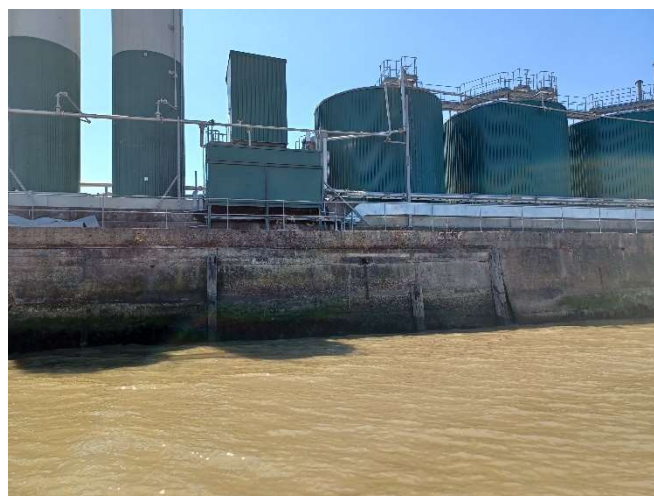
**Photo 22 – View of wall 1 fenders**

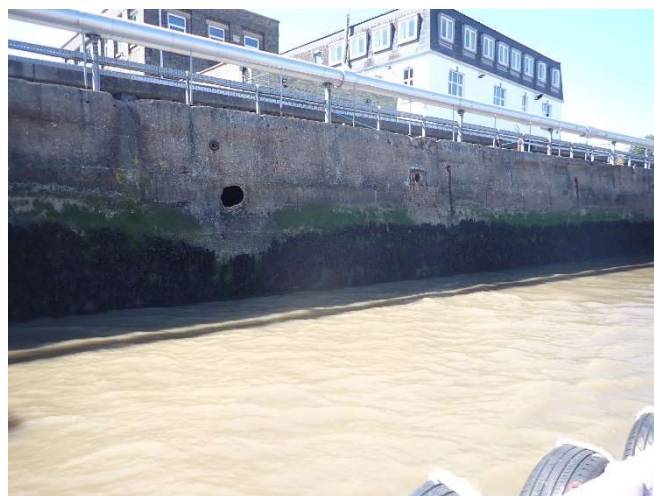
Wall 1 was found to be in overall fair condition with minor honeycombing ([Photo 23](#)) at 3 m from the downriver end of Wall 1. Along the concrete wall 4 No. voids size 0.6 m x 0.8 m, 0.3 m x 0.35 m, 0.2 x 0.3 m and 0.54 m x 0.19 m each were observed. The origin of the voids is not clear but they are not deemed critical for the stability of the deck, which is supported by concrete beams, columns, and struts, and for the flood capacity of the wharf, which is understood being relied on Walls 2, 3, 4, 5, 6 & 7. It is suspected that the voids were created to allow a hydrostatic balance on both sides of the wall.

**Photo 28 – View of void on wall 1**
