Convent of Mercy Phase 3,  
Hillside Drive,  
Gravesend  
DA12 1NY

Flood Risk Assessment and  
Drainage Strategy Report

C1477 / November 2024

| Document Status | | |
|---|---|---|
| Document Reference: B2240-FRA & Drainage Strategy | | |

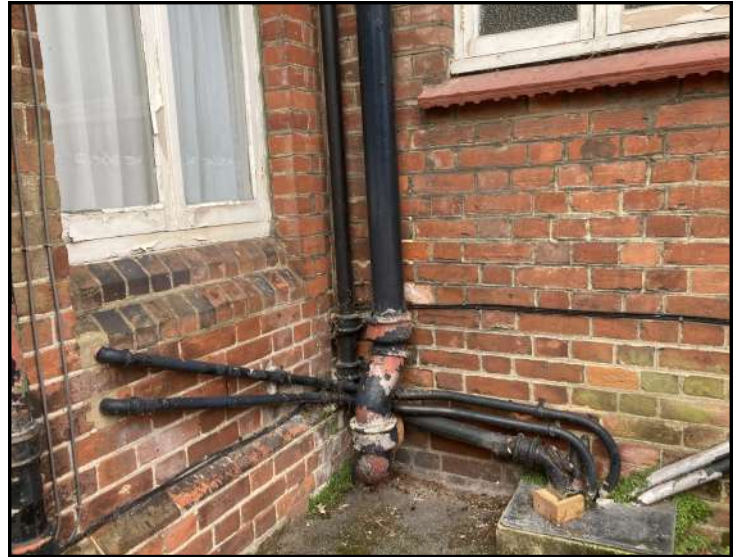
LOCATION OF VENT PIPE 1

VENT PIPE 1.  
UNABLE TO CCTV

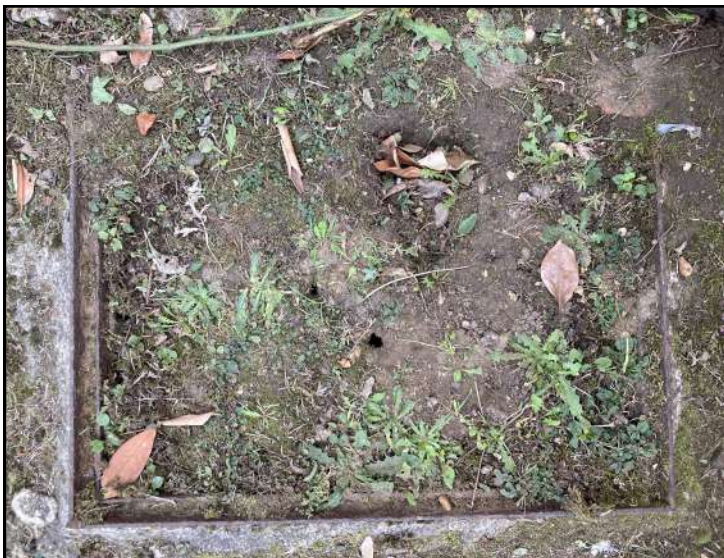
MH1.  
CHAMBER FILLED IN

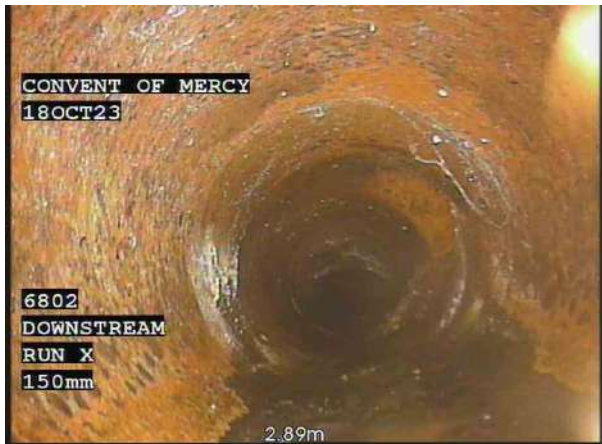
1, 00:00:29, 2.89 m  
Attached deposits, encrustation from 05 o'clock to 07 o'clock,  
5% cross-sectional area loss

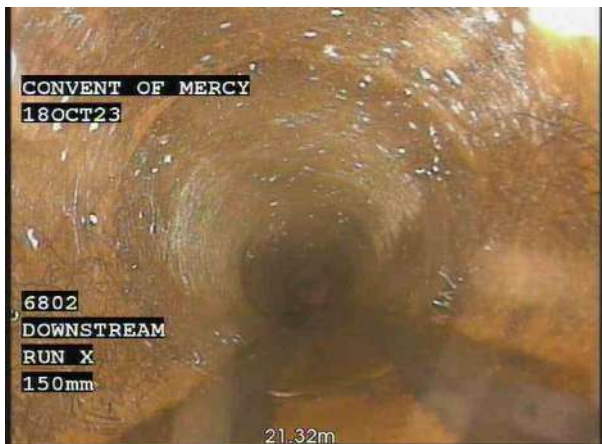
3, 00:02:58, 21.32 m  
Roots, fine at joint

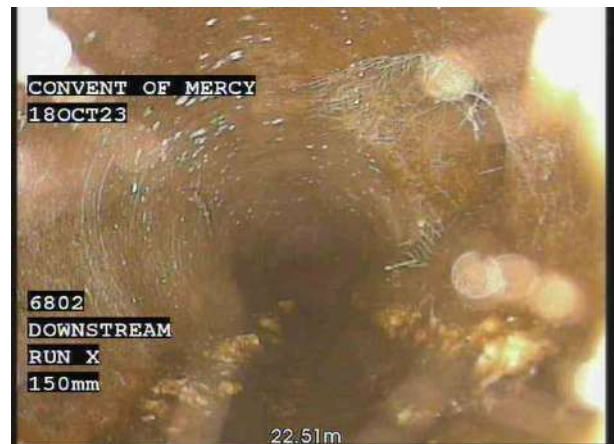
4, 00:03:27, 22.51 m  
Settled deposits, hard or compacted, 5% cross-sectional area  
loss

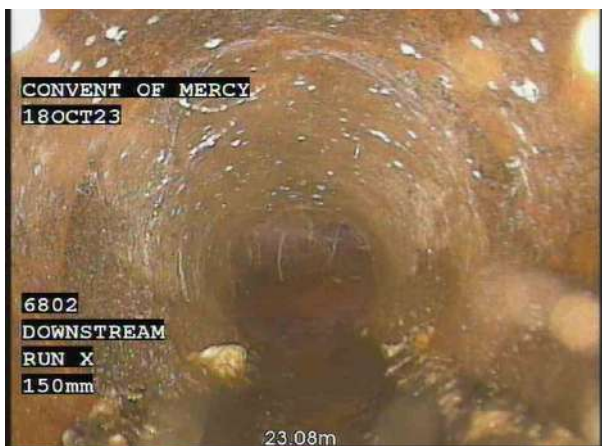
5, 00:03:46, 23.08 m  
Roots, mass at joint, 5% cross-sectional area loss

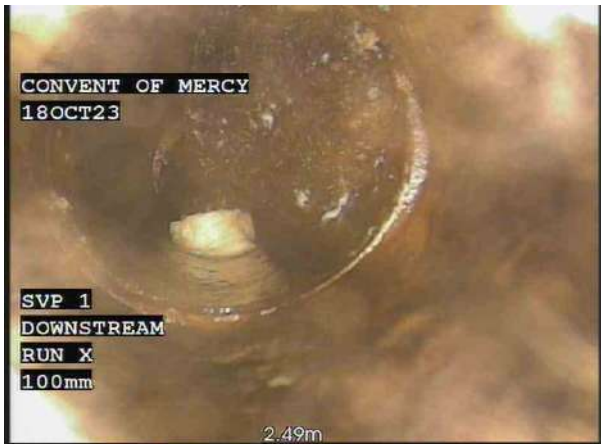
1, 00:00:54, 2.49 m  
Roots, mass at joint, 25% cross-sectional area loss

| Section number | Upstream manhole | Flow direction | Downstream manhole | Recommendations / Notes |
|---|---|---|---|---|
| 3 | SVP 1 | Downstream | RUN X | Clean by specialist root cutting and repair by lining |

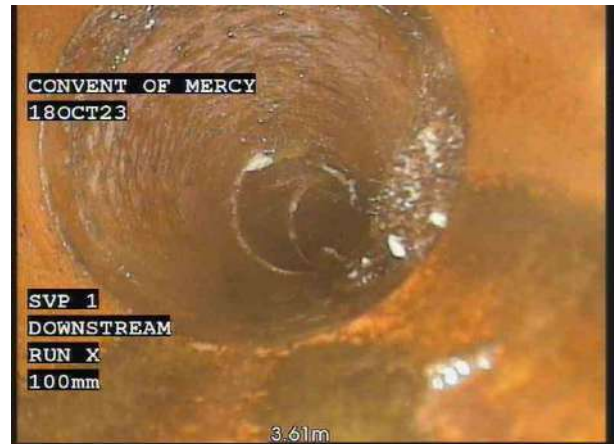
2, 00:01:28, 3.61 m  
Roots, mass at joint, 5% cross-sectional area loss

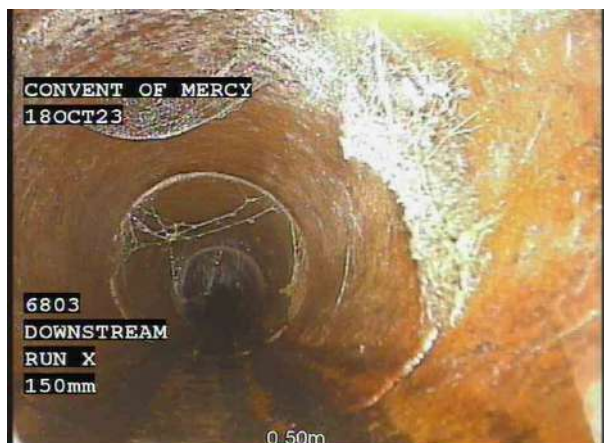
1, 00:00:05, 0.50 m  
Roots, fine at joint

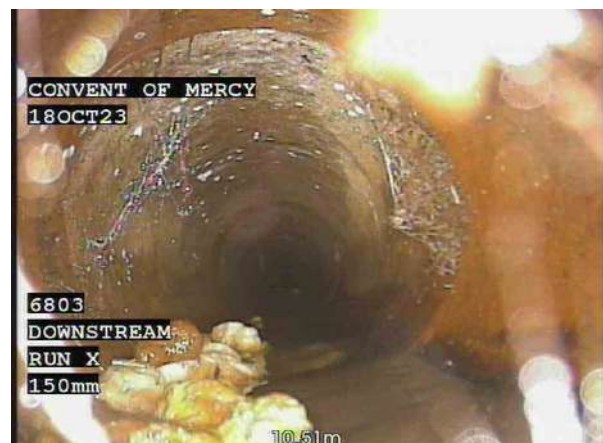
2, 00:01:00, 10.51 m  
Roots, fine at joint

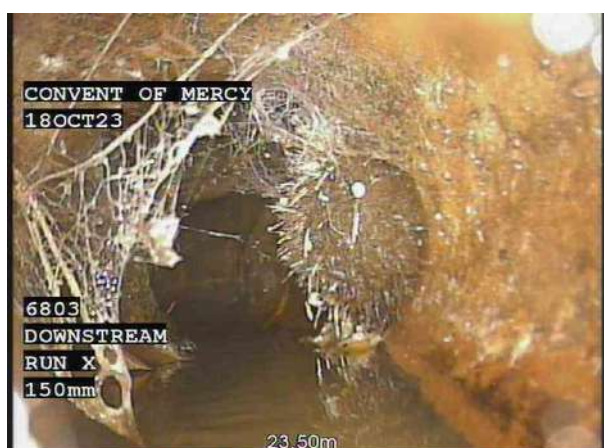
3, 00:02:20, 23.50 m  
Roots, mass, 10% cross-sectional area loss

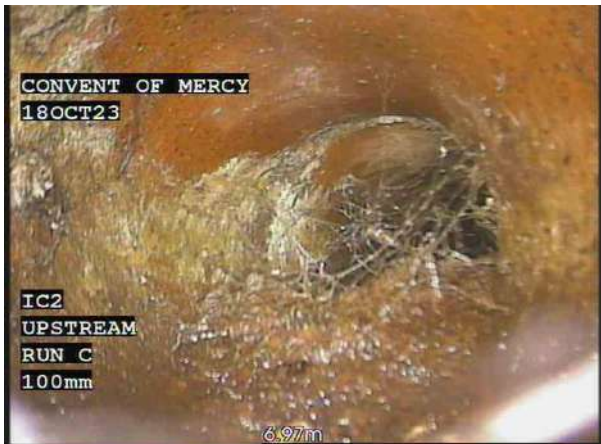
1, 00:01:20, 6.97 m  
Settled deposits, hard or compacted, 20% cross-sectional area loss

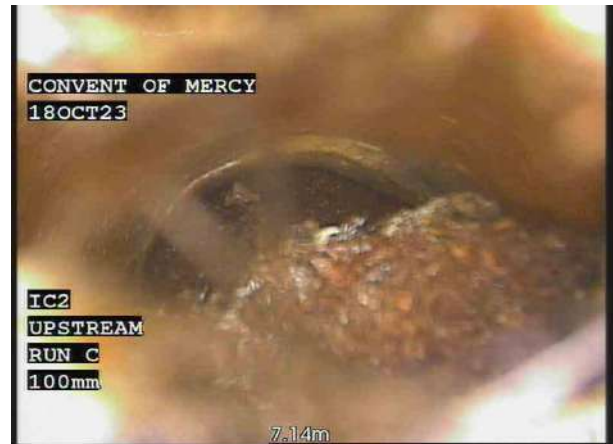
2, 00:01:44, 7.14 m  
Settled deposits, hard or compacted, 90% cross-sectional area loss

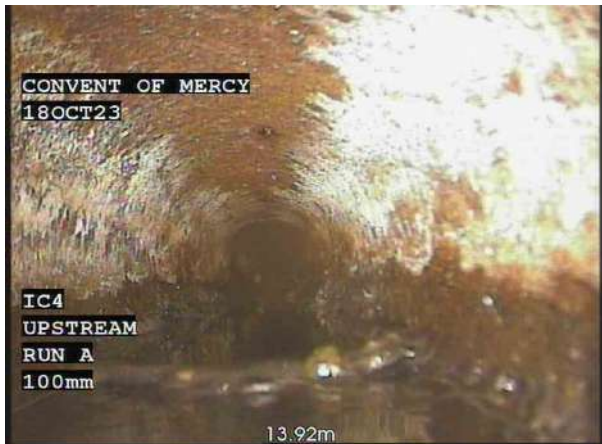
| Section | PLR | Grade | Description |
|---|---|---|---|
| 18 | IC4-AX | 3 | Multiple defects |

1, 00:01:49, 13.92 m  
Settled deposits, hard or compacted, 5% cross-sectional area loss

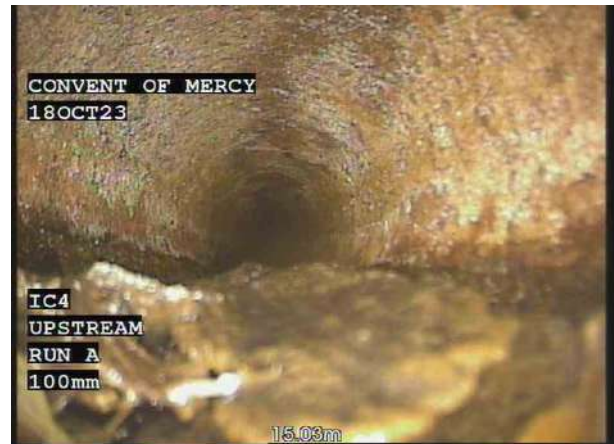
2, 00:02:12, 15.03 m  
Settled deposits, hard or compacted, 10% cross-sectional area loss

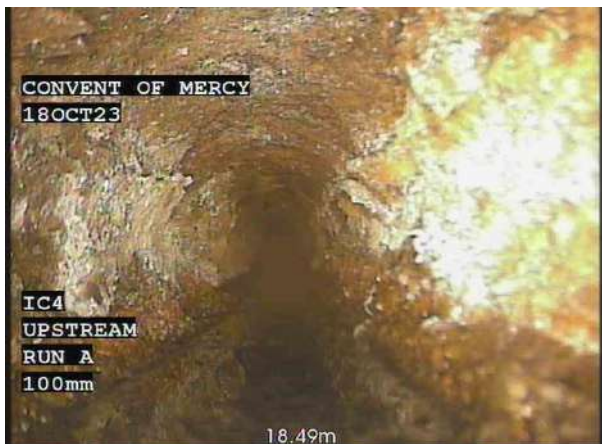
3, 00:02:47, 18.49 m  
Attached deposits, encrustation from 07 o'clock to 05 o'clock, 5% cross-sectional area loss, start

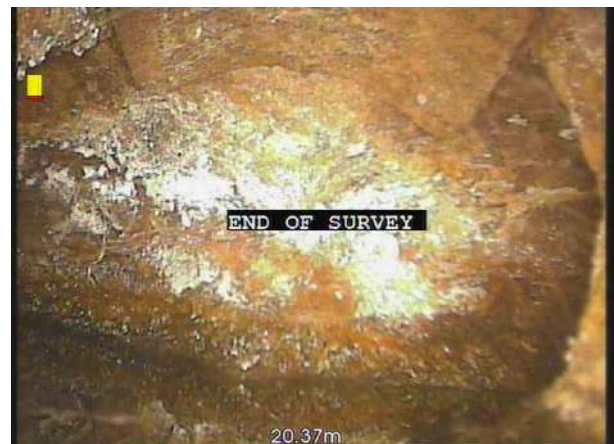
4, 00:03:36, 20.37 m  
Finish node, outfall, reference: IC4-A, At Y junction - unable to continue

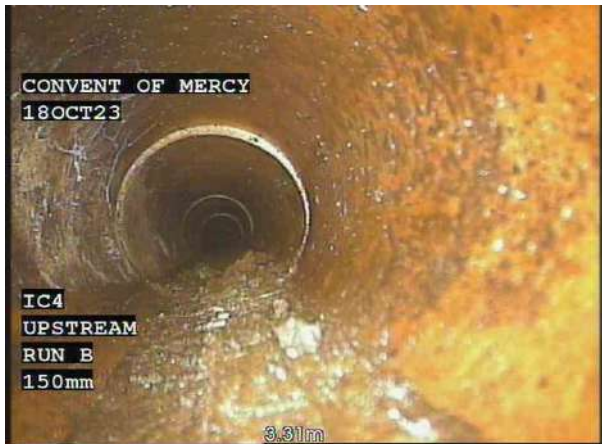
1, 00:00:42, 3.31 m  
Settled deposits, hard or compacted, 5% cross-sectional area loss, start

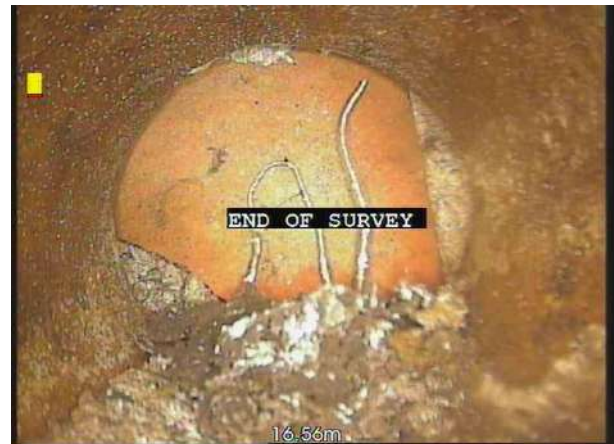
2, 00:02:30, 16.56 m  
Finish node, outfall, reference: IC4-B, At capped / redundant end

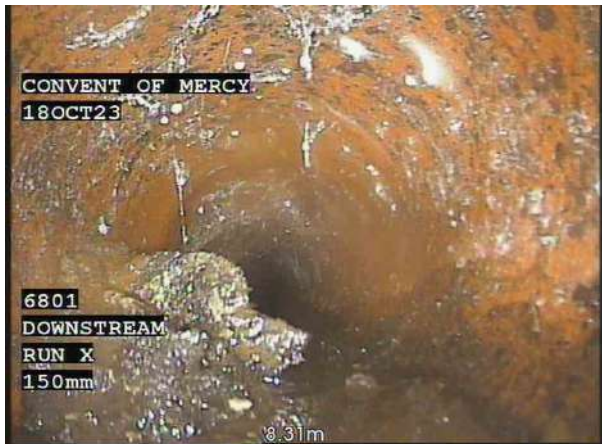
1, 00:00:46, 8.31 m  
Settled deposits, hard or compacted, 10% cross-sectional area loss

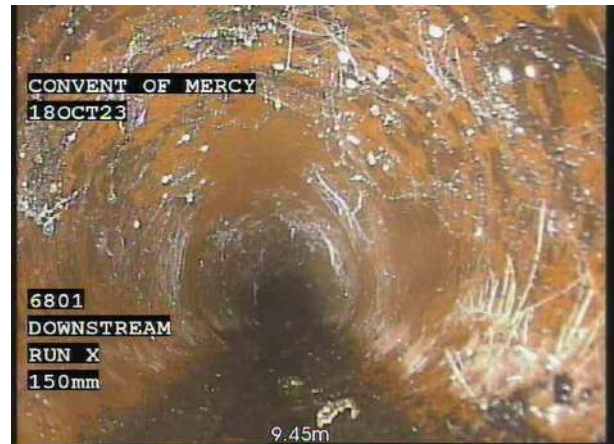
2, 00:01:07, 9.45 m  
Settled deposits, hard or compacted, 5% cross-sectional area loss, start
