## **CUSTOM HOUSE, THE TERRACE, GRAVESEND, DA12 2BW**

### **LEAD WORKS**

This statement formally sets out the methodology of the repair works required to the existing lead flashing and guttering across the Custom House site.

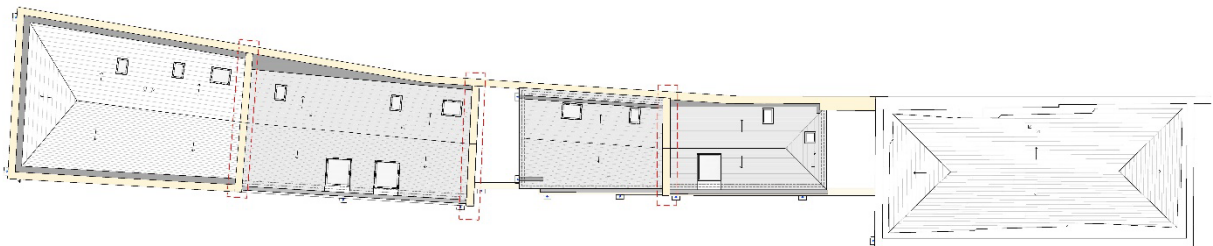
The new extensions to the outbuildings are separated by brick party walls and parapets, in keeping with the existing outbuilding aesthetic. These brick parapet locations will be the only location of new lead flashing across the site. See detail and locations below.

*Outbuilding roof plan – Red dash highlights brick parapets with new lead flashing.*

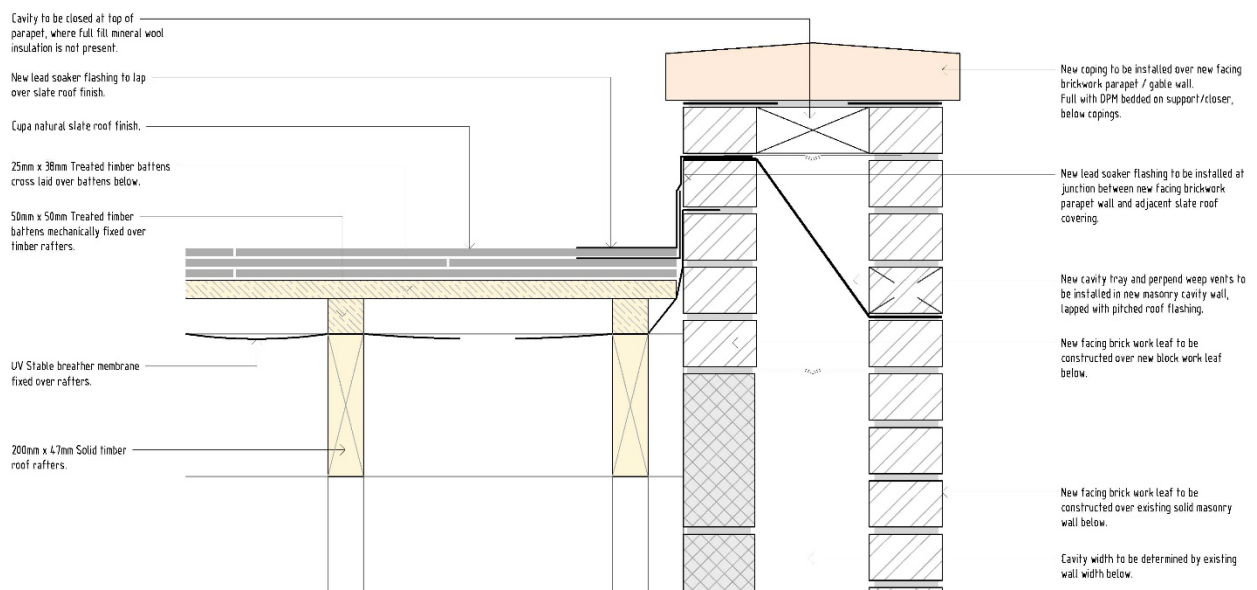
*Outbuilding new parapet party wall detail.*

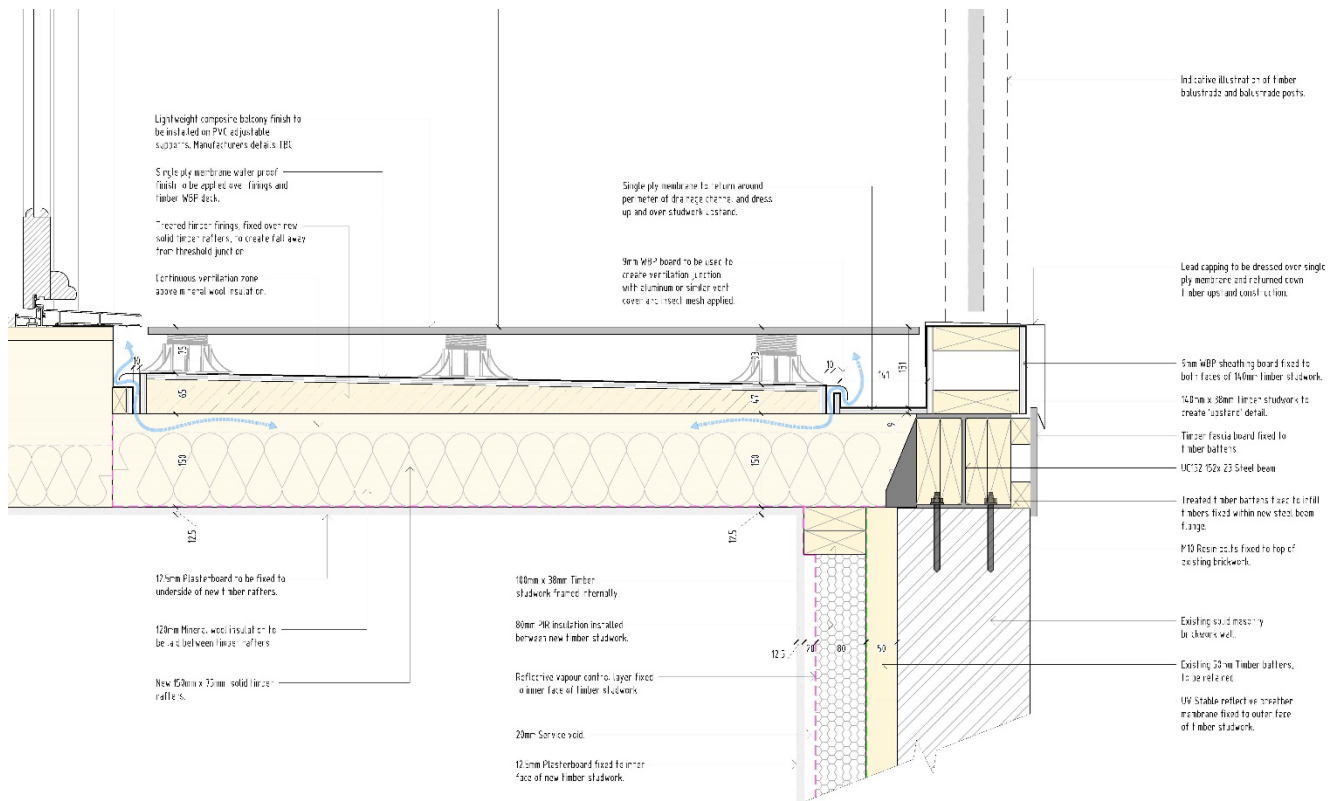
The leadwork to the balcony floor is to be removed. The current structure and finish are not suitable for a working balcony. A new detail has been provided to improve the structure and finish, making the balcony space usable. A lead capping is proposed to the balcony parapet.

*New boathouse balcony floor and capping detail.*
