# HB Archaeology & Conservation Ltd

MILTON MOUNT CHURCH,  
CLARENCE PLACE, GRAVESEND,  
KENT, DA12 1LD

## LEVEL 3 HISTORIC BUILDING RECORD

Prepared by HB Archaeology & Conservation Ltd  
Project No. 2023535  
December 2023

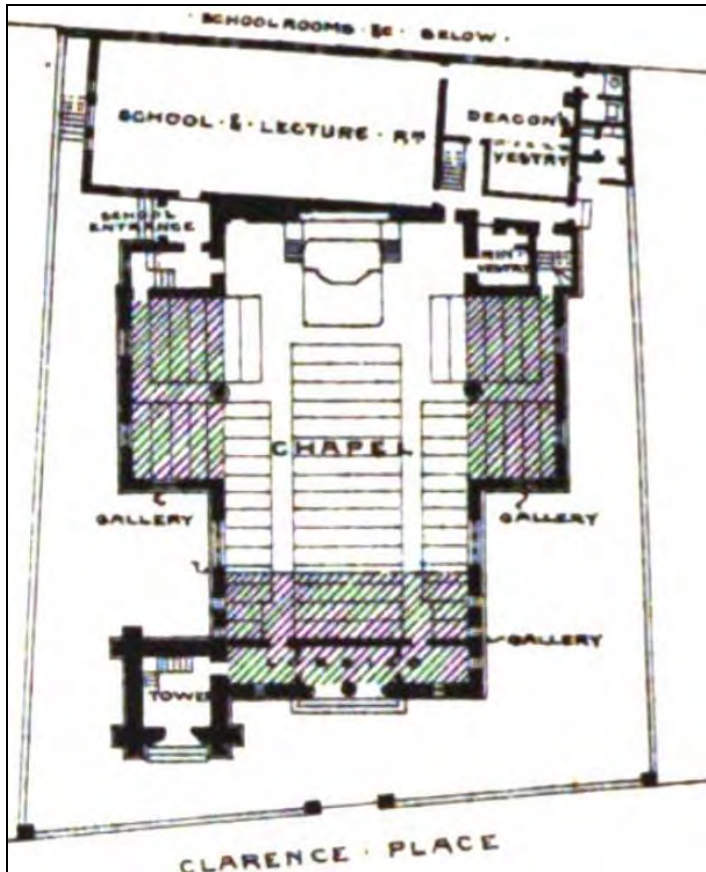
Plate 1: The ground floor plan as proposed and presented in The Building News, January 2<sup>nd</sup> 1874

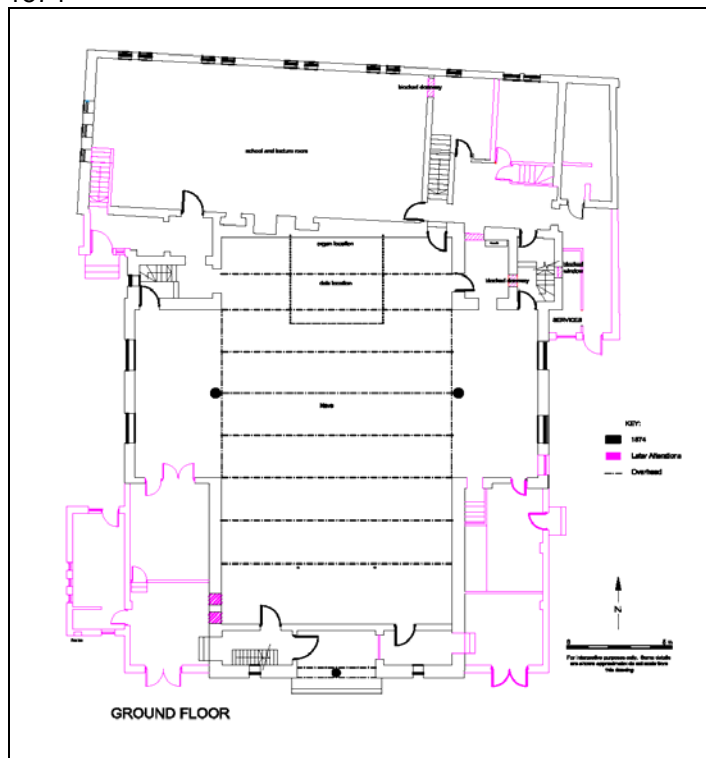
Plate 2: The ground floor plan as existing, 2023

- 6.1.8 Two two-storey extensions had been added (in stages) to the south of each aisle, extending down to meet the south elevation of the church (Plates 1 and 2). Three single-storey extensions had been added to the group. To the southwest, northwest and northeast, the two northern additions linked to the school and lecture theatre range (Plate 2).

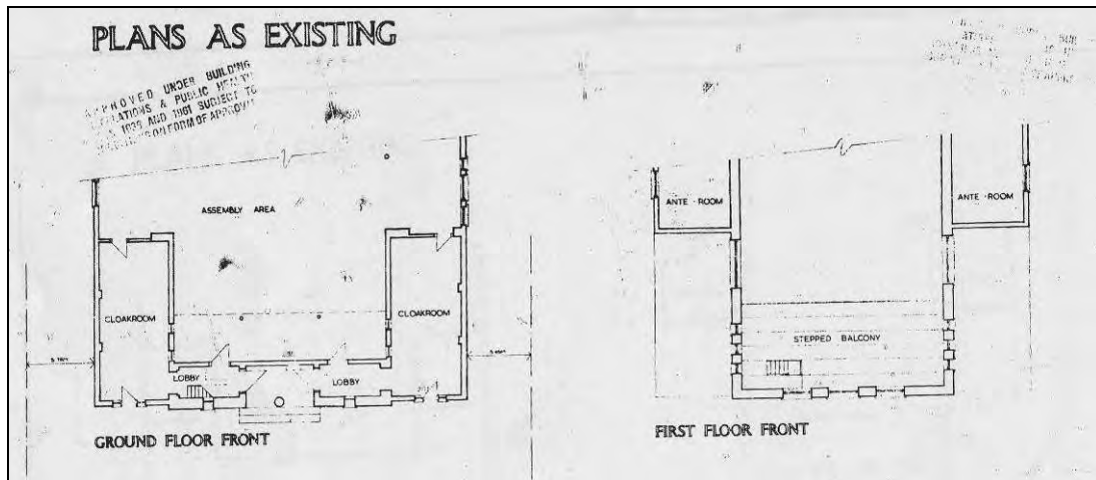
Plate 4: Extract of the building as existing showing the loading bay extensions made in 1955, converted to cloakrooms in 1968 and subsequently extended upwards to include first floor reading rooms

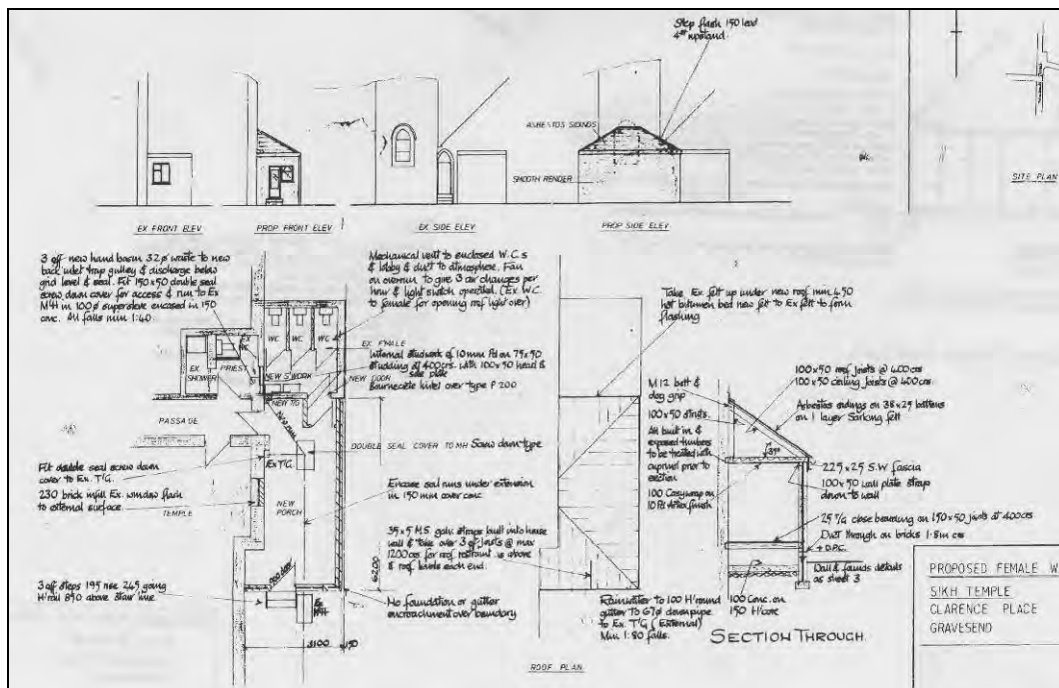
6.1.20 In 1982 extensions were made to the toilet facilities in conjunction with interior alterations (Plate 6).

Plate 6: Alterations to the WC facilities at the northeast corner of the former school building and the porch extension to the south of it added in 1982

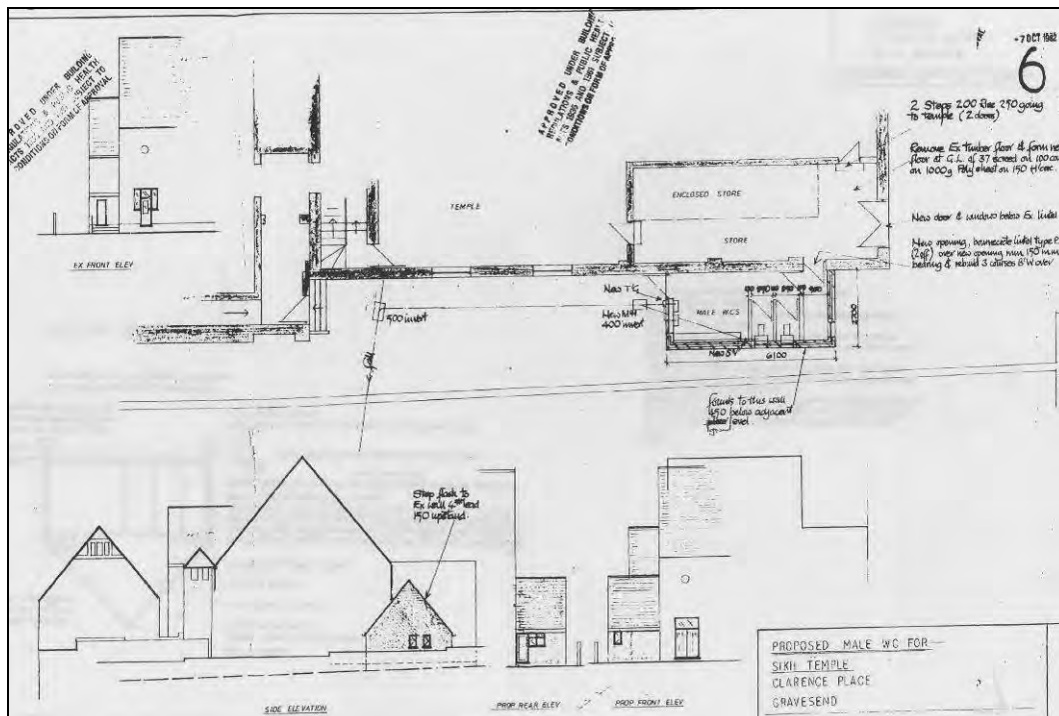
6.1.21 New toilet facilities were also added at the same time to the west side of the southwest cloakroom (the former loading bay; Plate 7).

Plate 7: The new toilet facilities added to the west side of the loading bay extension to the church in 1982

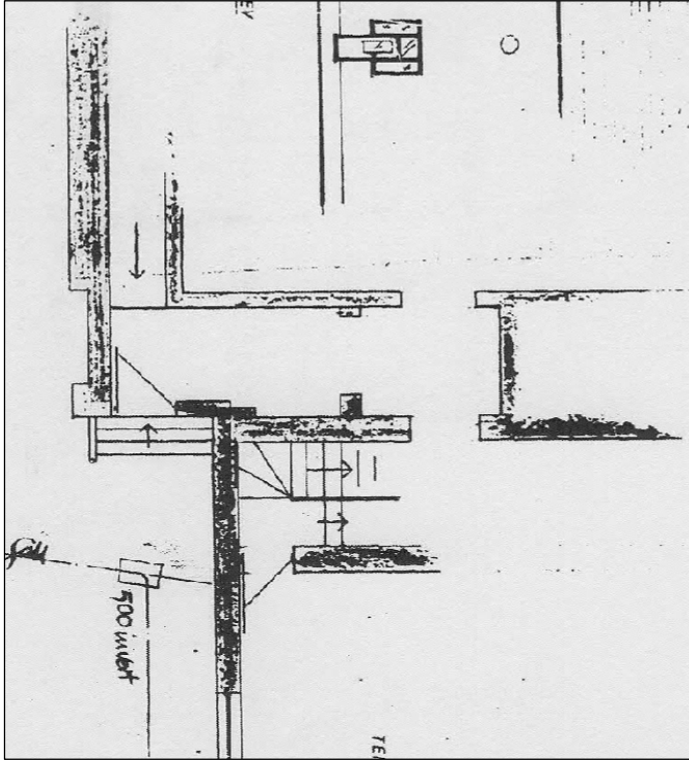
6.1.22 The remaining extension is located at the junction of the west aisle and the southwest corner of the former school: no proposal plans were located for the addition, however, it is shown *in situ* on the 1982 proposal plans (Plate 8).

Plate 8: The 1982 proposal plan showing the small lobby extension at the junction of the church and the former school *in situ* by that date

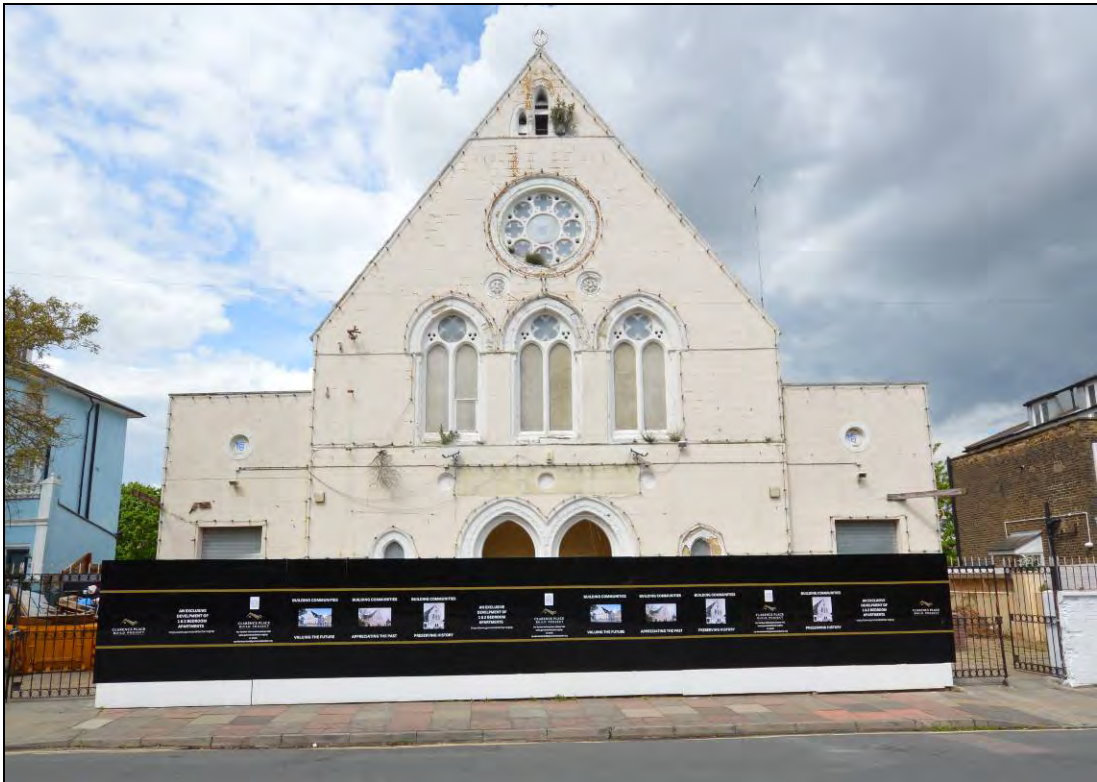
- 6.2.3 The first floor part of the elevation comprises a tripartite feature window, a group of three pointed arch-headed openings each of two lights surmounted by quatrefoil tracery (Plate 10).. The tripartite window is in turn surmounted by a large circular

'rose' window. Two round plaques with carved motifs sit between the base of the rose window and the arched heads below and a further three round recessed plaques of plainer design are situated between the base of the tripartite arched window and the entrance arcade (Plate 10). Further embellishments are included at the apex of the gable: this comprises another tripartite opening, a ventilator comprising a taller central pointed-arch flanked by a lower pair, the parts separated by carved columns (Plate 10). The finial currently *in situ* replaced the original carved cross when the building was converted to its temple function.

Plate 10: The feature front, the south elevation of the church fronting onto Clarence Place

6.2.5 The two extensions are set back from flush to the principal south elevation of the church. The additions are box-like with flat roofs and a rendered finish embellished by incised ashlar lines. Both extensions have wide central doorways surmounted by simple circular windows (Plate 10). The base of the additions have plinths of brown brick laid in stretcher bond (Plate 9: this continues onto the base of the church elevation indicating that the intervention occurred when the extensions were altered to their current form during the late 20<sup>th</sup> century.

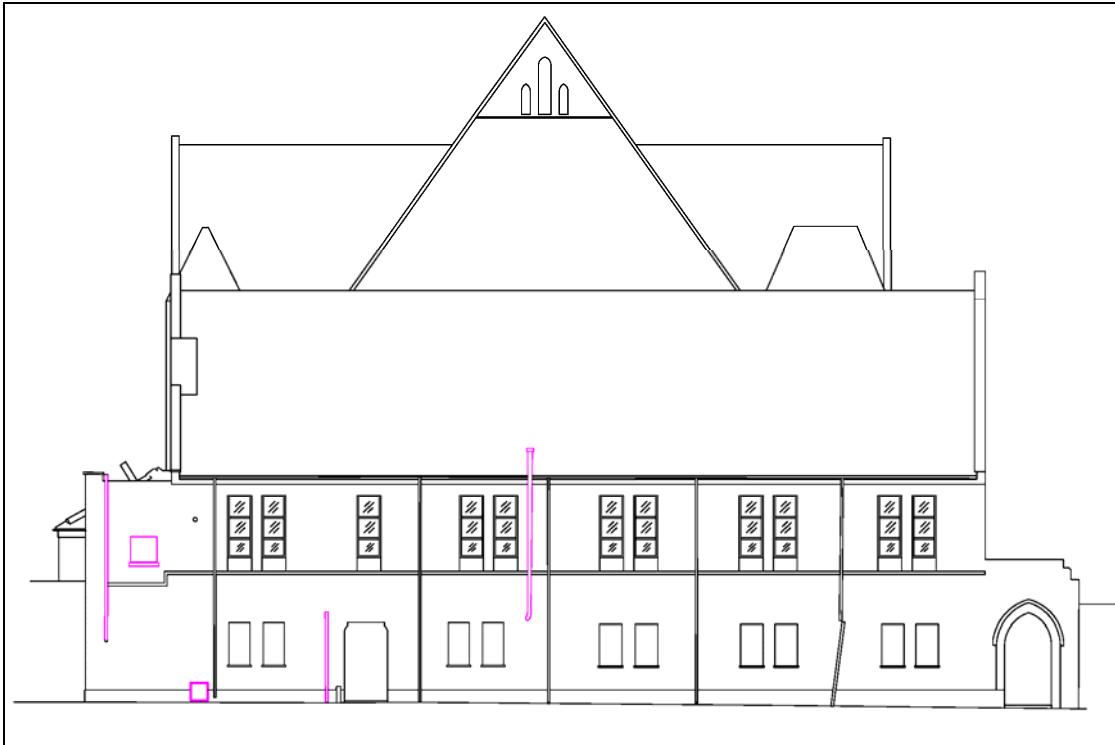
6.2.6 The north elevation of the property fronts onto William Street and comprises the side elevation of the former purpose-built school building. The school, at two storeys in height, had a substantially lower ridge-line in comparison to the church proper, emphasising the hierarchy and different functions of the two ranges (Plate 11).

Plate 11: The north elevation (based on the drawings prepared by Survey and Engineering Services Ltd for Haskins Designs)

- 6.2.8 The final features on the north side of the group is the pointed arched opening at the eastern end of the building: this is an external entrance leading to the narrow courtyard on the western side of the church. A single modern window is situated at the western end of the building: this lights the interior of the WC facilities in that location, concealed behind a parapet effect on the north side of the group (Plate 11).

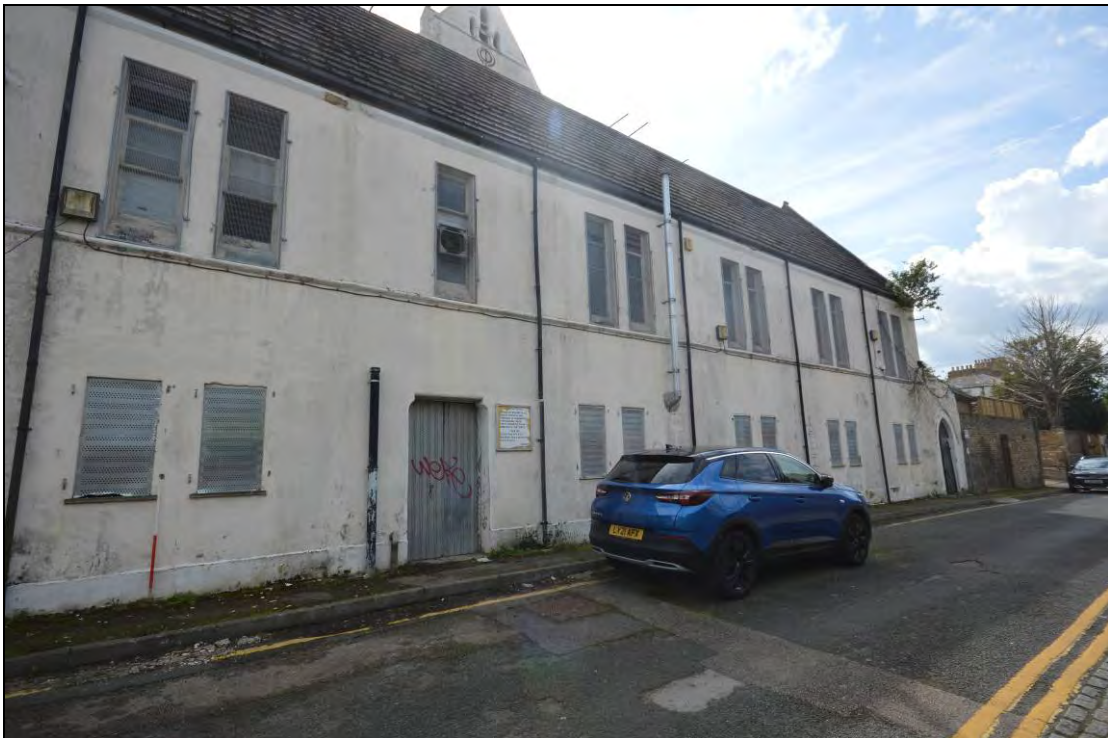
Plate 12: An oblique view of the north elevation as existing in 2023

- 6.2.7 The north elevation comprises a single entrance with a shouldered-arch head, situated towards the eastern end of the range: this leads to the lower ground floor and the stair hall (Figure 2). The remainder of the elevation comprises windows arranged in pairs at regular intervals. The fenestration for the upper ground floor is laid out to

match that of the floor below, with an additional single-light window over the entrance (Plates 11 and 12). The subtle embellishments to the elevation comprise a moulded string course at the base of the upper ground floor windows and a moulded cornice. The roof is gabled at each terminal and is under a cover of slate.

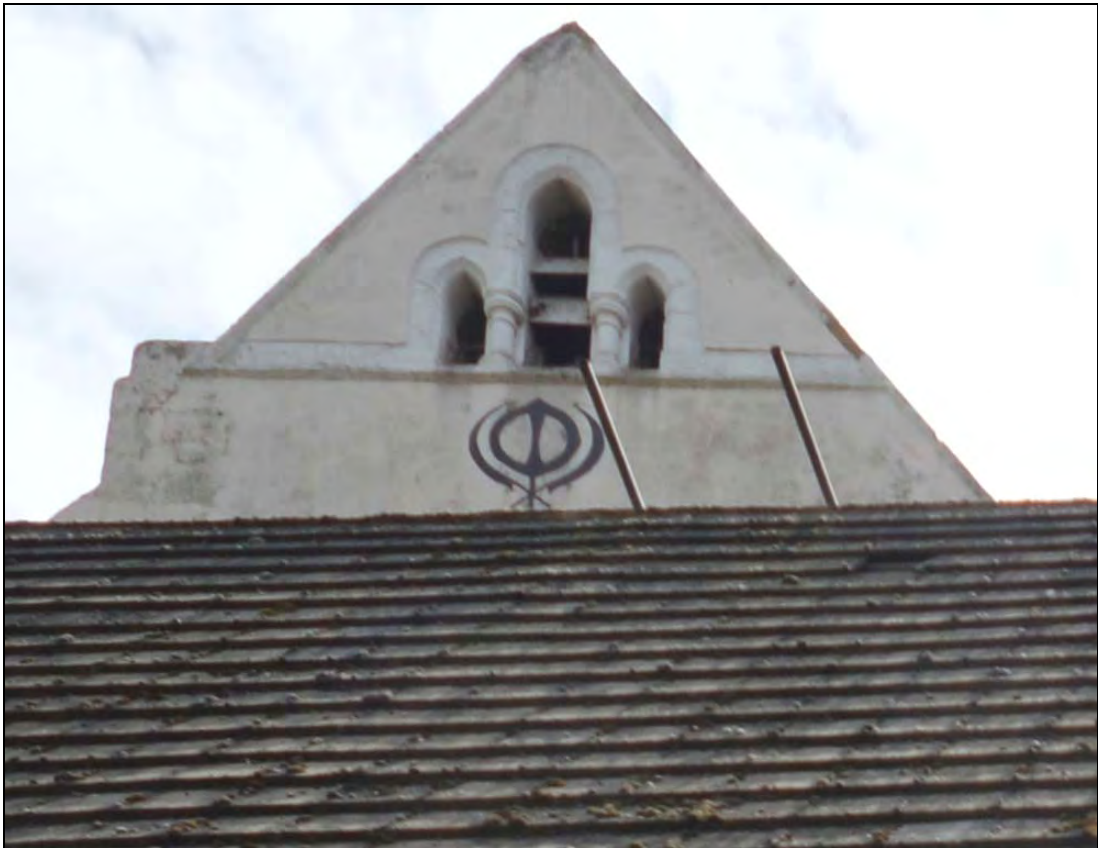
Plate 13: The north gable of the church

- 6.2.9 The north gable of the church rises above the roof-line of the former school building. The gable is pierced by another tripartite ventilator to match that *in situ* at the front of the church (compare Plates 10 and 13). A decorative band defines the base of the windows and extends to the slopes of the roof: this steps out to the east side in the location of the former (now truncated) chimney stack that had served the fireplace in the minister's vestry at the northern end of the east aisle. The painted motif below the ventilator relates to the temple function of the property.

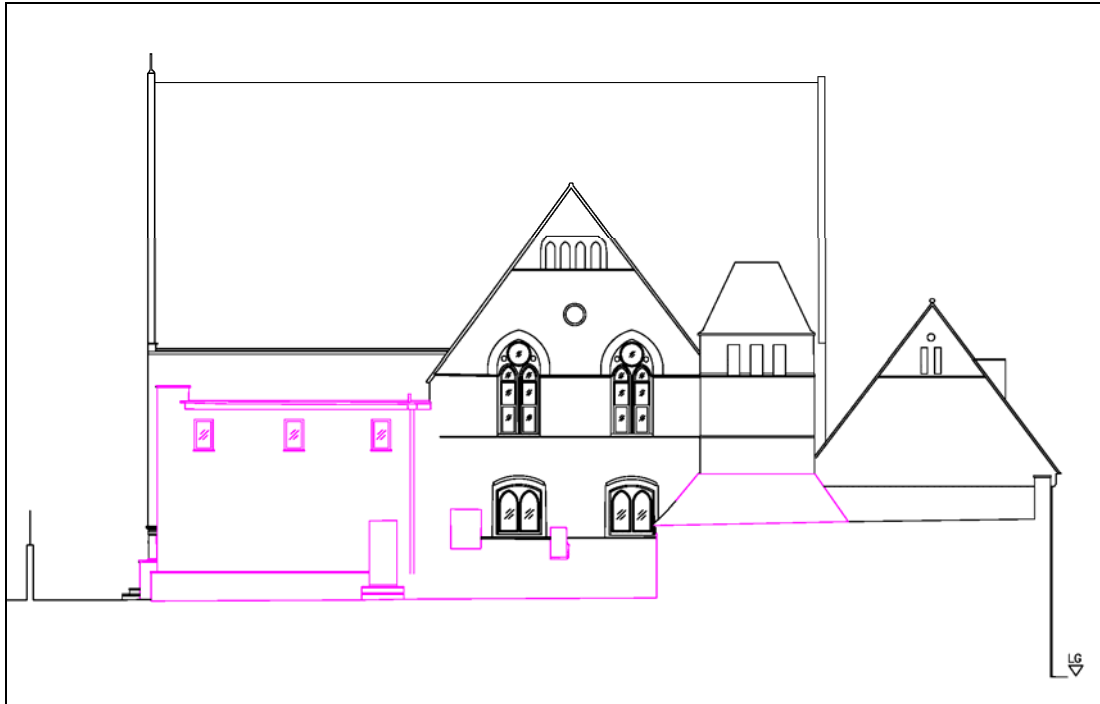
Plate 14: The east elevation (based on the drawings prepared by Survey and Engineering Services Ltd for Haskins Designs)

- 6.2.10 The east elevation comprises the rendered gabled end of the school: this is rendered with moulded detail to the gable coping and as a string course situated at the base of a two-light ventilator. The ventilator is surmounted by a round openings at the apex of the roof (Plate 14).
- 6.2.11 A squat rectangular projection on the north side of the gable is the chimney stack that served the hearth in the Deacon's rooms at the eastern end of the school building.. The base of the gabled end of the school is concealed behind the single storey WC facilities: this part of the group is in brick laid in Flemish bond (Plate 15).

- 6.2.15 A recessed circular plaque with carved floral motif is situated below the centre of the ventilator (Plate 14). The ventilator is not without its own embellishments: the four openings include pointed-arched-heads and the junction of each arch includes a decorative plaque.

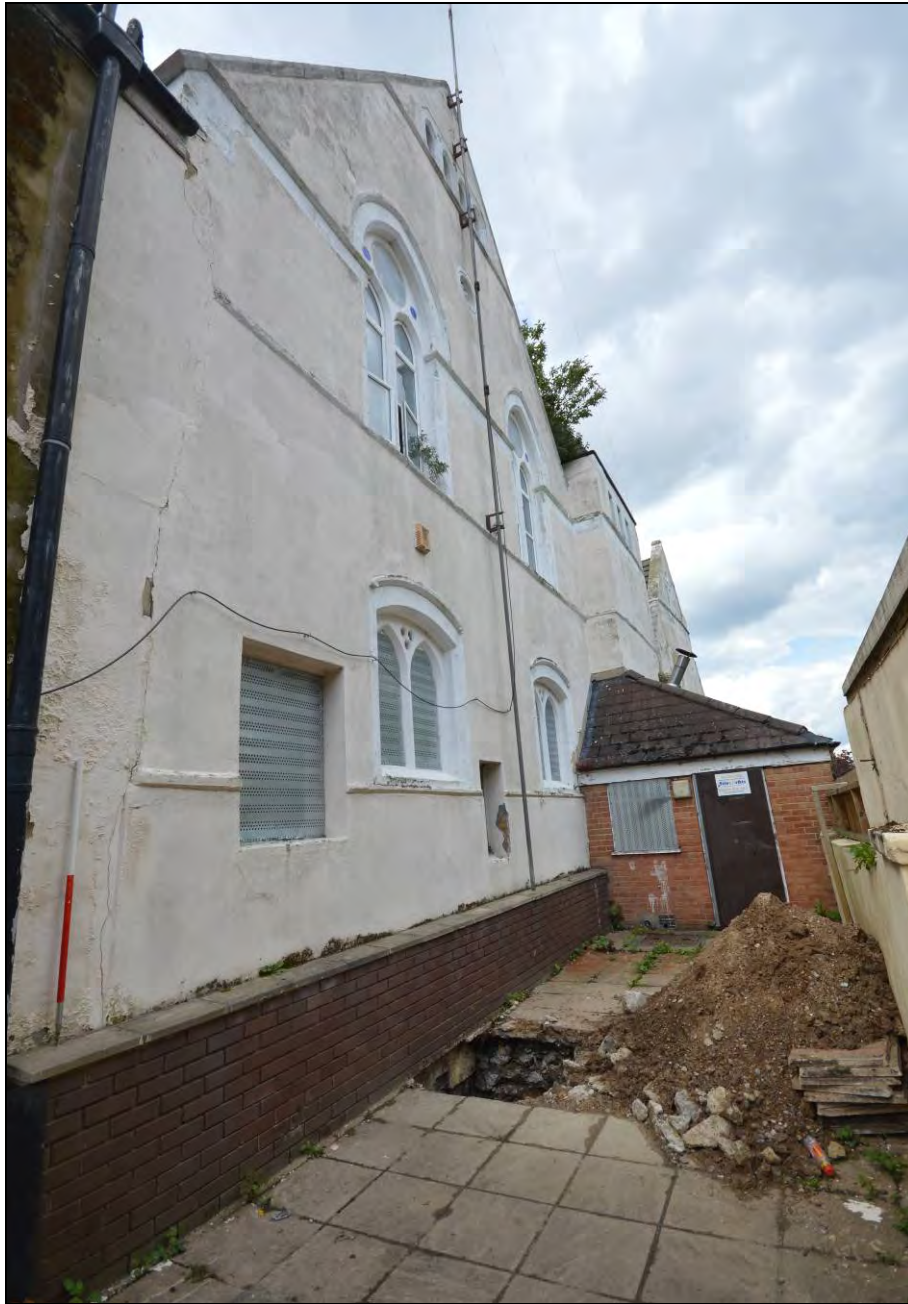
- 6.2.16 Two modern windows have been inserted into the wall at ground floor level: these are plain rectangular openings that interrupt the string course in that location. The applied brick plinth described above for the south elevation and the 20<sup>th</sup> century extensions has been continued along the length of the east elevation (Plate 16).

Plate 16: The east elevation and the porch added in 1982

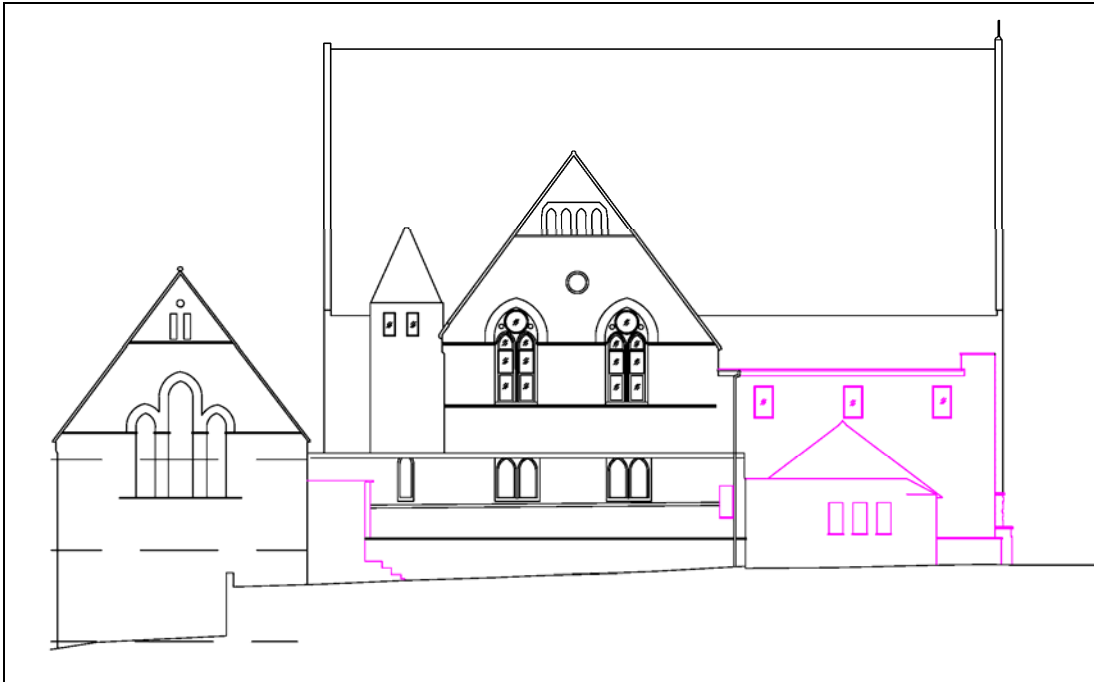
Plate 17: The west elevation (based on the drawings prepared by Survey and Engineering Services Ltd for Haskins Designs)

- 6.2.18 The west elevation of the school building comprises a feature tripartite window that lights the interior of the original school room on the upper ground floor (Plate 17). A doorway had been situated at ground floor window: this has since been blocked on the interior and there was no external access to the small courtyard in front of the doorway at the date the survey was undertaken.

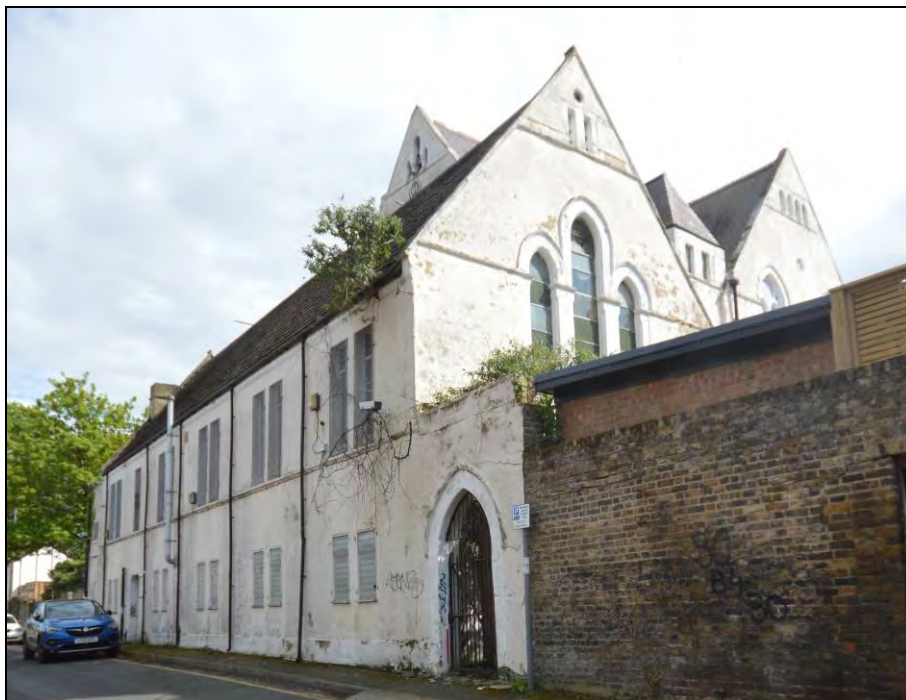
Plate 18: The west end elevation of the school, stair turret and west aisle from William Street

- 6.2.19 The gabled end of the school is under render: the capping to the eaves is moulded and there are two visible moulded string courses with at least one further course anticipated at the base of the tripartite window. The two extant string courses are situated at the springing point on the window and at the base of a two-light ventilator at the apex of the roof.
- 6.2.20 The tripartite window includes a tall central light flanked by a pair of lower lights, all with pointed arched heads. The string course is punctuated by the openings yet picked up again on the columns that separate each light (Plates 17 and 18).
- 6.2.21 The ventilators match those *in situ* at the eastern end of the school range, surmounted once again by a circular opening (Plate 18).

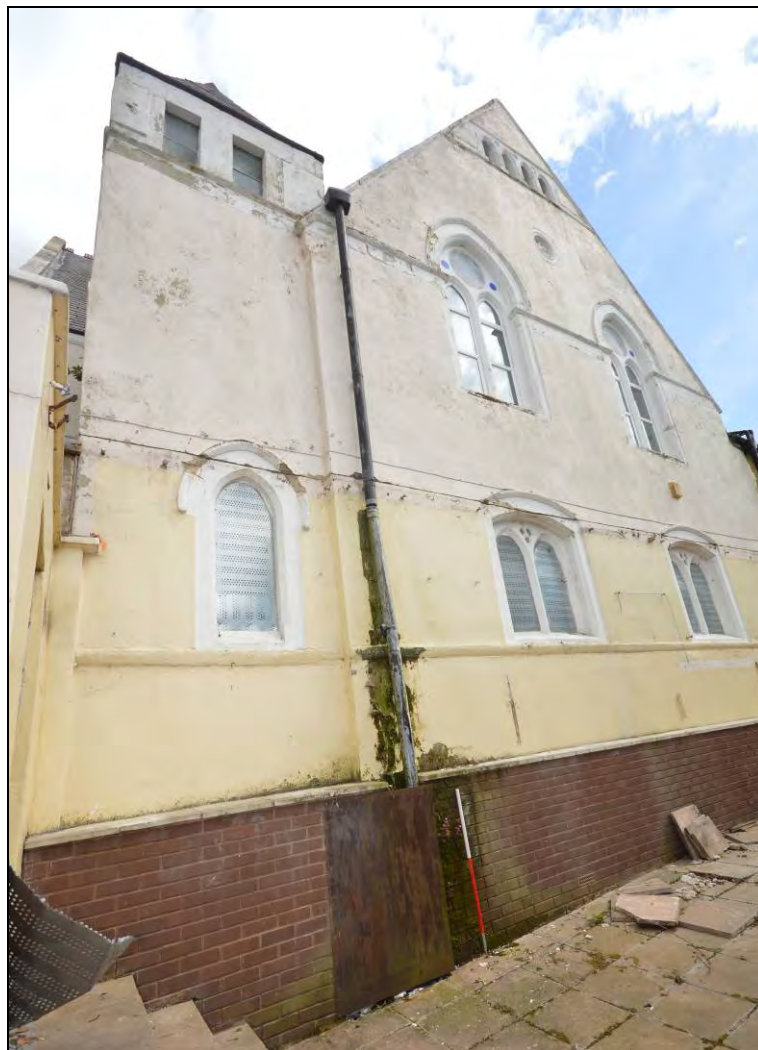
Plate 19: The west side of the building showing the stair turret and west aisle

- 6.2.23 The ground floor window is a single light one with chamfered leading edges and a prominent moulding that is almost more of a hood-moulding in this instance (Plate 19). The two plain rectangular openings at the eaves do not sit well within the tower and it is possible that they had been altered in the 20<sup>th</sup> century to the current form (Plate 19).
- 6.2.24 As before, the applied brown brick plinth continues along the entirety of the west elevation excepting the location of the WC facilities added in 1982 and removed by the date of this survey.

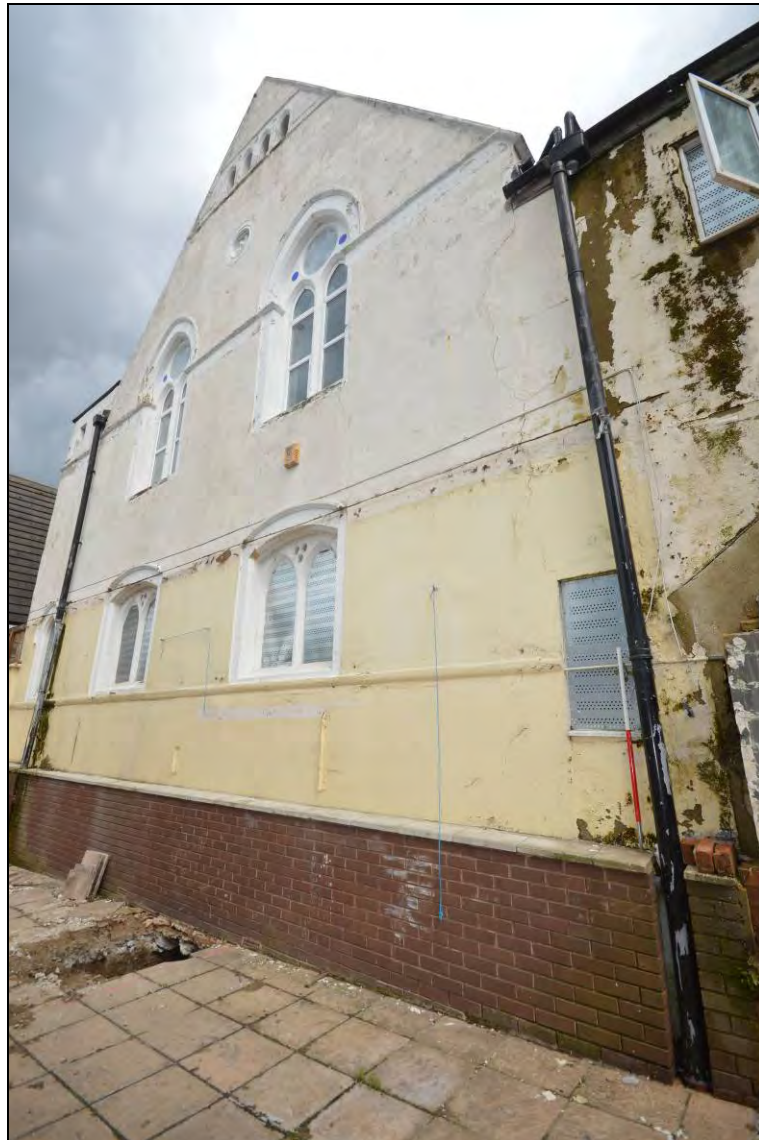
Plate 20: The west aisle

- 6.2.25 The stylistic details of the west aisle match those described above for its eastern counterpart. The exception to the west aisle is the inclusion of a single modern rectangular window at the south end of the structure. The inserted window truncated the lower string course in that location (Plate 20).

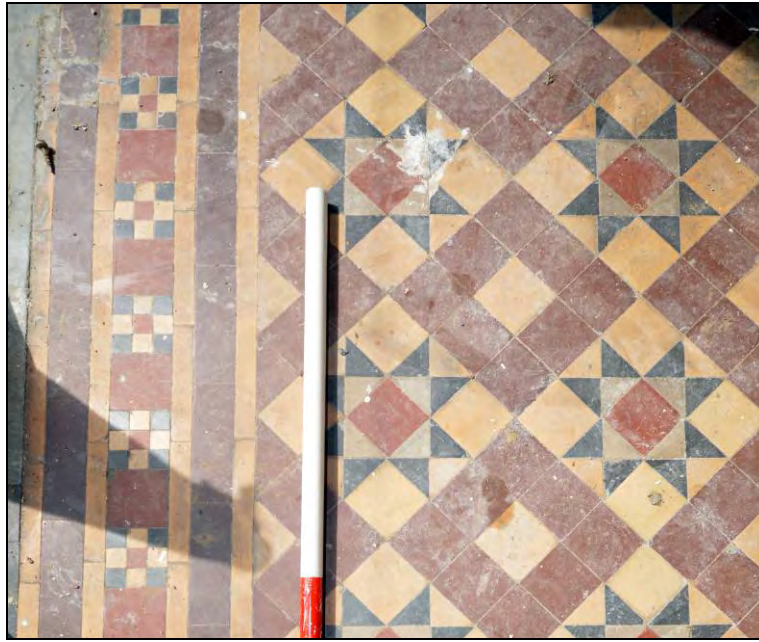
- 6.3.1 The entrance arcade is rectangular in plan, the open central part includes a tiled ceramic tiled floor finish with a geometric motif (Plate 22). The walls are rendered and the ceiling under-plastered. The two entrances leading to the lobbies have rounded jambs with bar-stops detail: additional moulded embellishments surmount the jointed and pegged timber doorframe (Plate 23)
- 6.3.2 The doors are of vertical boarded type, the details on the exterior have been concealed behind recent boarding, added as a security measure.

Plate 22: Detail of the tiled floor in the entrance arcade

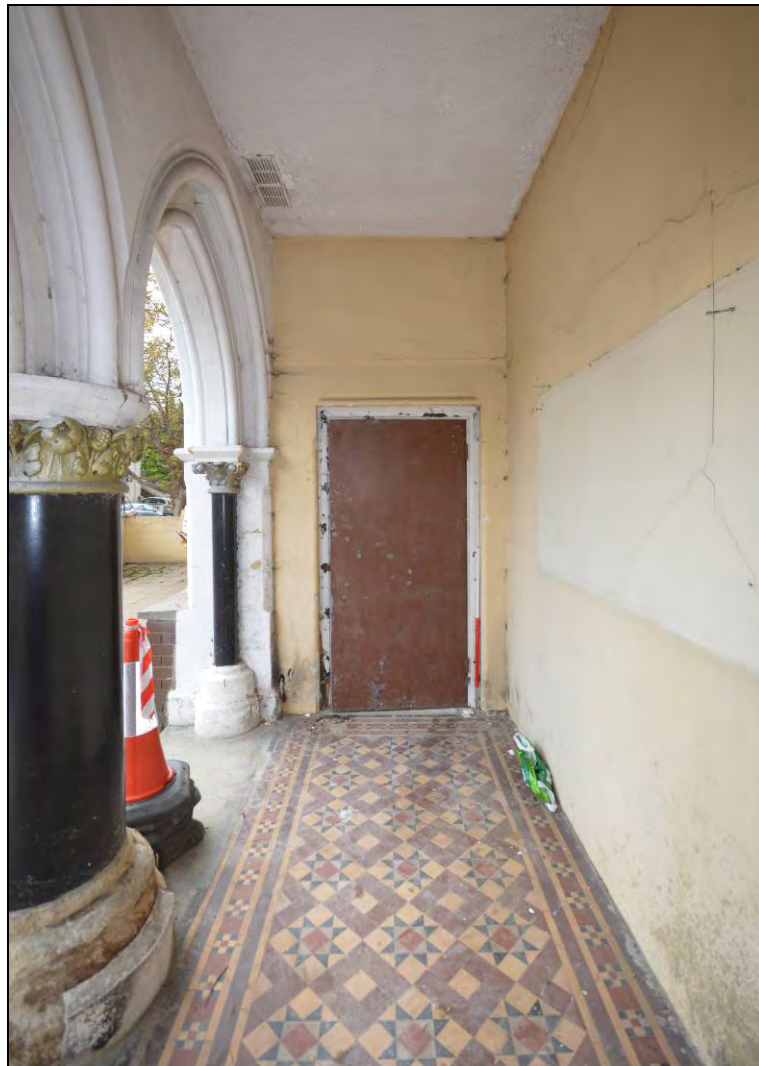
Plate 23: The entrance arcade, tiled floor and western entrance

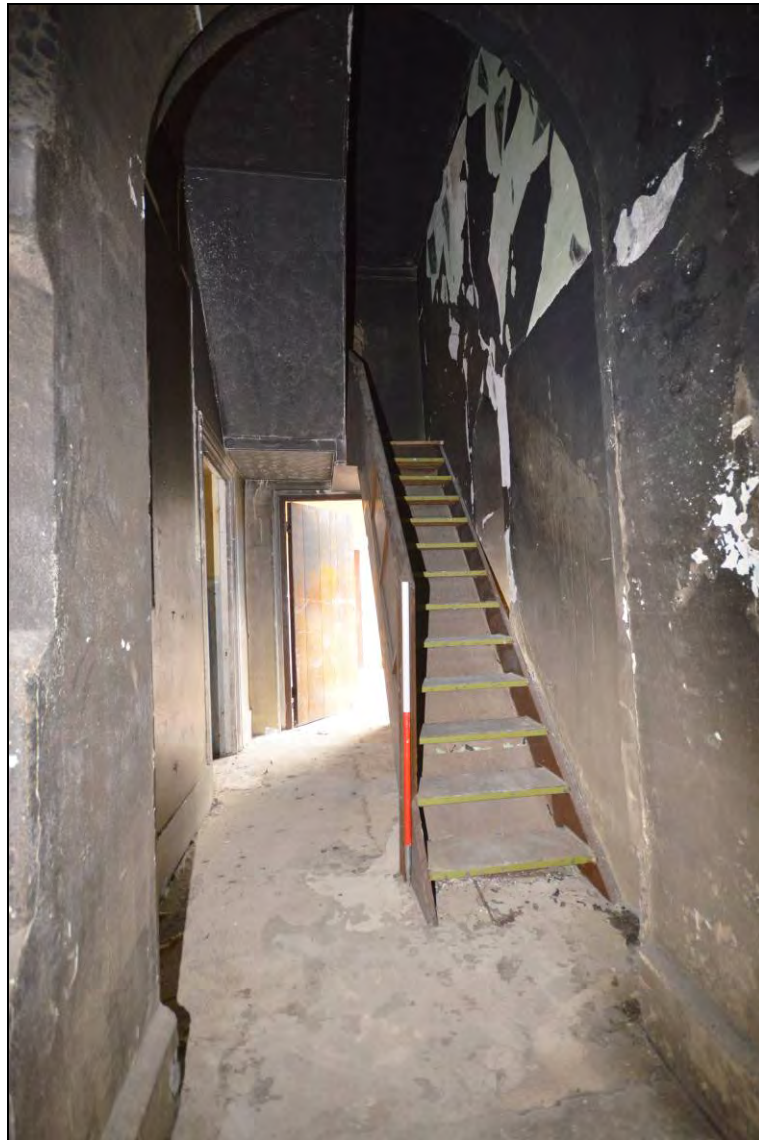
Plate 24: Interior of the west lobby and staircase leading to the south gallery

- 6.3.3 The west lobby has rendered walls, a concrete floor and an under-plastered ceiling. The staircase rising to the south gallery is a plain and very basic straight flight of stairs that overly the southwest window. A pointed arch-headed entrance, with its door removed, is situated to the west side of the lobby providing external access in the first instance, later utilised to link the lobby to its southwestern extension. A further doorway leads from the west lobby to the interior of the church: the door is no longer *in situ*.

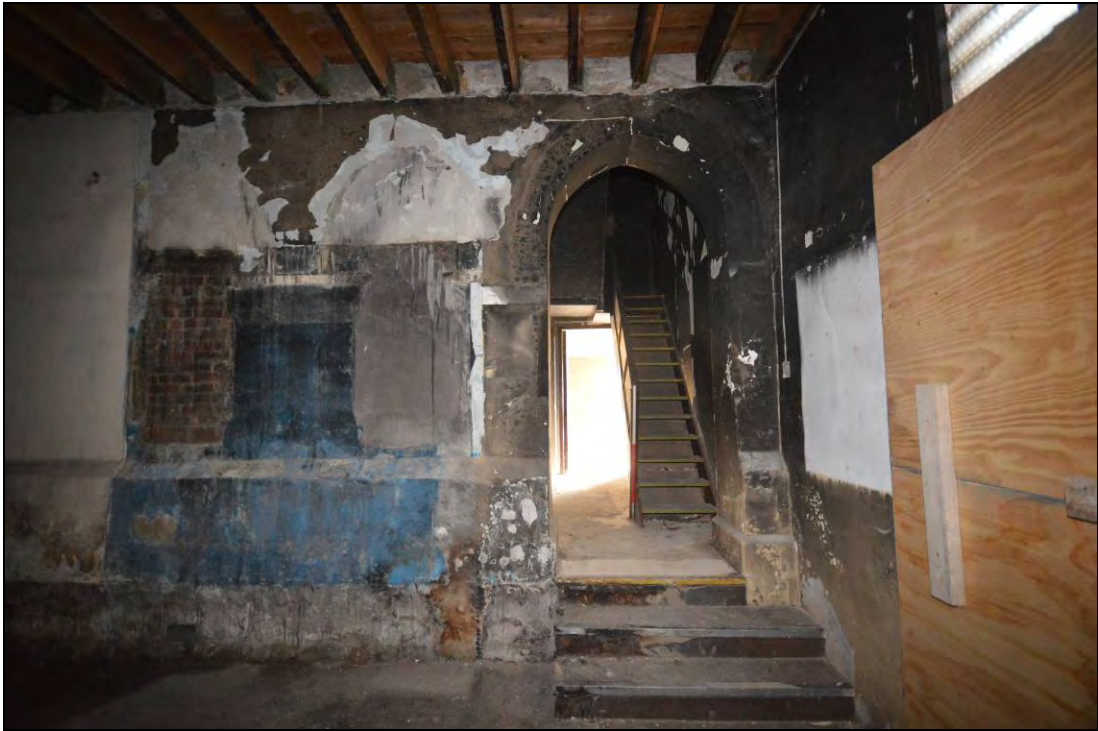
Plate 25: The entrance to the west lobby from the southwest extension

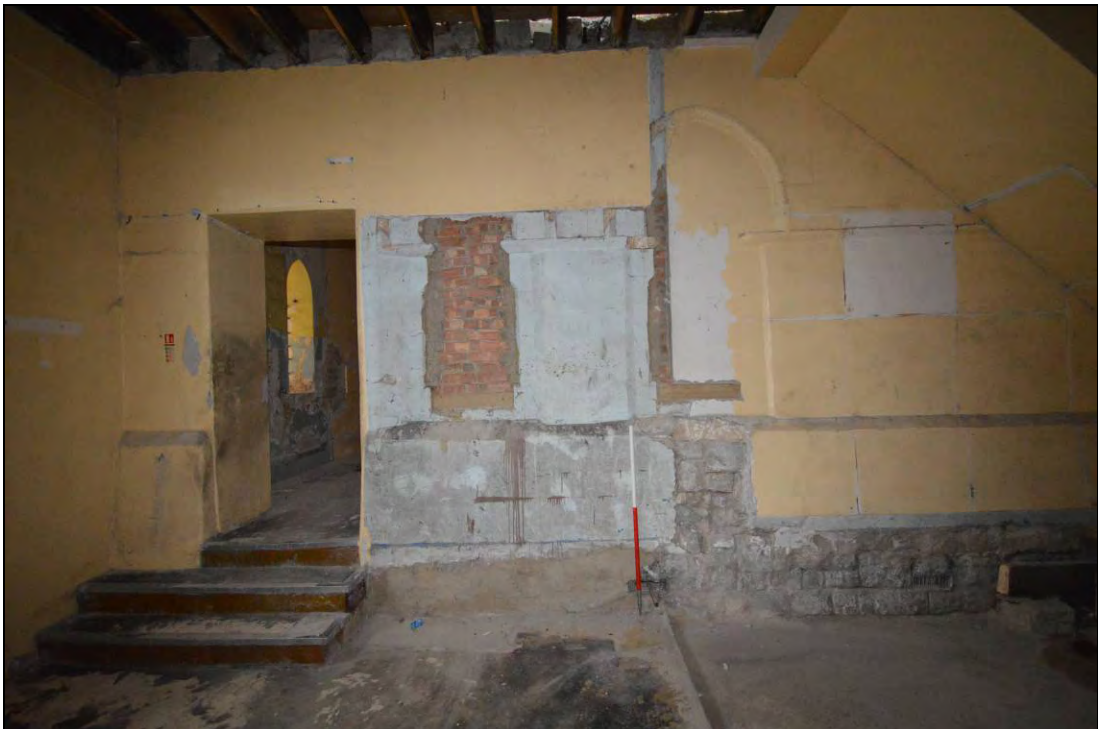
- 6.3.4 The east lobby matches the west lobby in terms of finishes: the plain flat-arched head to the entrance in the east elevation indicates that it was a later alteration to the building, added to access the extension.

Plate 26: the inserted doorway in the east elevation of the east lobby, viewed from the extension added in 1955

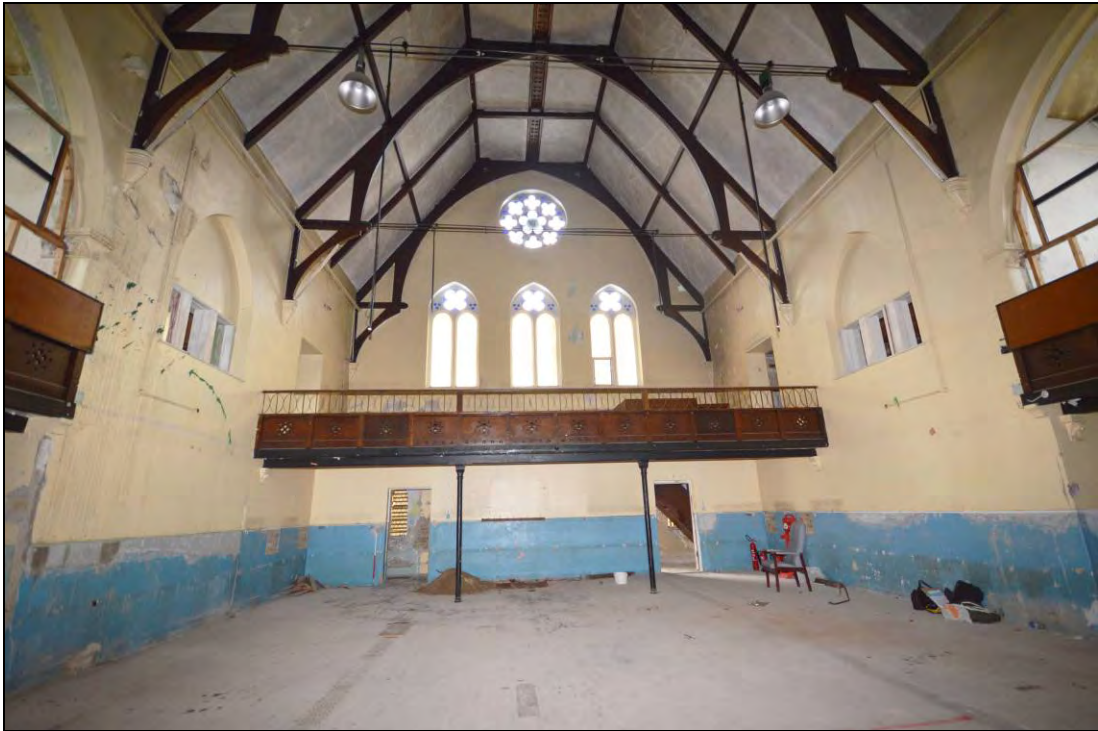
Plate 27: The nave looking south towards the gallery and entrance areas

- 6.3.6 The nave, excepting its south gallery, was full height, entirely open to its hammer-beam roof (Plate 27). The north end of the room had included a raised platform as shown on the 1874 plan (Plate 1). The platform was raised in front of a tall pointed-arch-headed recess in the wall (Plate 28): this had framed the organ and created a strong focal point of the group at the northern end of the nave where the minister would have led his congregation.
- 6.3.7 The walls of the church are under render, the floor is a suspended timber one comprising floorboards at 160 mm wide by 30 mm thick raised over joists that are 50 mm wide by 80 mm thick, set at 400 mm centres.

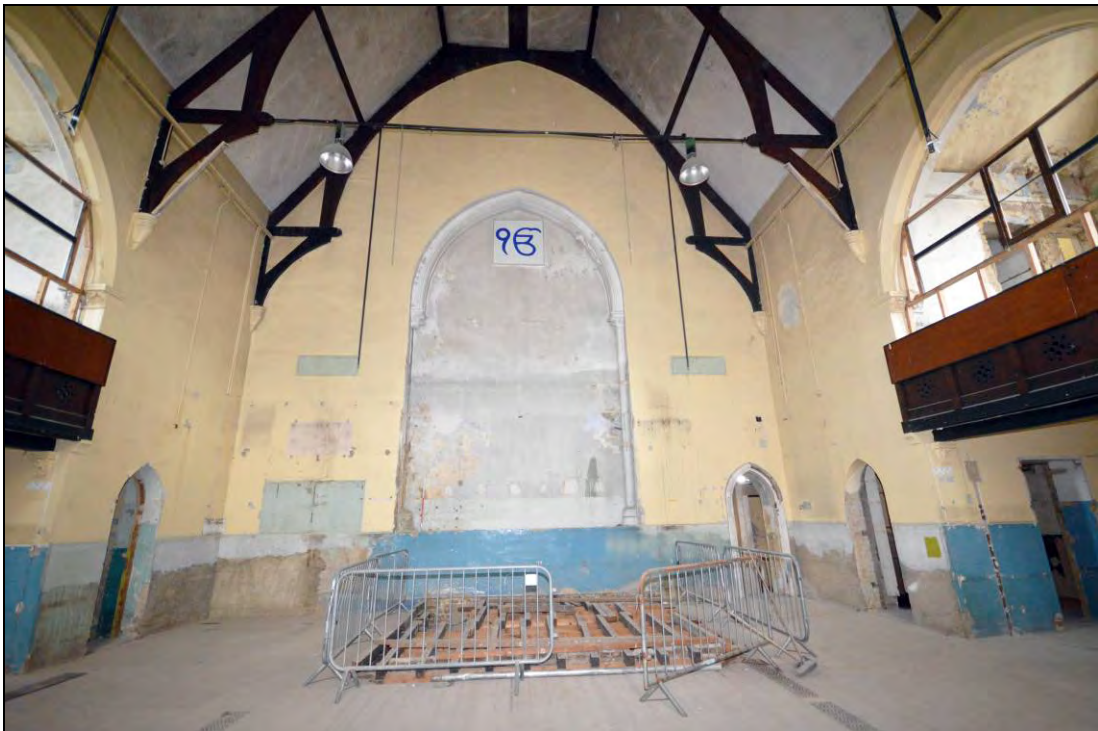
Plate 28: The north end of the nave with the remains of the platform and the recess that had framed the organ
