## Proposed Chimney and associated Roof Works – Design and Access Statement with Heritage Statement

**Project:** Repair and maintenance of chimneys and associated roof works

**Location:** The Mill House, Mill Hill Lane, Shorne. Gravesend. DA12 3HA

**Date:** 4<sup>th</sup> August 2022

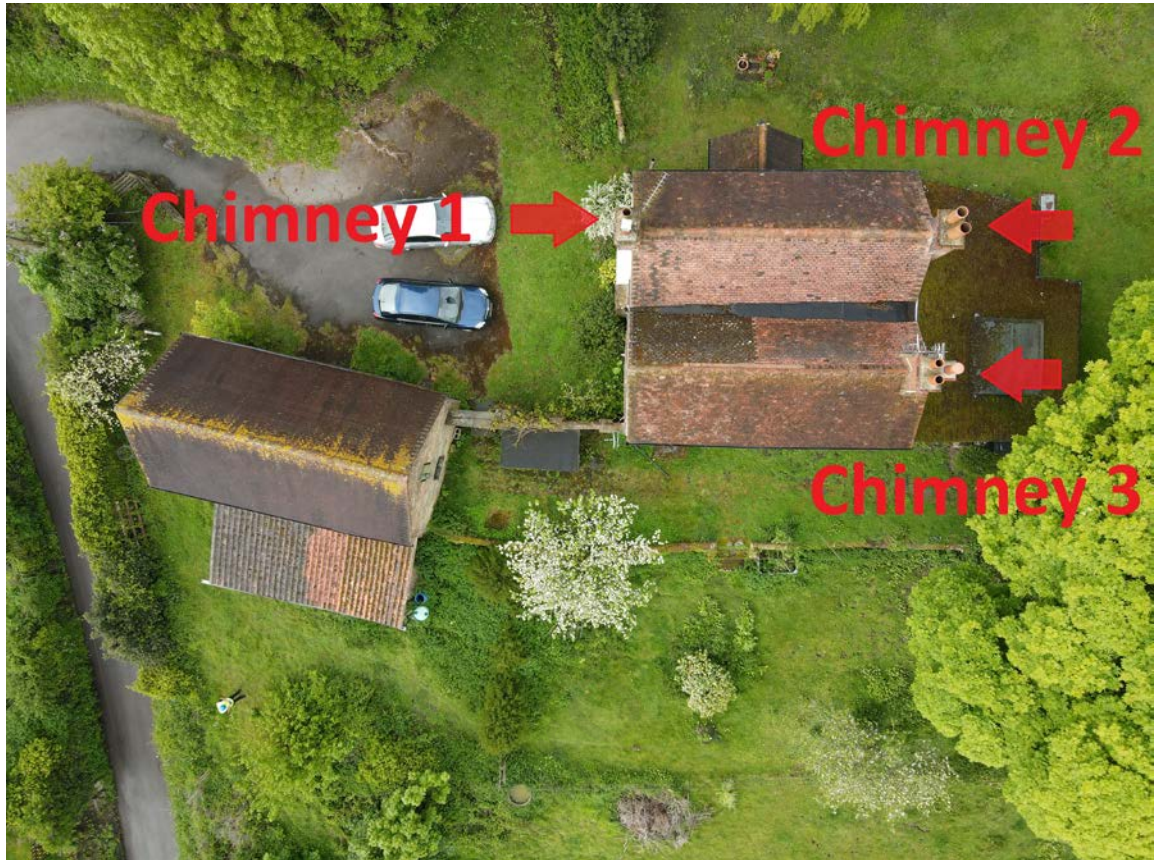
2.14 The Mill House from above with the three chimneys numbered

- 3.02 Chimney stacks 1 and 2 are suffering from neglect and from the photos can clearly be seen as unstable from the corbelling upwards as are the pots with cracked and missing mortar. Chimney 3 has been re-built at some point, but the pots have become more unstable in the recent storms. (Photos taken prior to the storms).

- i. Carefully removed chimney pots setting aside for reinstallation
  - ii. Take down chimney brick work to roof level to Chimney 1 and Chimney 2
  - iii. Re-use bricks from both Chimney 1 & 2 to re-build Chimney 2 complete with corbelled brickwork and tile creasing detail, new flaunching to bed original pots (replace 1 cracked pot with reclaimed matching pot). Mortar colour and joint style to match existing.

- v. To reset chimney pots on Chimney 3 due to movement
  - vi. To provide vents to all reset chimney pots to stop bird and insect invasion
  - vii. To remove tile flashing detail between roofs and chimney stacks and replace with code 4 lead flashing dressed into stacks and beneath tiled roofs with lead soakers to provide long lasting weather tight detail
