CASCADES LEISURE CENTRE  
7313-FUR-XX-XX-RP-0001  
STRUCTURAL SURVEY  
NOVEMBER 2022

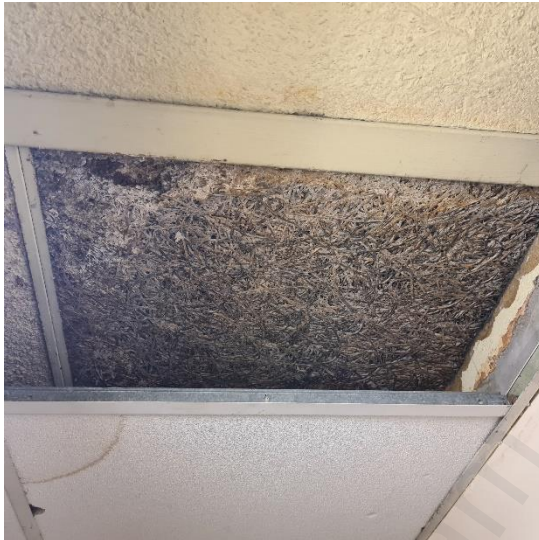
- 3.2.4 The roof construction above the squash courts is enclosed above the suspended ceiling but was inspected in an adjacent store cupboard by locally removing ceiling tiles. The roof construction in the inspected area comprises of fabricated steel trusses supporting wood fibre soffit boards with metal edge trim. The exposed wood fibre soffit was damaged with underlying fibrous material exposed.

- 3.2.5 The nature and details of the soffit boards and the overlying flat roof build-up are unknown but the wood fibre soffit may be indicative of woodwool roof slab construction which is known to be deleterious material and is a potential structural defect.

Figure 12: Exposed wood fibre soffit in cleaners cupboard

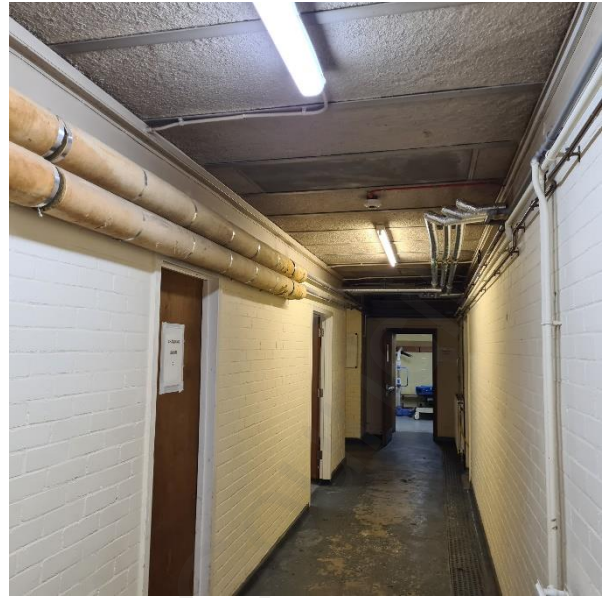
- 3.1.6 Some instances of localised damage were observed to the exposed rib and board soffit in the sports changing rooms. These include cracking and spalling of the soffit board, and rust staining to surface of ribs.

Figure 17: Exposed roof slab soffit to sports changing rooms

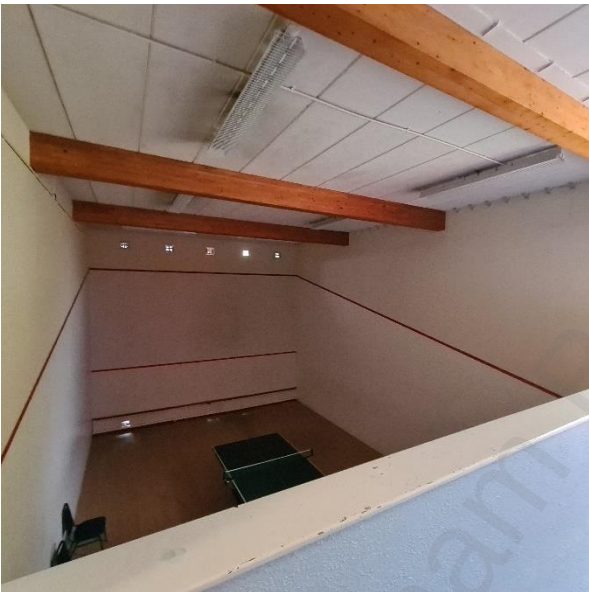
- 3.3.5 The exposed elements of the roof construction were observed to be in good condition with no apparent defects, although it is noted that close inspection was not possible due to restricted access.

Figure 30: Exposed roof structure above squash courts 3 to 6

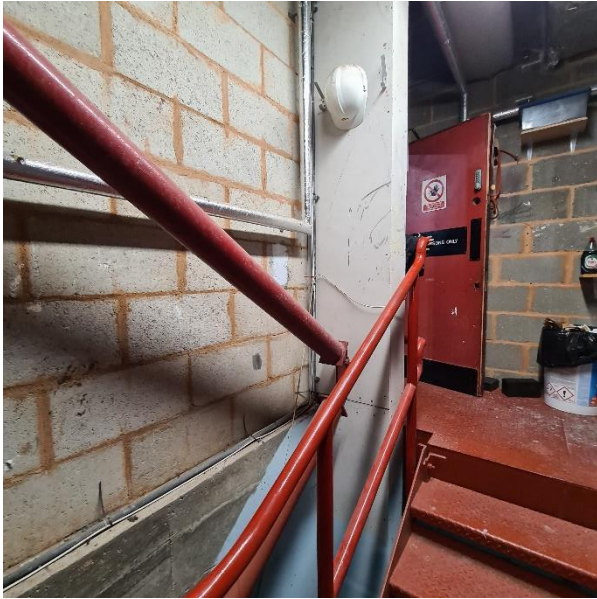
Figure 51: Pool plant room roof structure

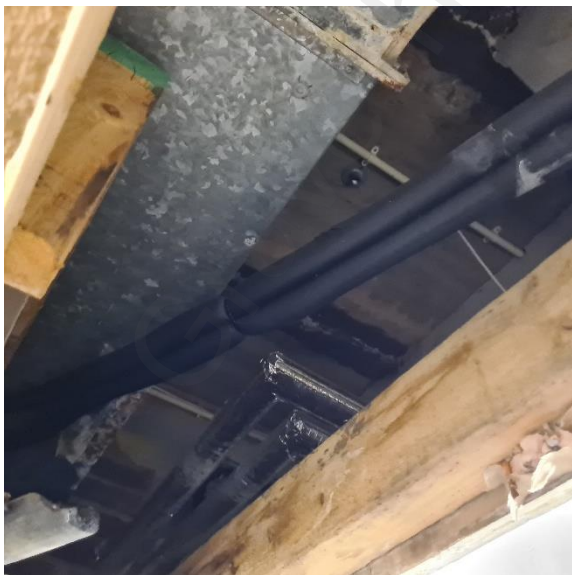
Figure 67: Ground floor store room

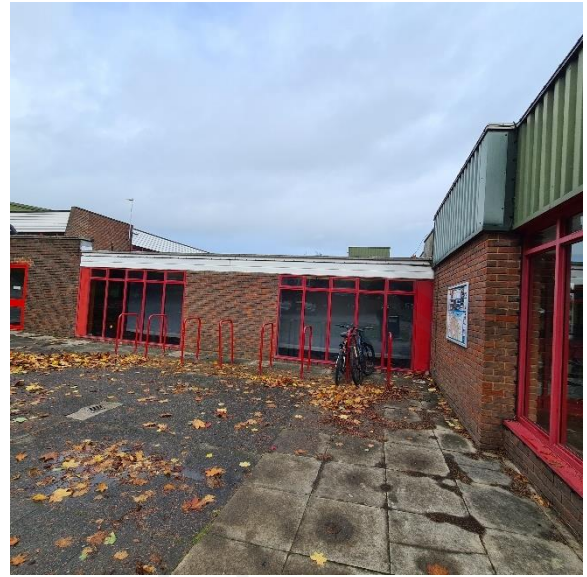
Figure 69: South elevation of main entrance

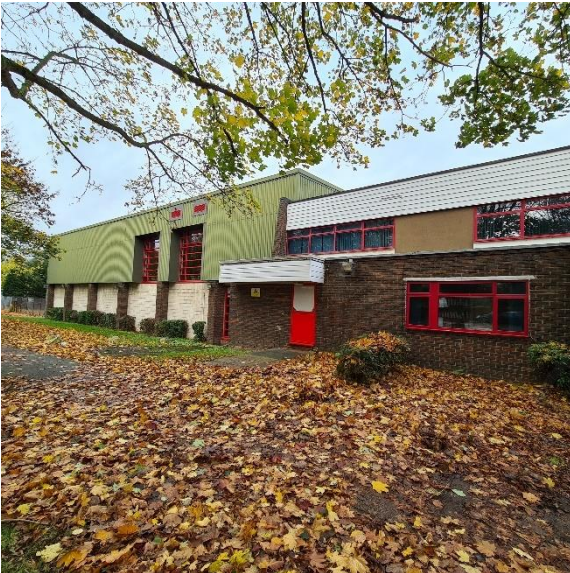
Figure 70: South elevation of original building

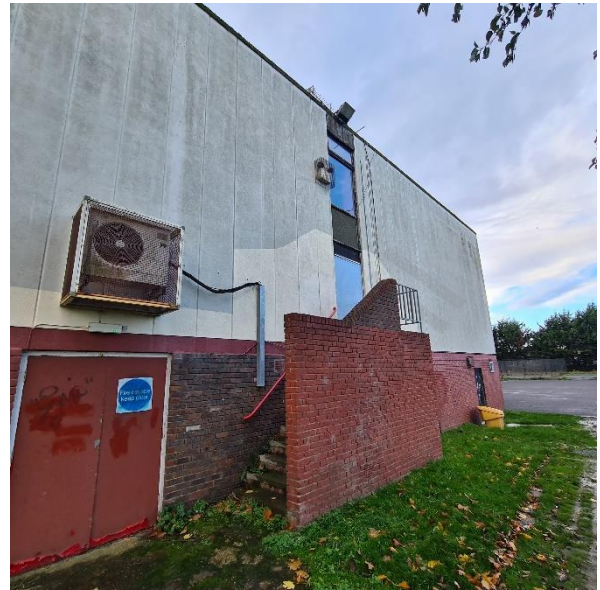
Figure 75: East elevation of squash courts with cracked render and damaged timber

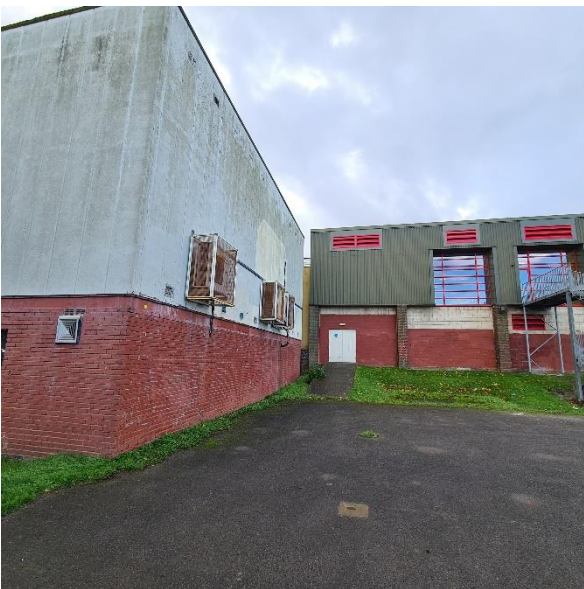
Figure 76: North elevation of squash courts

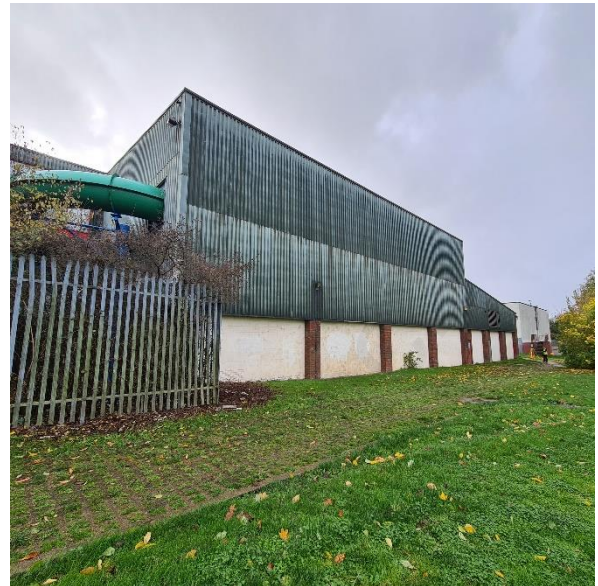
*Figure 81: Damaged blockwork to west elevation of pool hall and plant room*

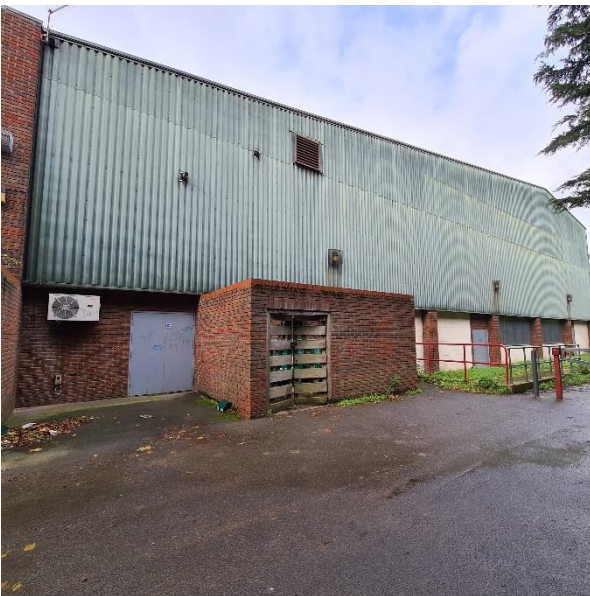
*Figure 82: North elevation of pool hall*
