PROJECT  
GRAVESEND  
ROYAL TERRACE PIER  
ROOF & ASSOCIATED REPAIRS

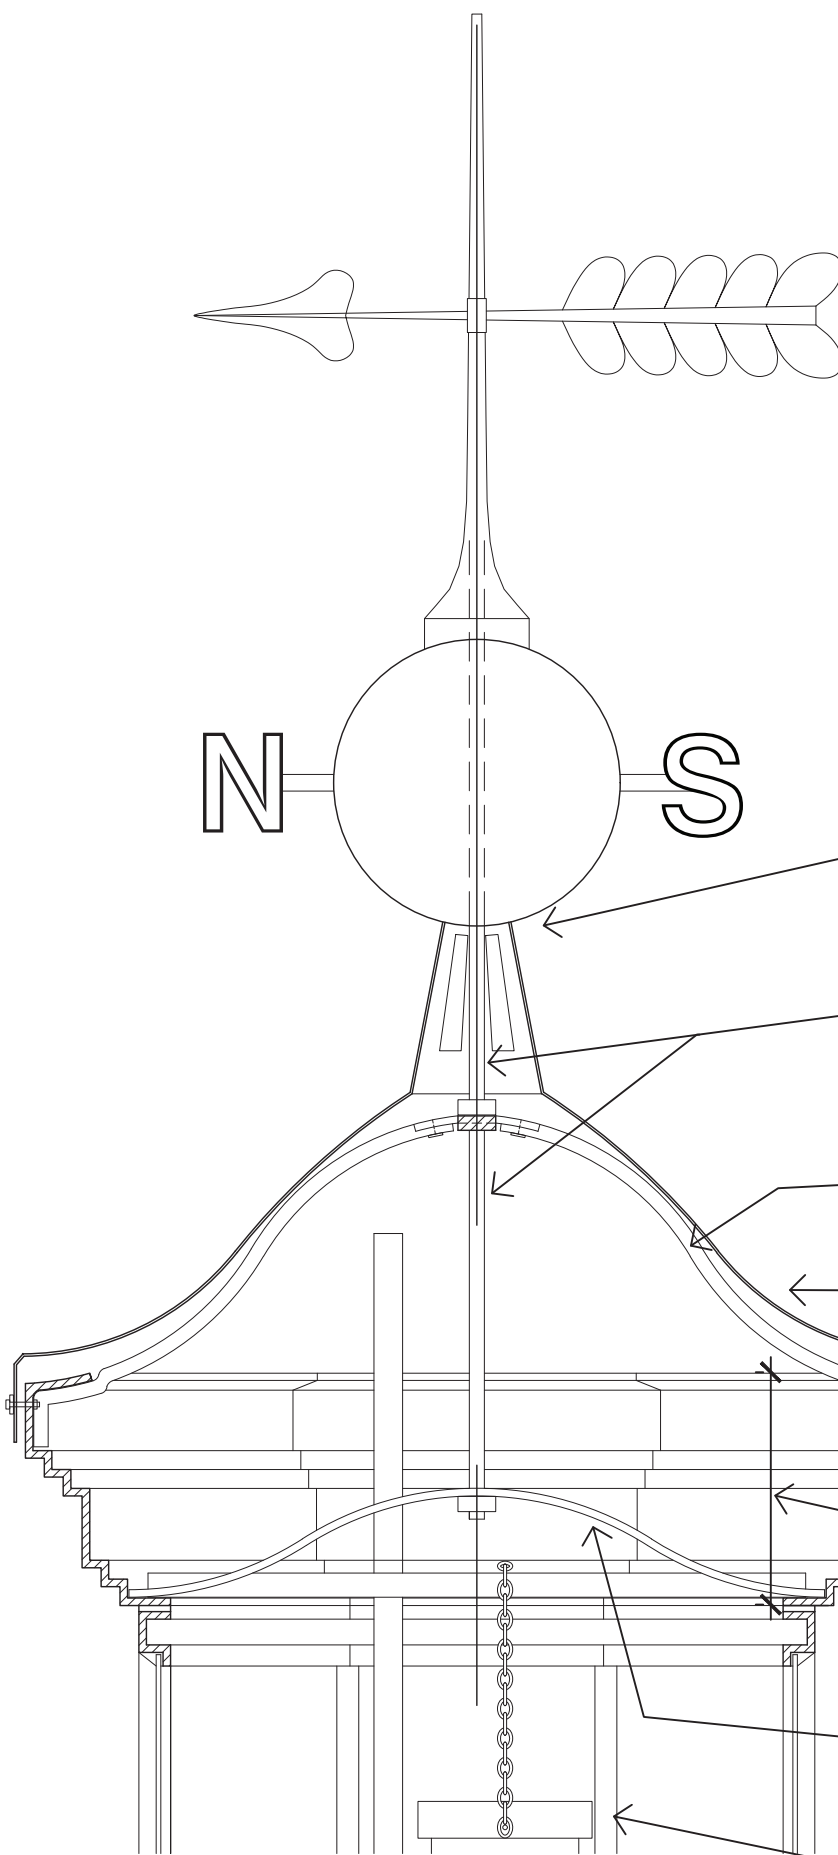
20  
DET-210  
ELEVATION - CUPOLA ROOF  
EXISTING - scale 1:10

Existing copper weathervane to be carefully removed and set aside for alteration and repair, and reinstallation.

Existing copper sheet base to weathervane to be carefully removed from globe.

Existing steel strap to be released and copper sheet cupola roof to be removed.

Existing putty fronted single glazing to be replaced as L40.

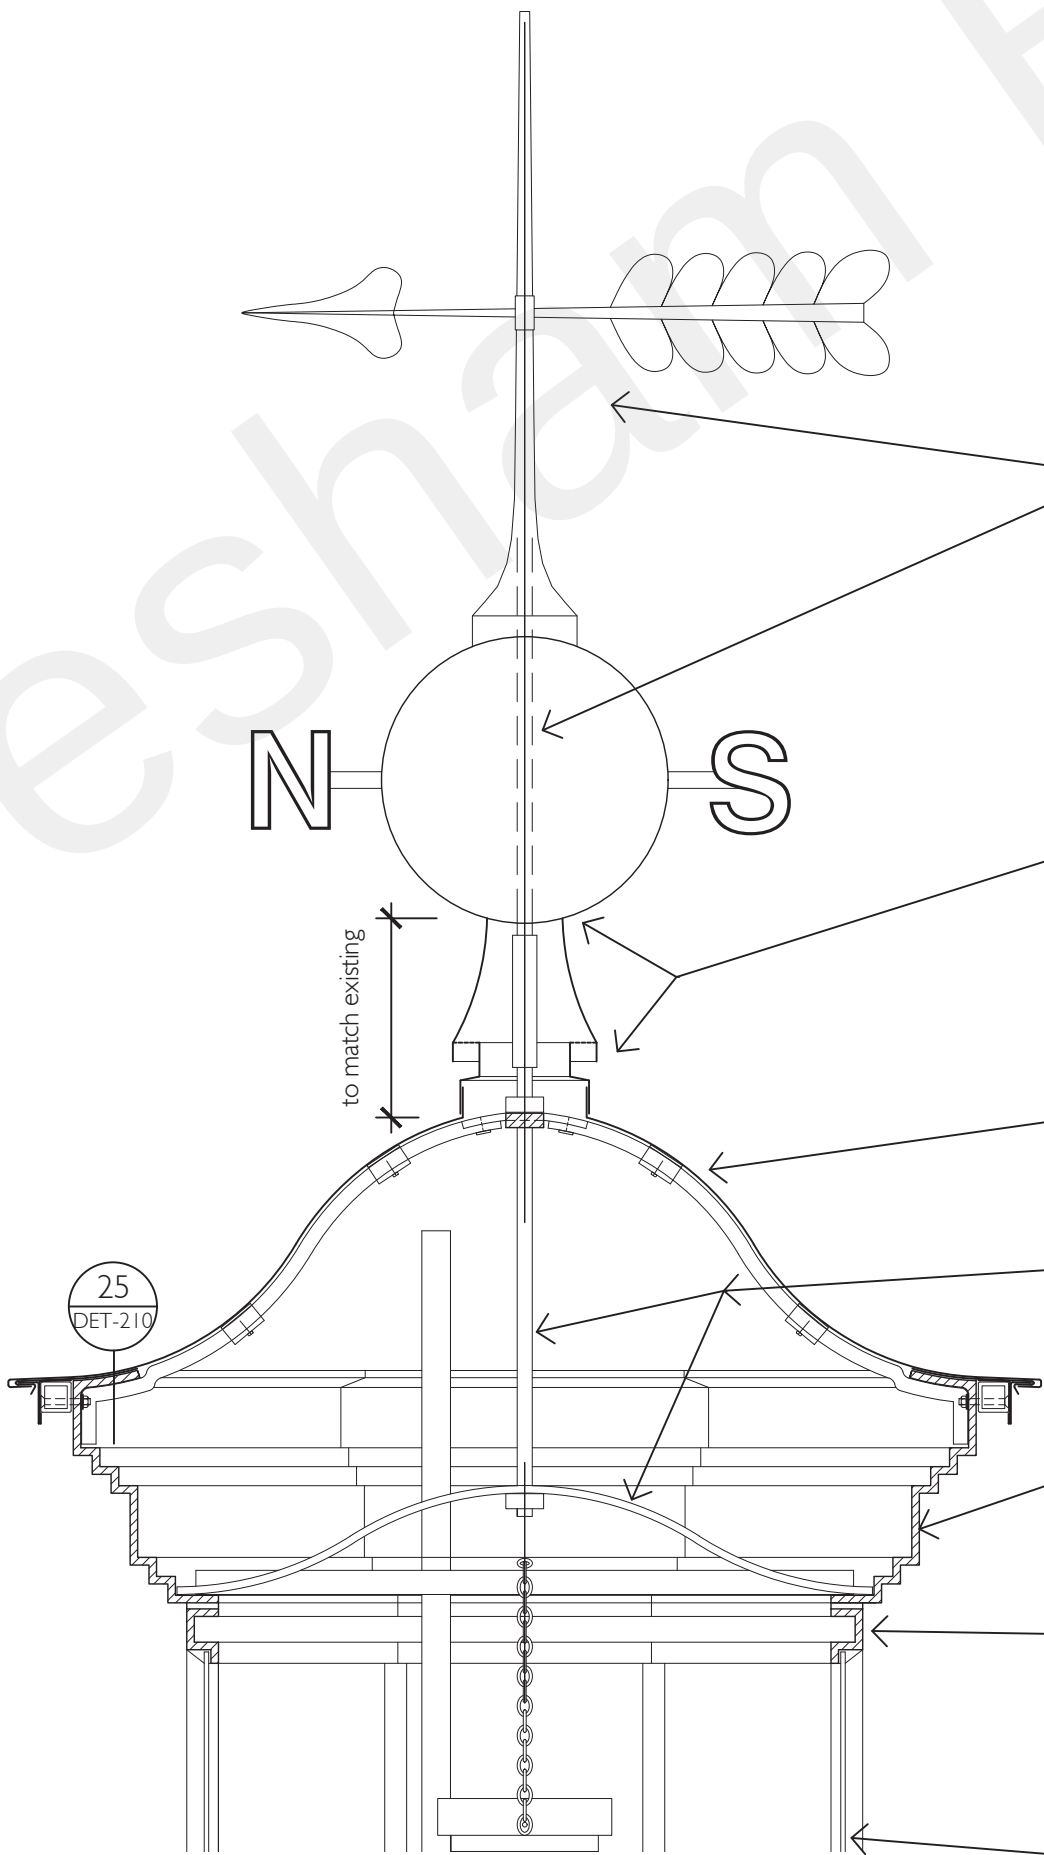
22  
DET-210  
ELEVATION - CUPOLA ROOF  
PROPOSED - scale 1:10

Repair/refurbish/ overhaul existing copper sheet weathervane ensuring moving parts operate smoothly; then reinstall. Gild including globe as M60/190.

New copper sheet finial stem welded to existing weathervane globe and fixed to new cupola roof all as H31/120; and gilded as M60/190.

New copper sheet roof as H31/120; and decorated as M60/144.

New cast iron Lighthouse cornice as C61/210 and 410 in 4nr castings; decorated as M60/144.

Lighthouse cast iron window lintels, mullions and cills repaired as C61 and redecorated as M60/142.

New putty fronted single glazing as L40/210.
