**Heritage Statement  
Whitehouse Farm  
Land Way  
Higham  
Kent  
ME3 7JH**

**NGR TQ 71782 72219 (centre)**

**Prepared for Mr Paul Giles**

**July 2024 V.2**

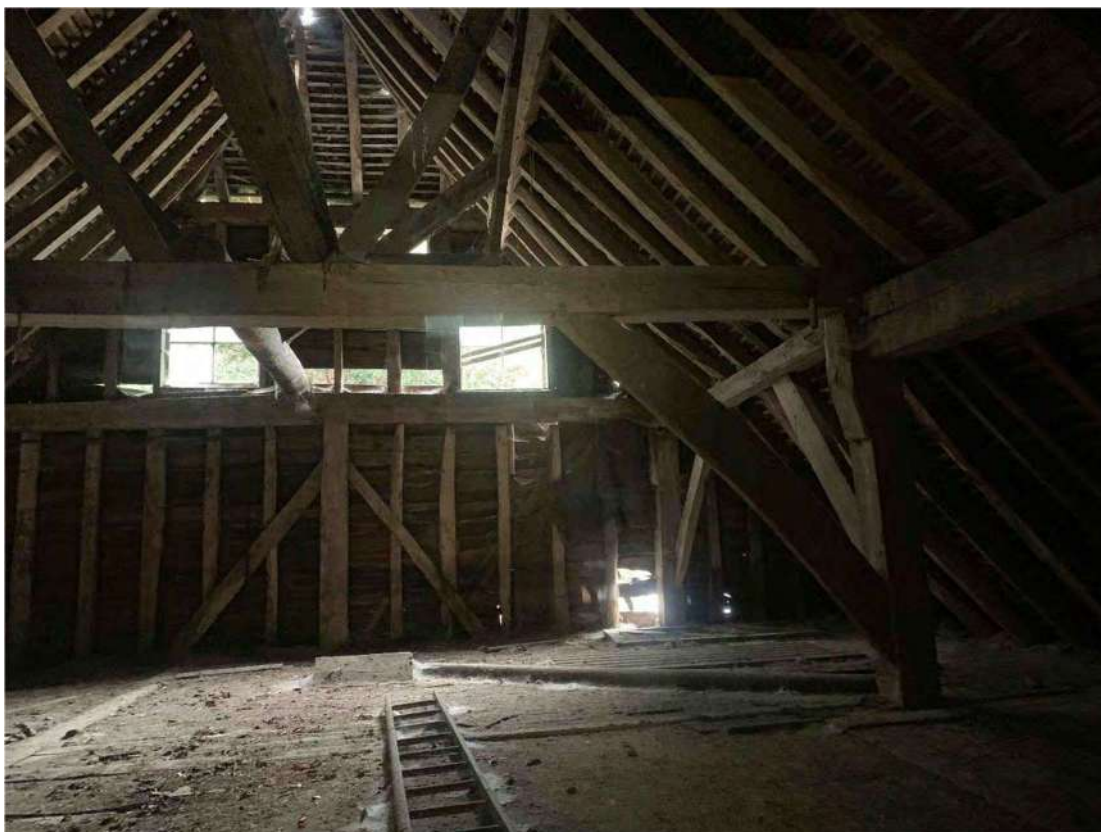
*Plate 9: Roof structure of building 2 looking east*

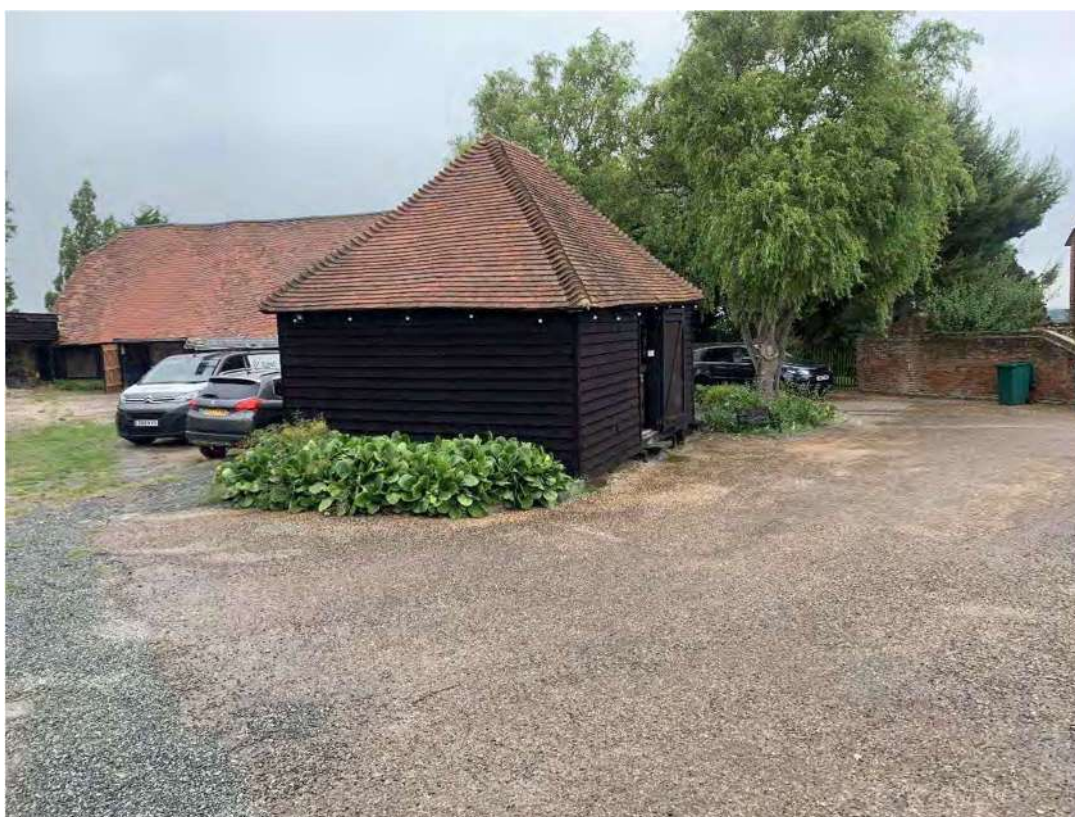
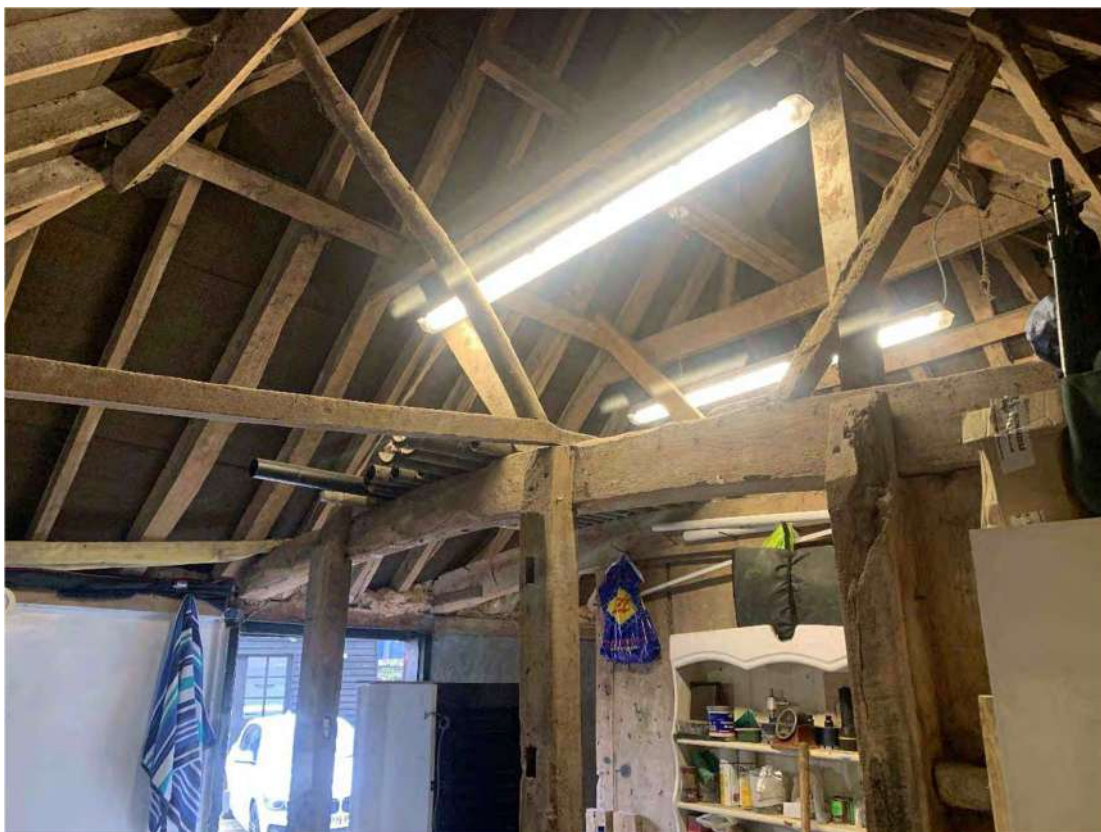
*Plate 10: Building 3 looking north*

*Plate 11: Interior of building 3 looking north-east*

### **Building 3, Grain Store (plates 10,11)**

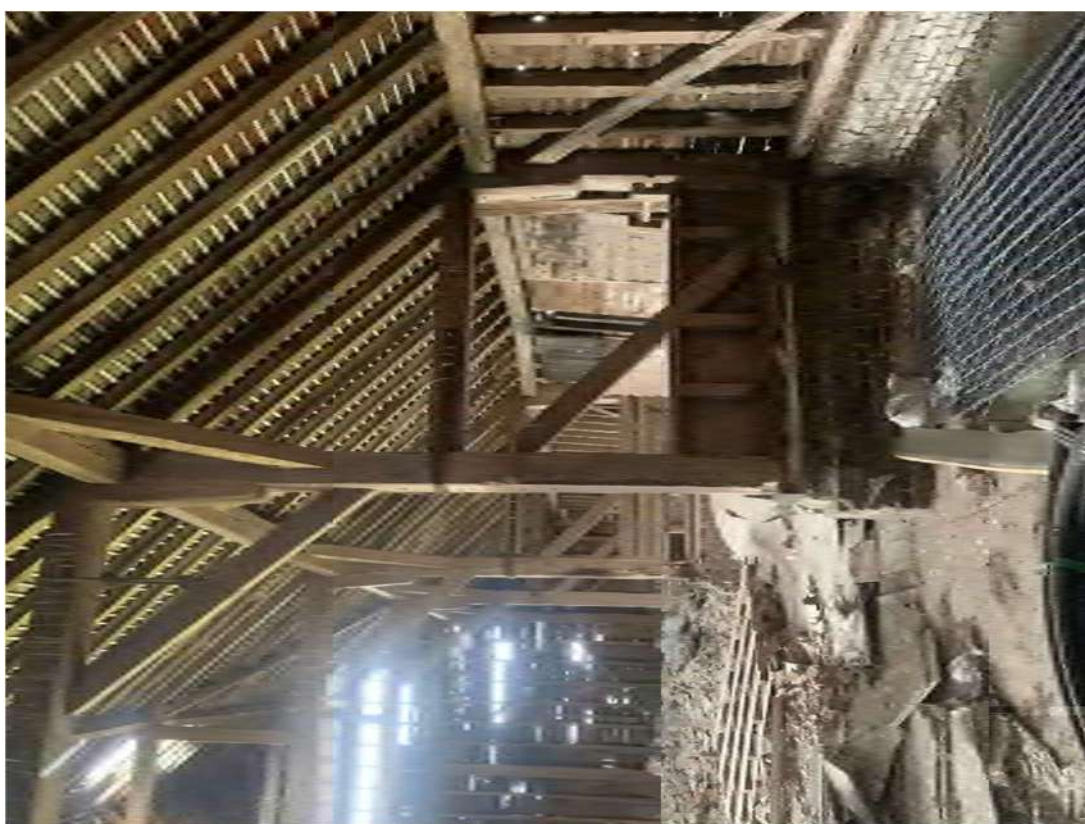
*Plate 16: Detail of building 5 timber framing*

- 6.10 The timber framing is in excellent condition; however, the weatherboarding is in poor order with many gaps. The roof is also in poor condition with missing tiles and no longer weathertight.

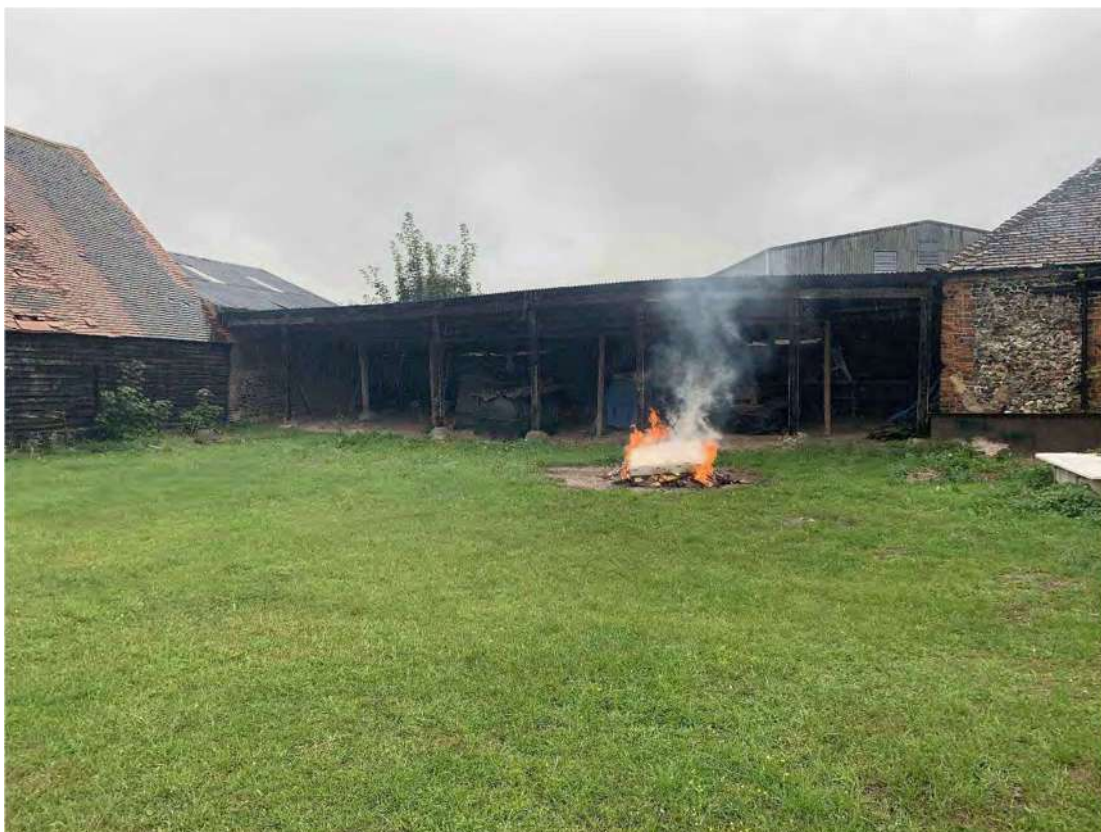
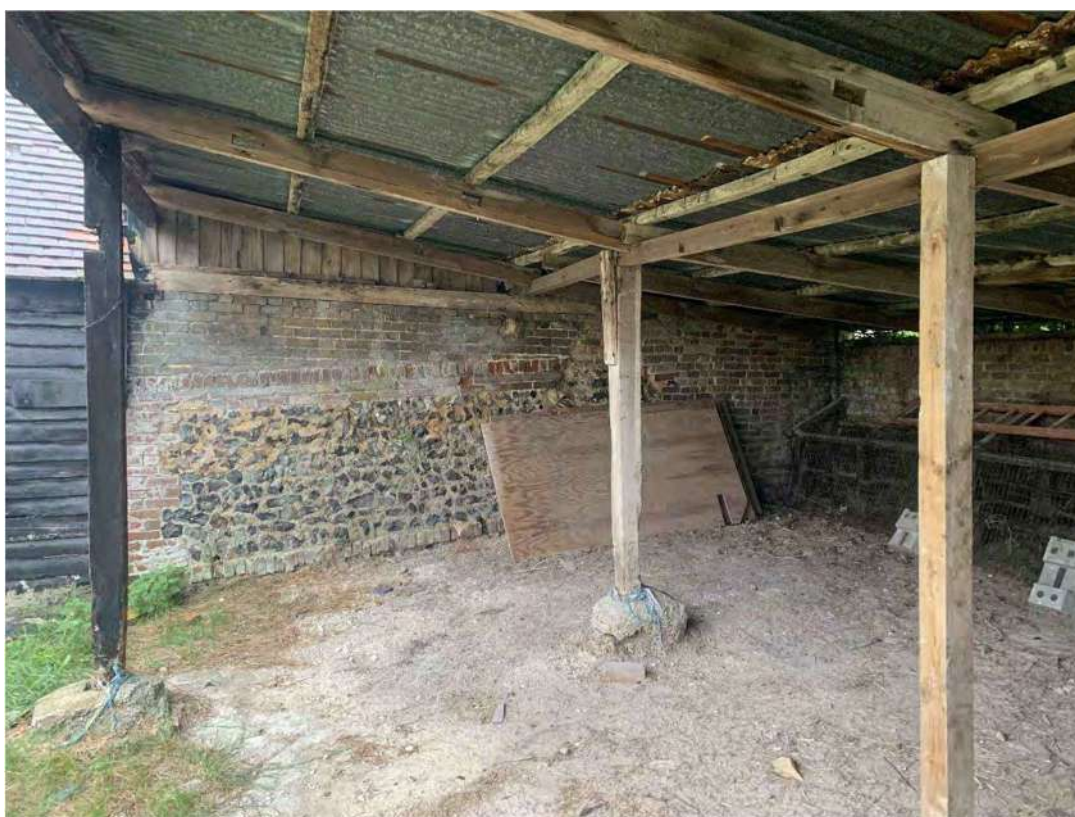
*Plate 23: Building 9 looking south*

*Plate 24: Interior of building 9 looking south-east*

**Building 9, Winter Animal Cover (plates 23,24)**
