# FLOOD RISK ASSESSMENT & DRAINAGE STRATEGY

Project: Milton Place, Gravesend

Document Ref: 10109-PTA-XX-XX-RP-C-9071

Date: February 2025

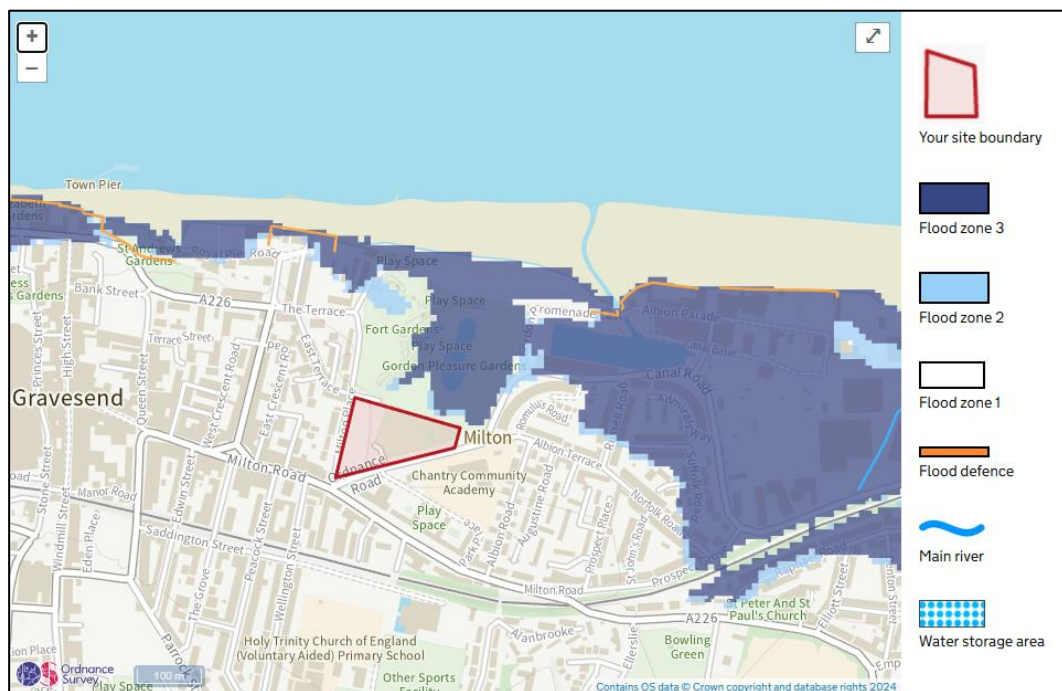
Figure 3: EA's Flood map for planning

The EA's flood risk map below shows the entire site is located within Flood Zone 1, which is defined as having a less than 1:1000 (<0.1%) annual probability of flooding from rivers and seas. See extract from the EA's Flood Map for Planning in Figure 3 below.

The River Thames (a tidal river) is located approximately 250m north to the site. As the site is located entirely within flood zone 1 there is less than 0.1% annual probability of flooding from rivers, refer to the map shown in Figure 3. Therefore, the site is at a very low risk of flooding from rivers and tides.

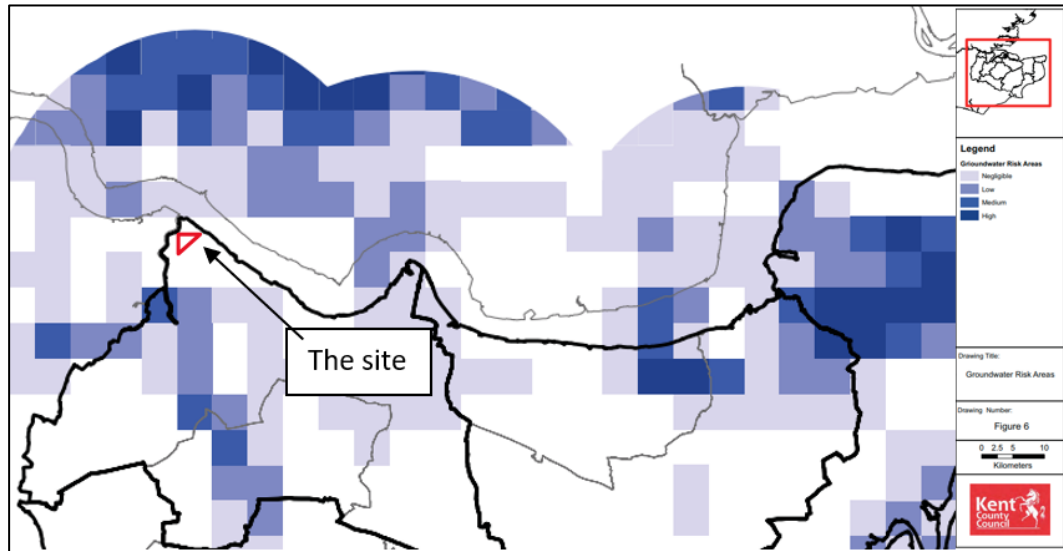
**Figure 4: Groundwater Risk Area from Kent County Council's Preliminary flood risk assessment**

Kent County Council's Groundwater Risk Areas map, as seen in Figure 4 below and included in Appendix D, the risk of ground water flooding can be deemed negligible. With this information, as well as the ground water being monitored at 9m bgl as stated in the Geo-Environmental Assessment, the overall flood risk of groundwater can be considered very low.

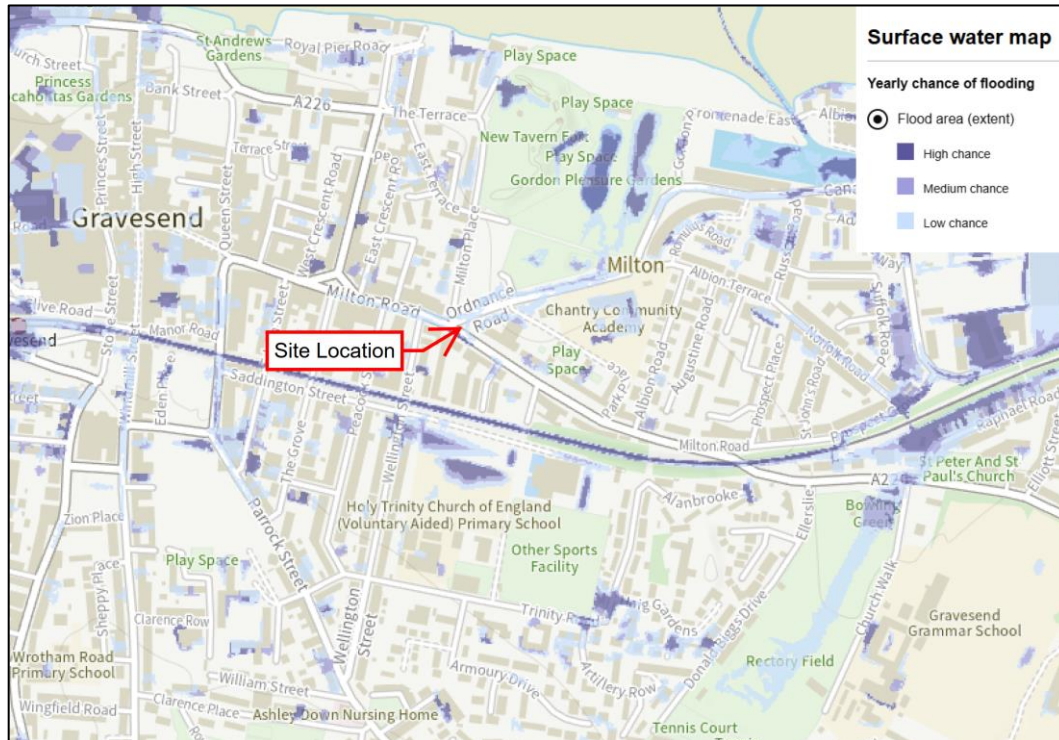
**Figure 5: EA Flood Map – Surface Water Flood Risk Map**

The EA's Surface Water Flood Risk Map, Figure 5 below, shows that the Site is predominantly at a very low risk of flooding from surface water with localised areas of low and medium risk to the North of The Site.

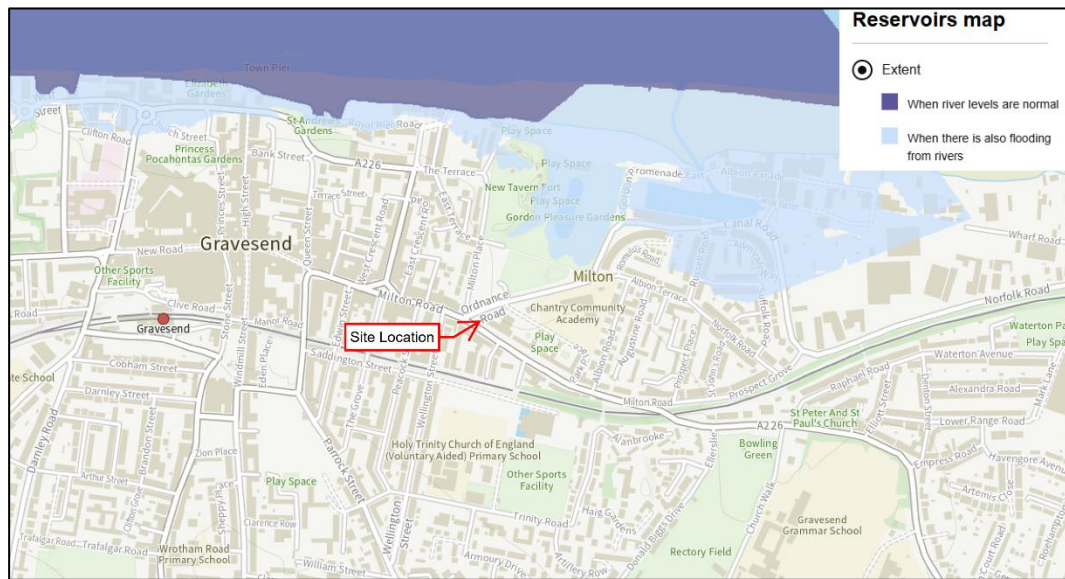
Figure 6: EA Flood Map –Reservoir Flood Risk Map

The EA flood map shown in Figure 6 below does not indicate that The Site is at risk of flooding from reservoirs.

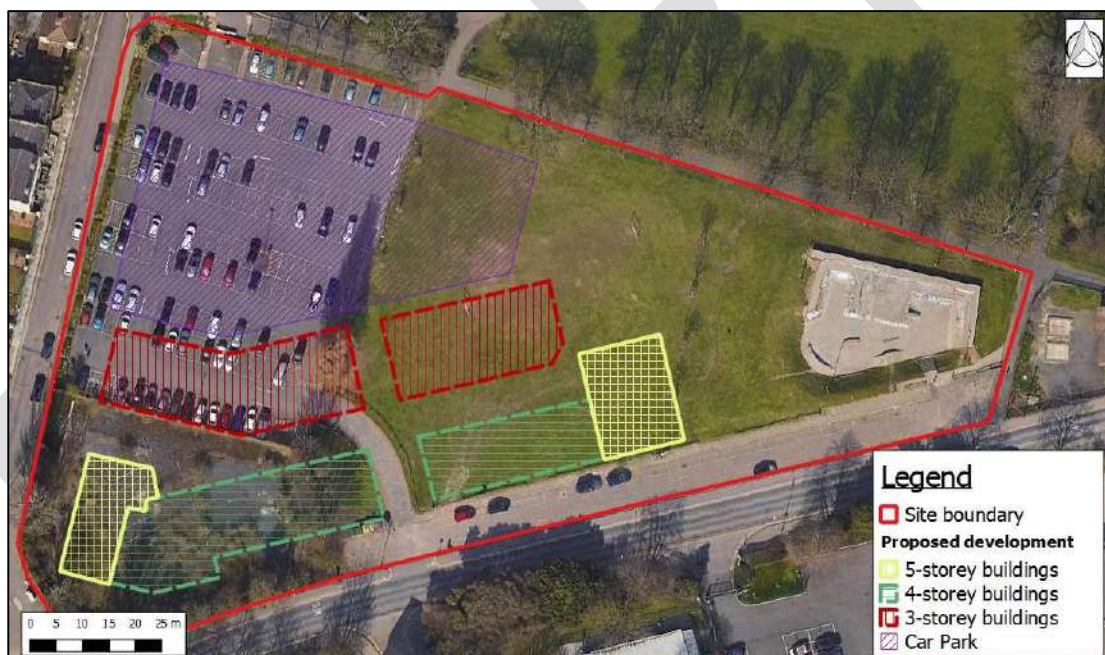
**Figure 1.1: Proposed Development Layout**

- 1.2 The Client plans to submit a planning application to Gravesham Borough Council for development of the Site with 2No. five-storey and 2No. four-storey apartment blocks and 10No. 2/3-storey houses, with private gardens, associated car parking and areas of soft landscaping.
- 1.3 The proposed development layout is illustrated in Figure 1.1, below:

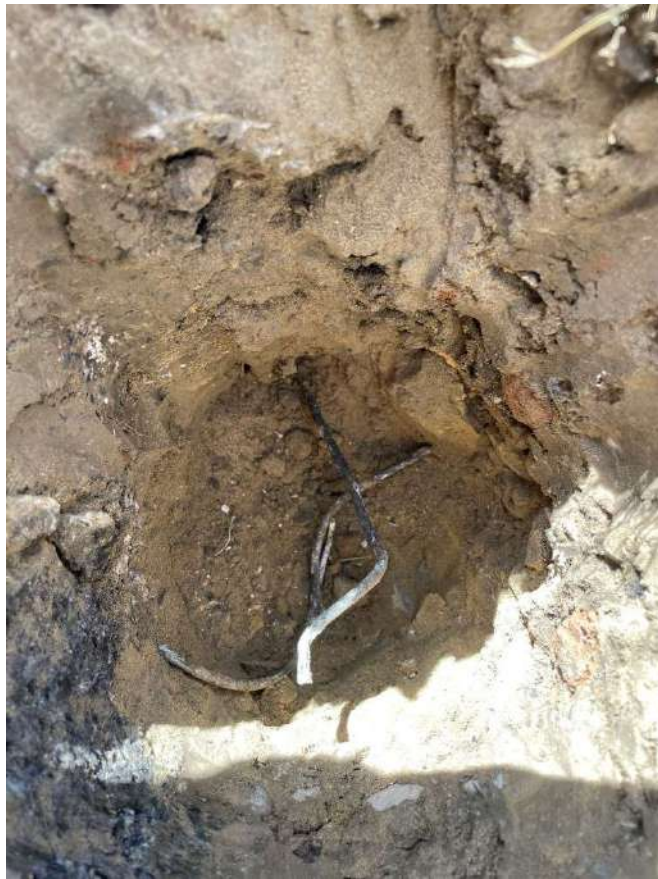
**Plate 1: WS01 – refusal on possible reinforced  
concrete wall of former swimming pool**

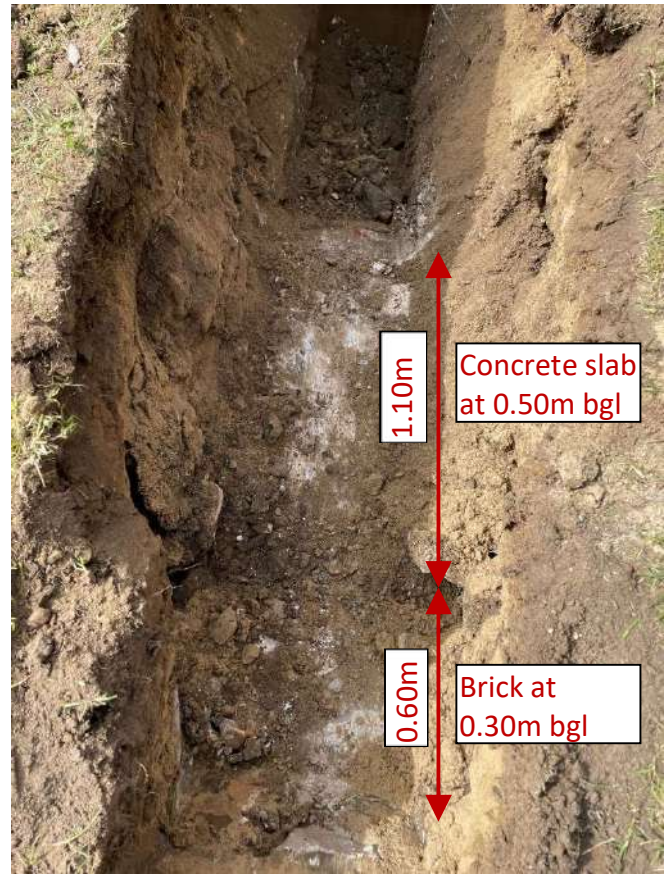
**Plate 2: TP08 – concrete at 0.50m steps down**

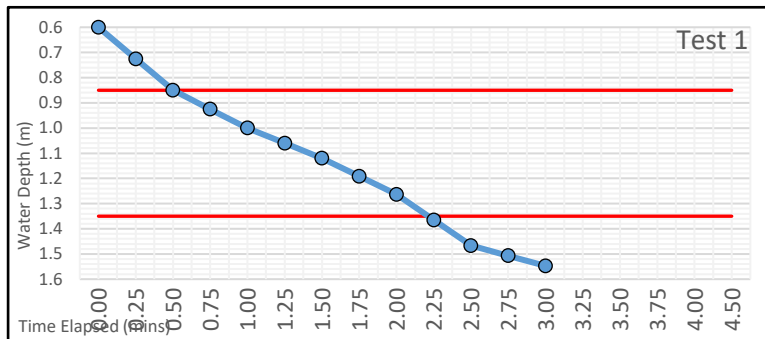
| <b>Soil infiltration rate</b><br>$f = \frac{V_{p75-25}}{a_{S50} \times t_{p75-25}}$ | <b>3.94E-04</b> |

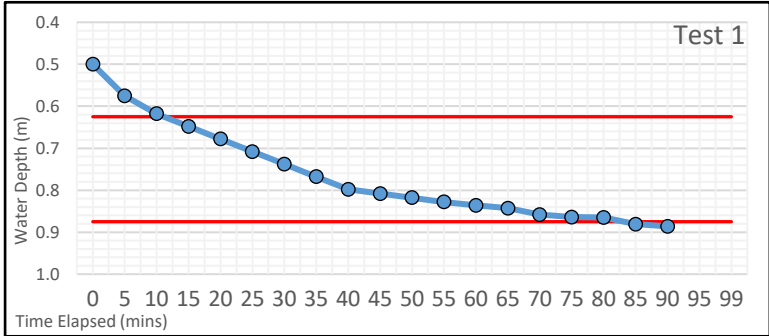
| <b>Soil infiltration rate</b><br>$f = \frac{V_{p75-25}}{a_{S50} \times t_{p75-25}}$ | <b>8.11E-06</b> |

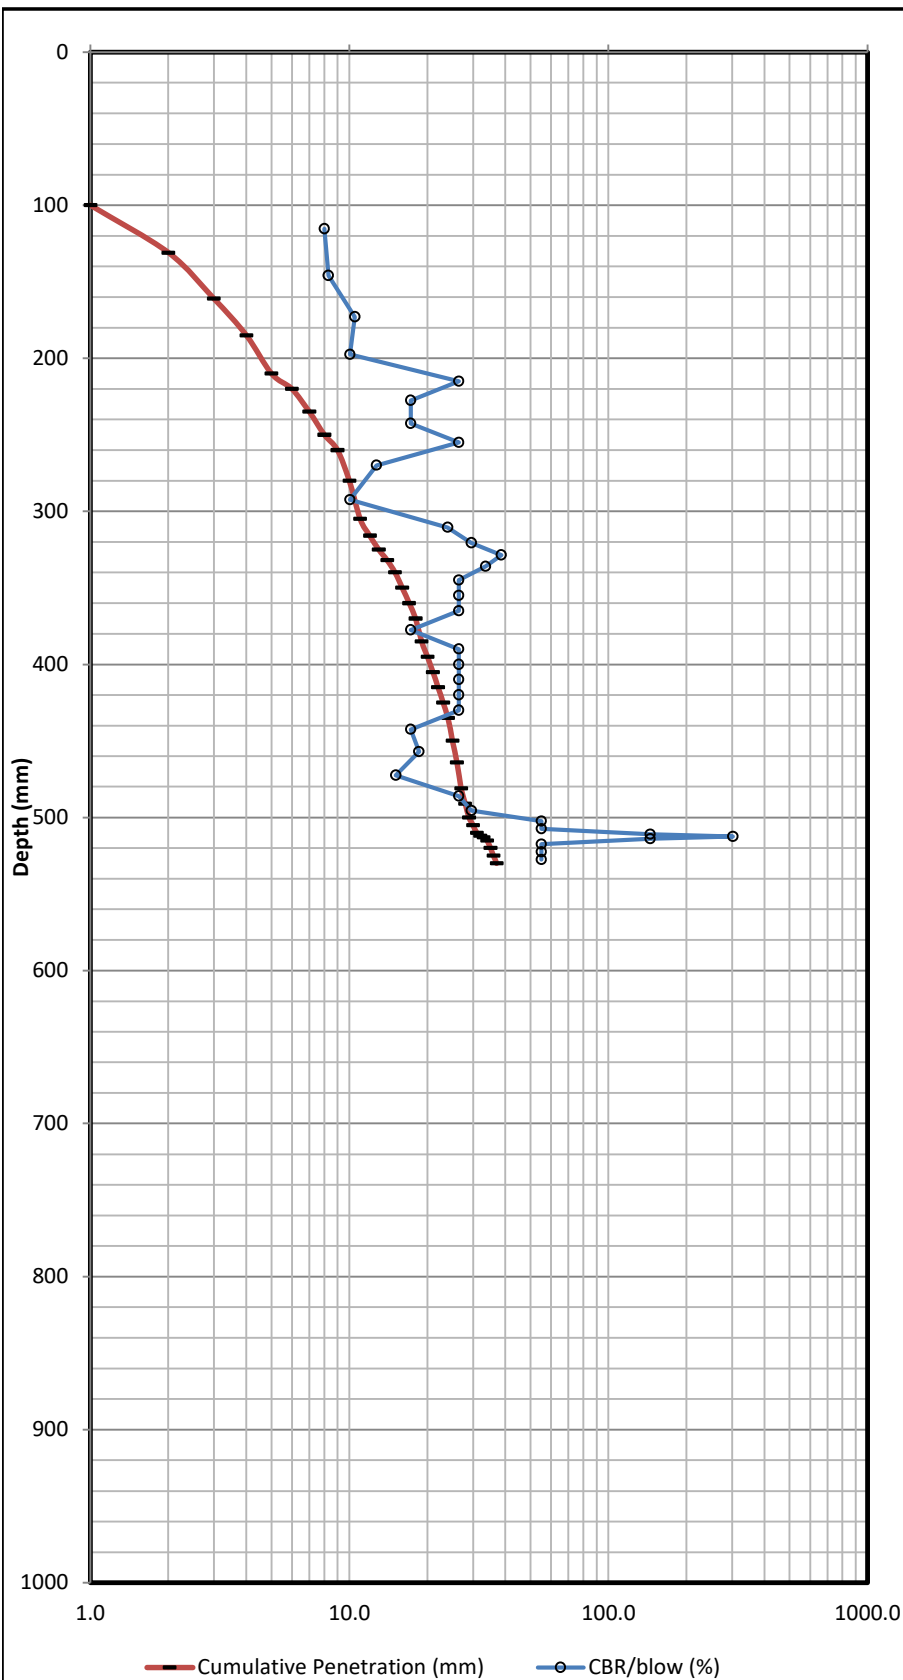
| | DCP02 |

Interpreted CBR Value

100mm Made Ground removed

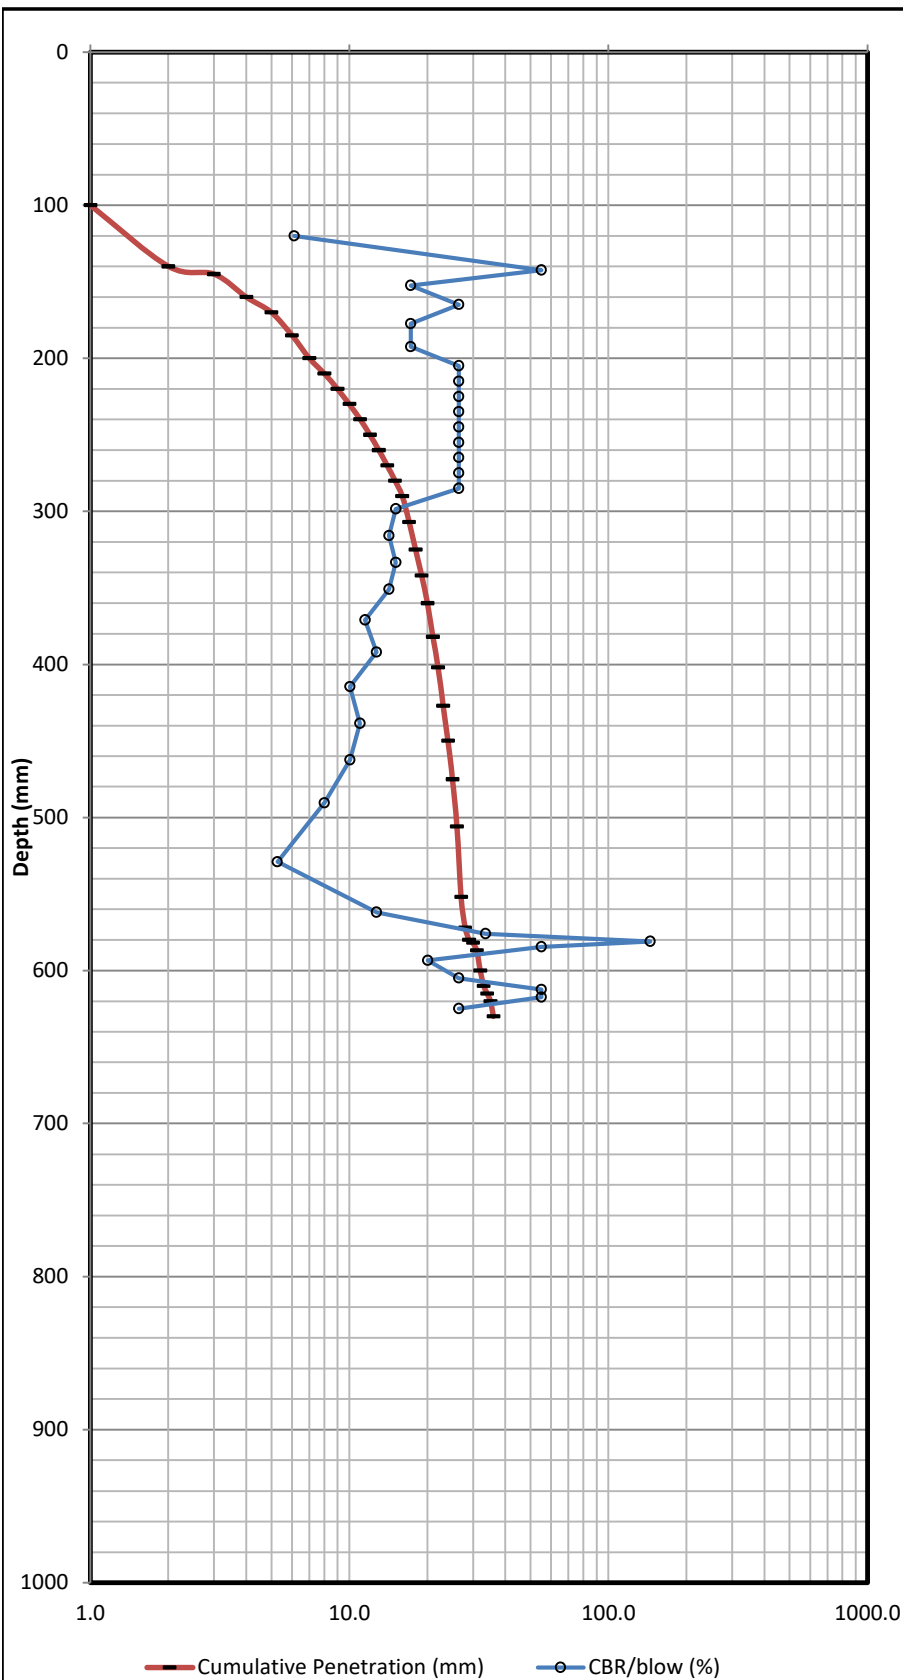
| | DCP04 |

Interpreted CBR Value

100mm Made Ground removed

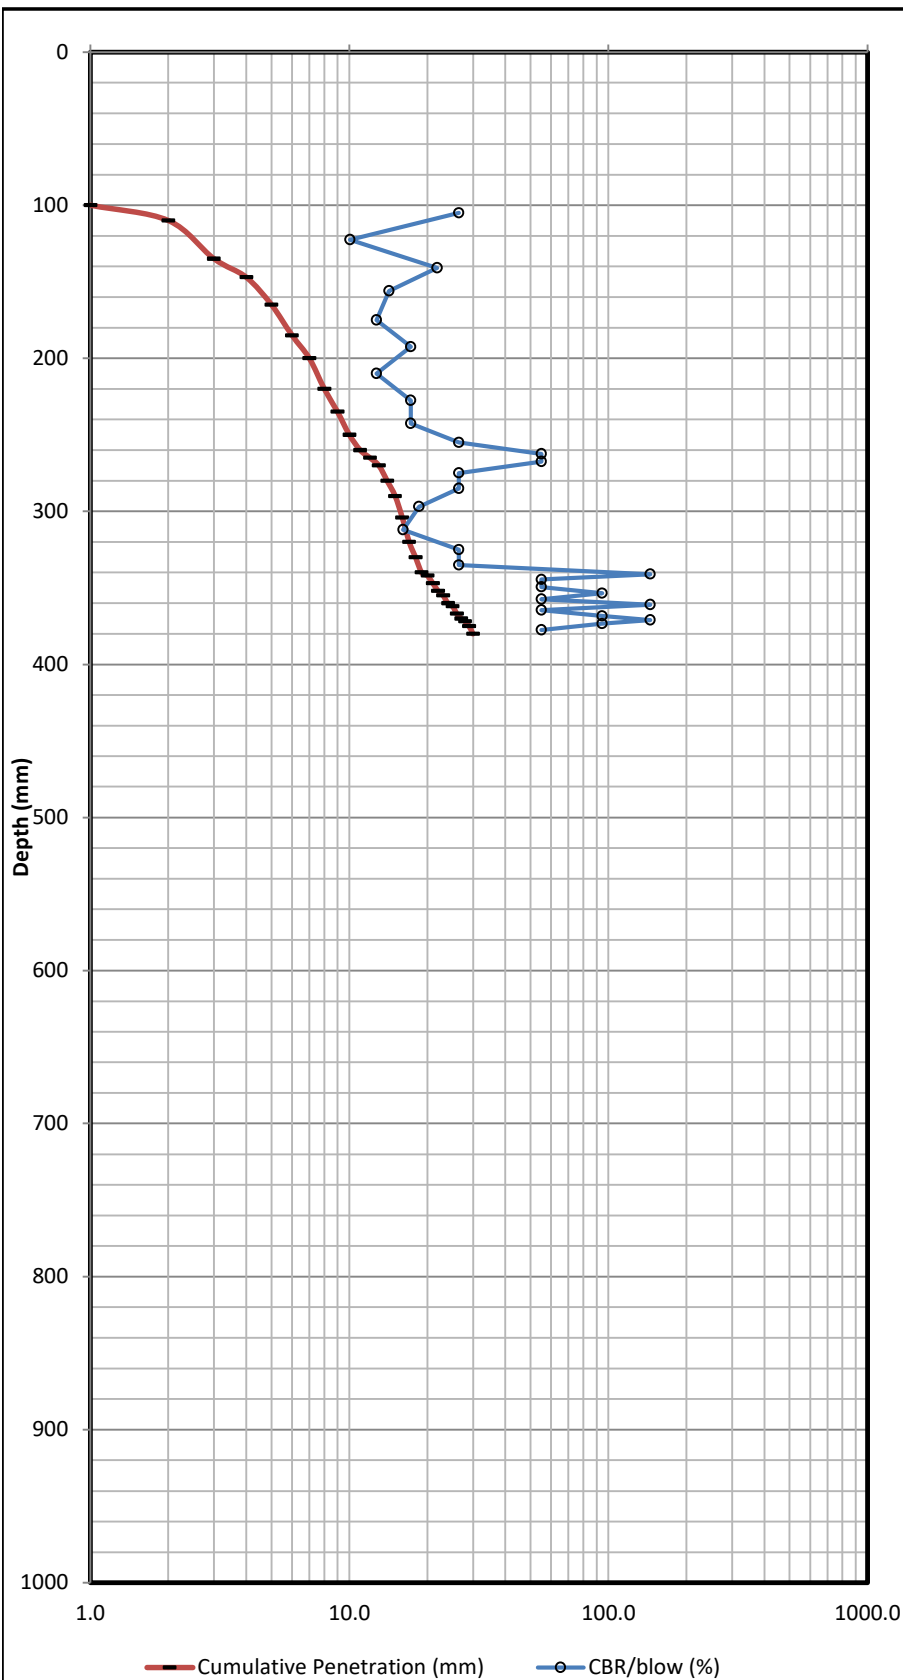
| | DCP05 |

| Interpreted CBR Value | |
| 100mm Made Ground removed | |

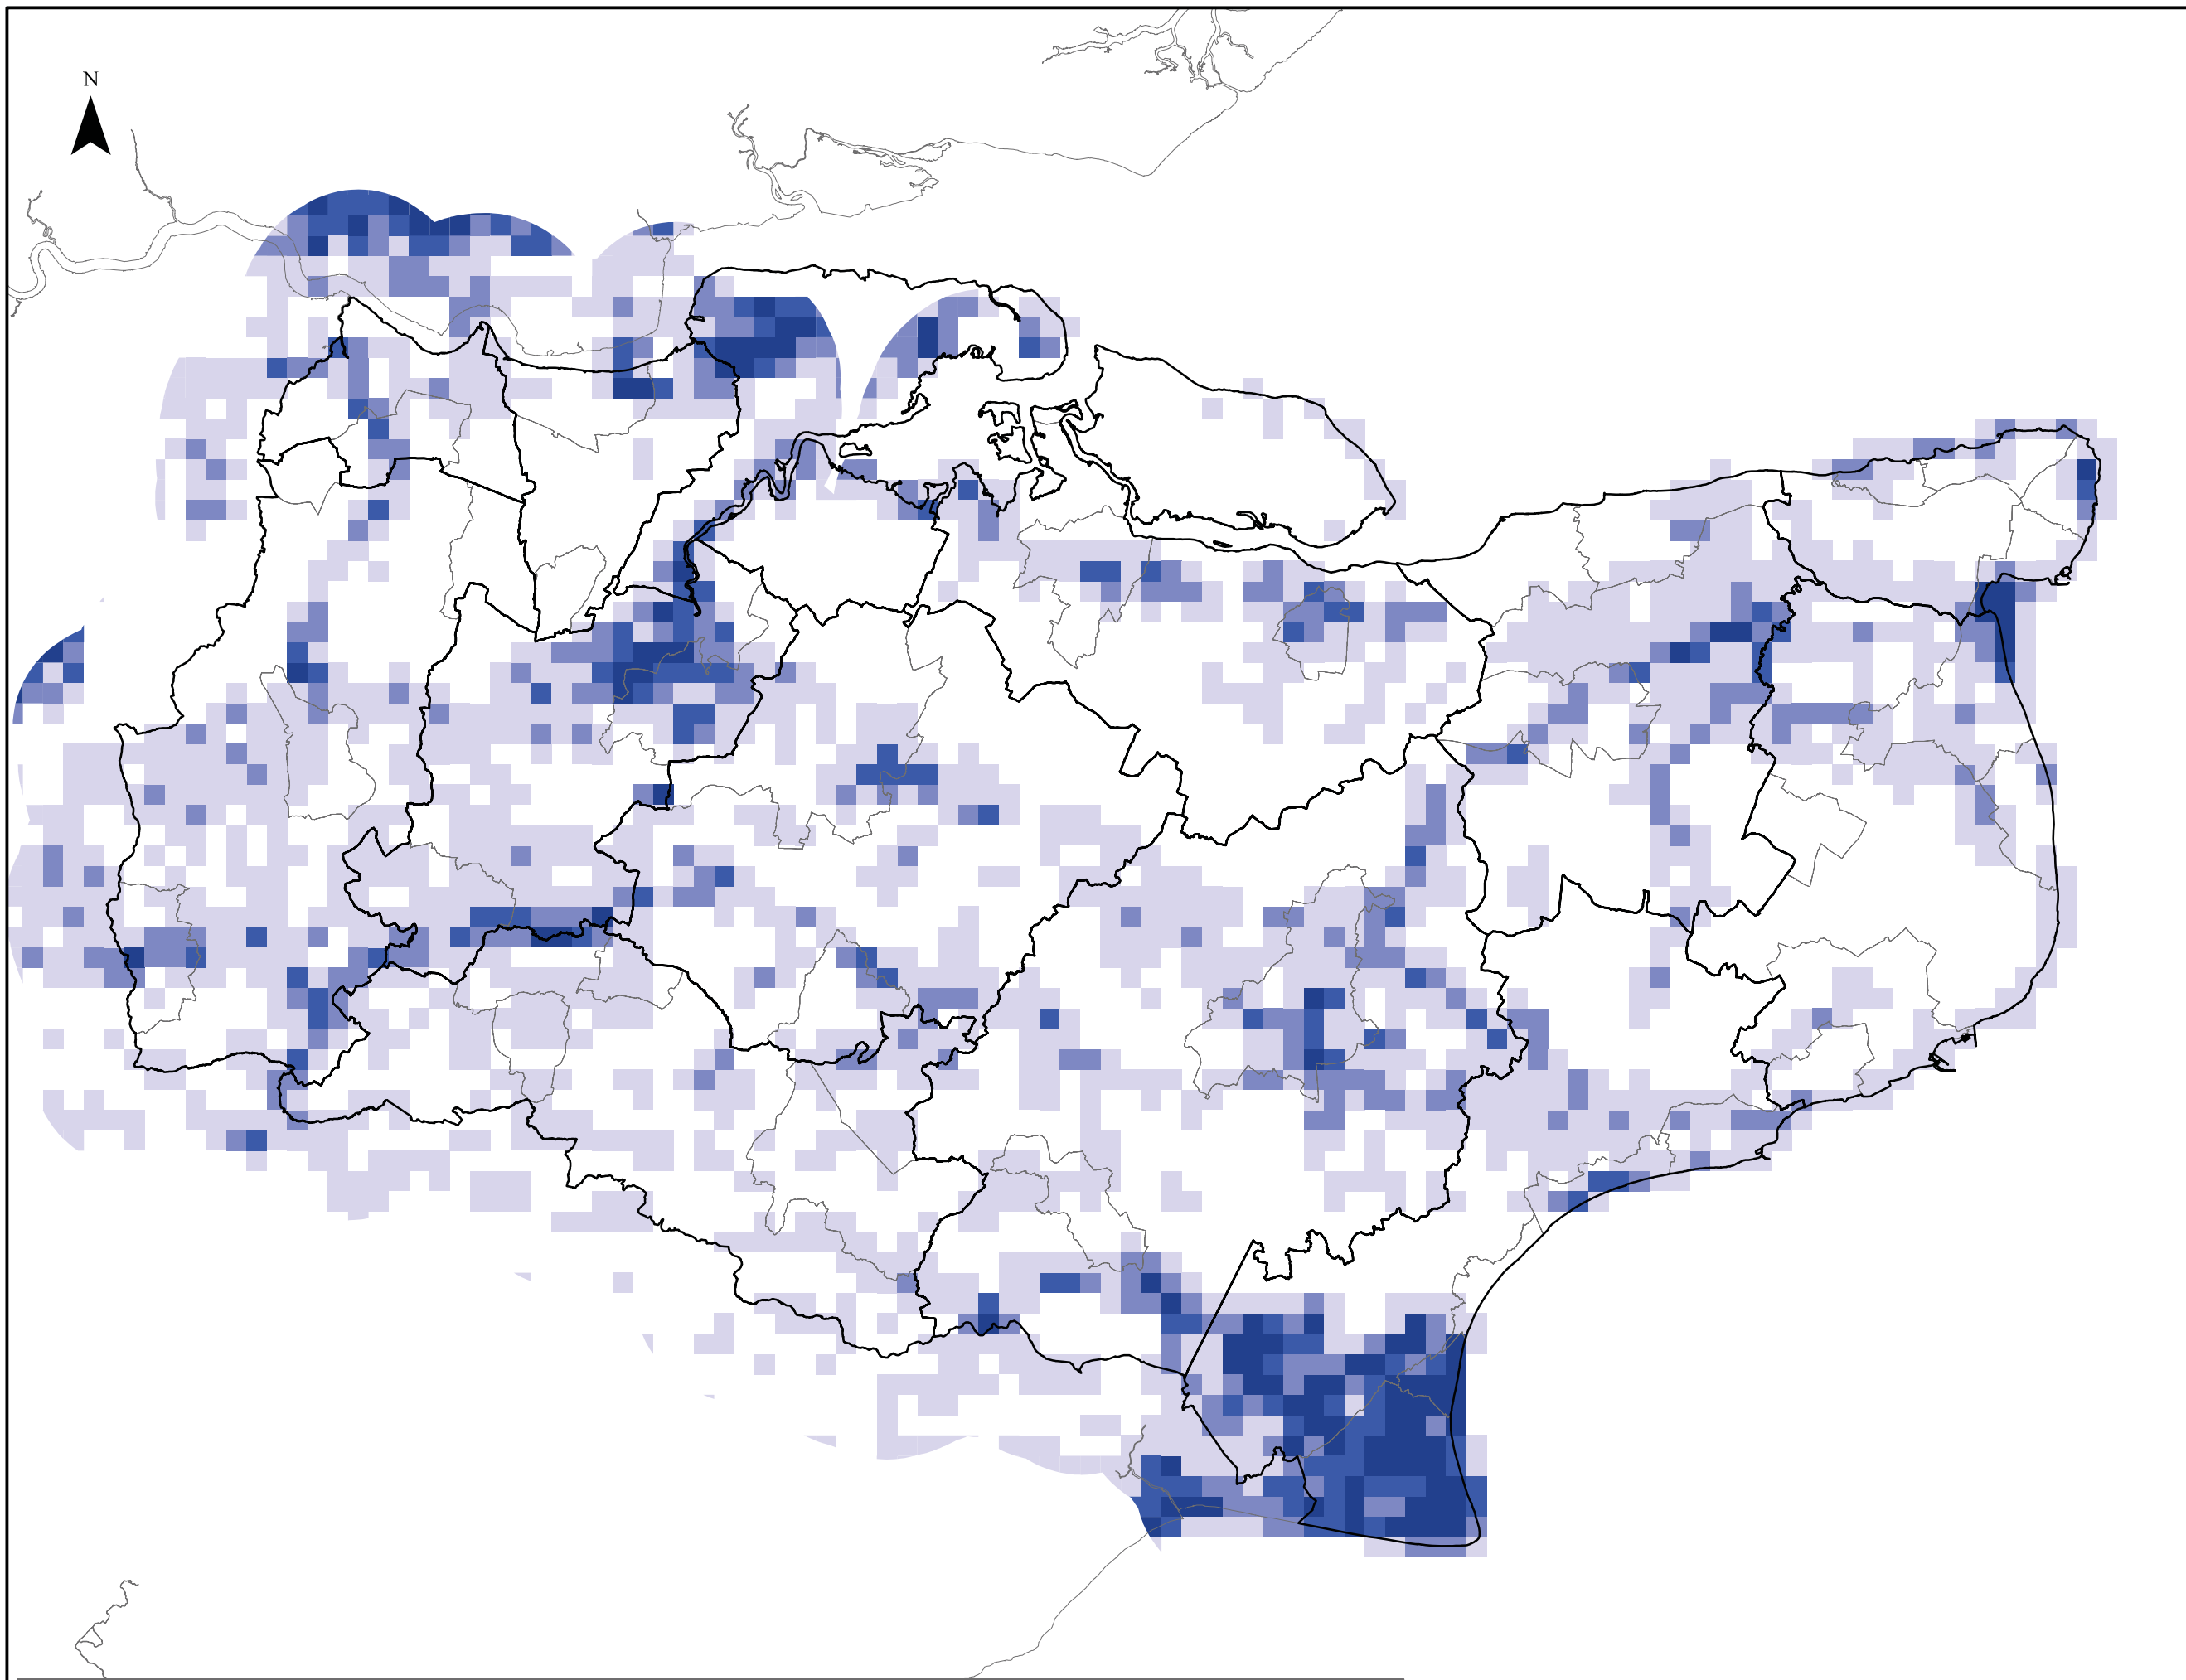
Figure 6

Extract from Kent County Council's Preliminary Flood Risk Assessment
