## TECHNICAL NOTE

**WORKSHOP UNIT FACTORY ROAD**

**240802 Rev A**

### FLOODING AND DRAINAGE PROPOSALS

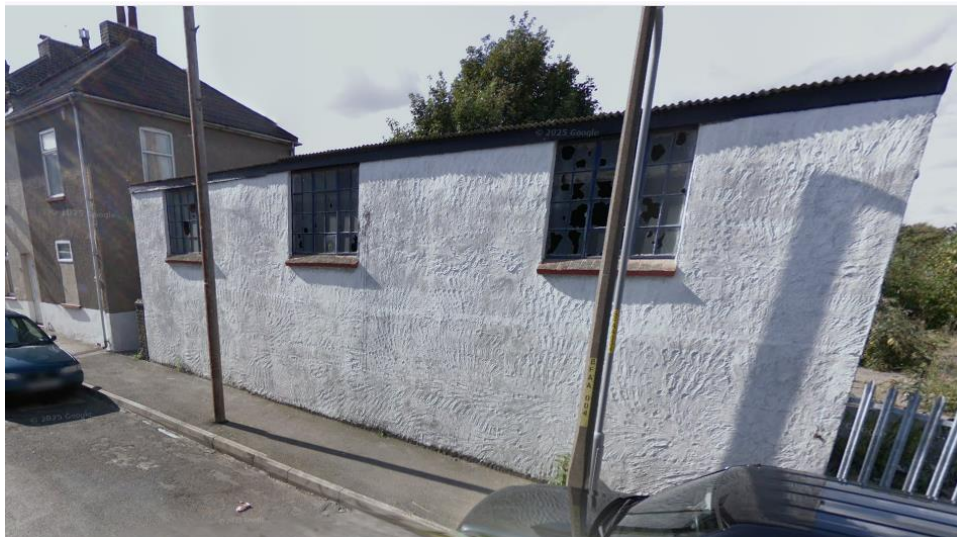
**Image 1: View of former workshop at the site from 2008.**

The area for the proposed construction of a new small workshop unit is sited at the Northern extent of Factory Road in Northfleet Kent. There was formerly a workshop building constructed on the site, but this was demolished in 2008 when the general demolition and clearance of the main cement works was undertaken. The site has been surveyed and there is no surface water sewer flowing offsite. The surface water from the old workshop previously infiltrated into the ground via a shallow soakaway with the historic made ground.

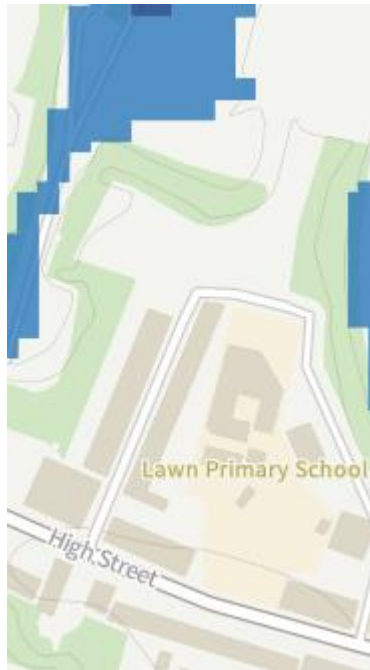
### Tidal flooding

The site is situated next to existing early 1900 terraced houses of Factory Road and above the adjoining Factory Road pavement. There is no recorded history of flooding in this area and the Environment Agency maps show there that there is no likelihood of surface water or ground water flooding. Due the elevation position and lying above permeable soils this was as expected. See below tidal flooding and surface water flooding map extracts from the Environment Agency.
