| <b><i>DRAINAGE DESIGN AND INFORMATION</i></b> | | | |
| <b><i>Job Title</i></b> | <b>St Patricks Gardens<br/>Gravesend</b> | <b>Job No</b> | <b>WG1264</b> |

# Soakaway Investigation Report

**Project Name:** St Patrick's Gardens

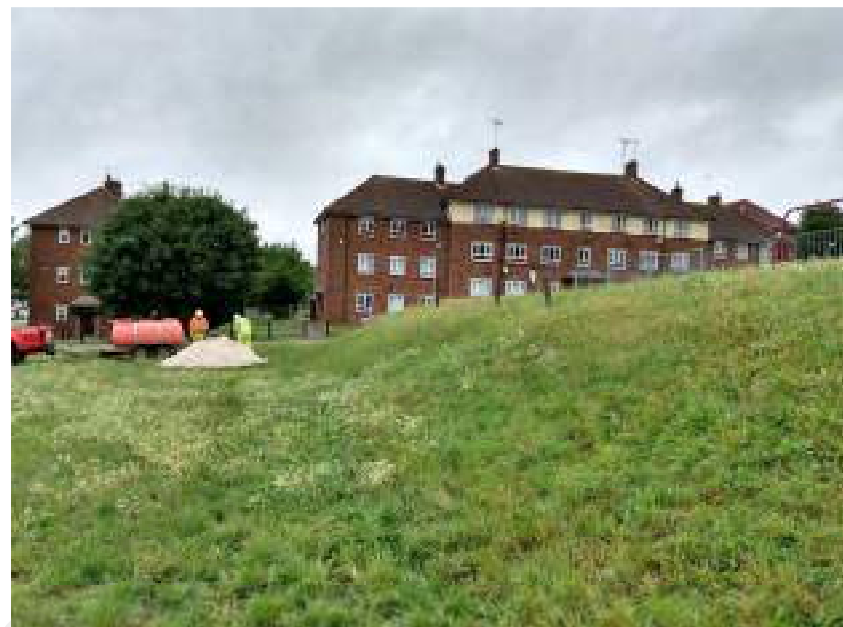
Slope to western end of site

The site was noted to slope from east to west, with a fall in levels of around 7°, for the steepest section.
