Existing Floor Plans and Heritage Assets Statement

PROJECT  
Proposed Rear Extension  
62 Woolfham Road  
Gravesend Kent DA11 0GF  
for: Simple Solutions Ltd

1522.WD.01A

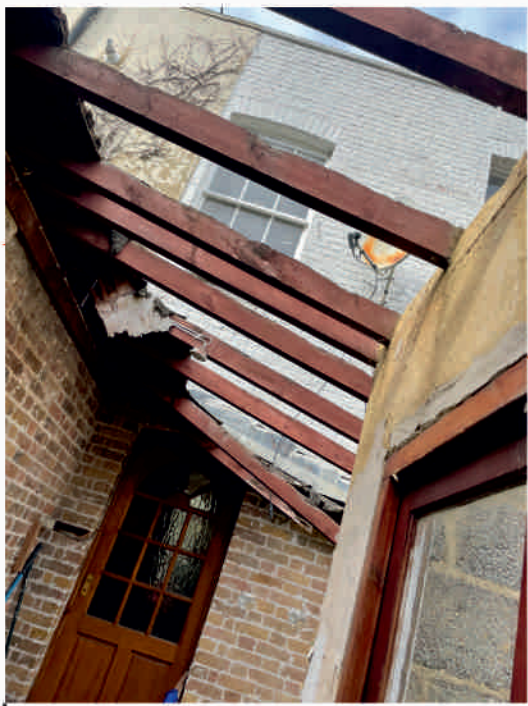
PHOTOGRAPH 7,  
Showing derelict rear addition

4. The proposal is to extend the property at ground floor level to the rear only and to retain it as a single family dwelling.
  5. The main original intact feature is the staircase. It is intended to repair the stair where spindles and handrail is missing making good throughout.

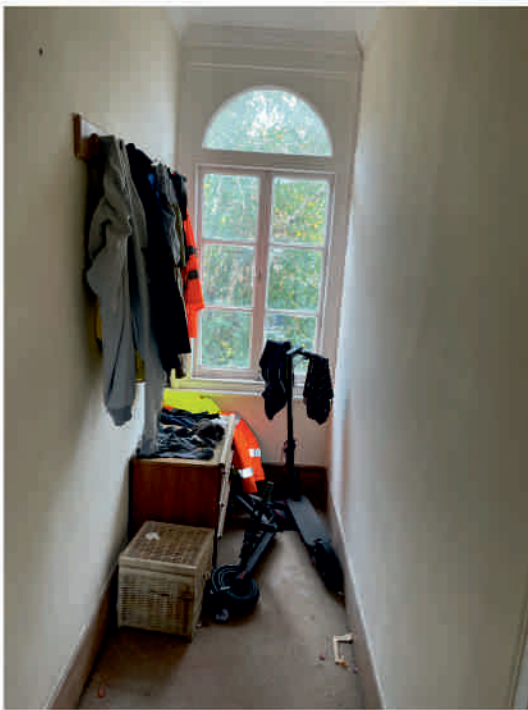
PHOTOGRAPH 6  
Landing window at first floor being an intact original photograph it also illustrates the existing skirtings which are generally intact throughout

3. Most of the original timber sash windows remain although some have glazing missing. It is proposed that all will be retained and refurbished with internal secondary glazing added.

9. All new internal doors, skirtings and architraves will be to match the existing.
  10. Existing skirtings remain intact and will be retained.

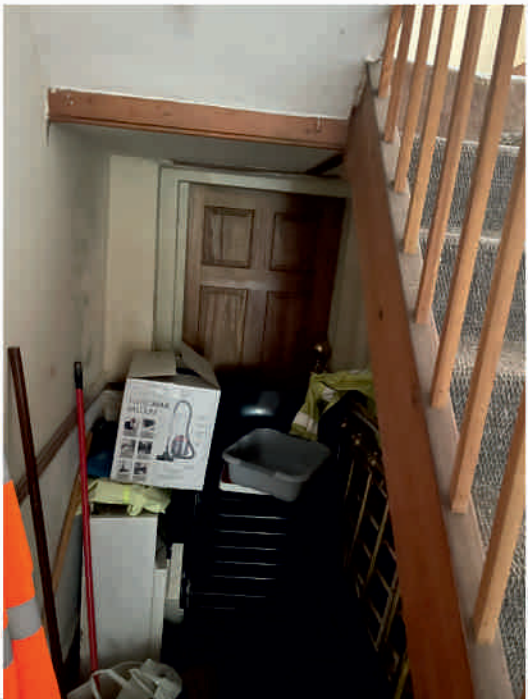
PHOTOGRAPH 3  
Showing original stair intact but rear access to former coal hole blocked off

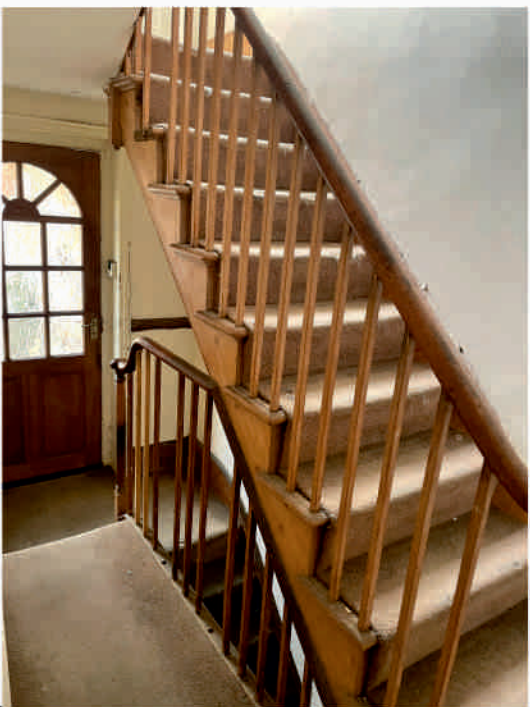
PHOTOGRAPH 4  
Showing original stair intact at first floor landing level

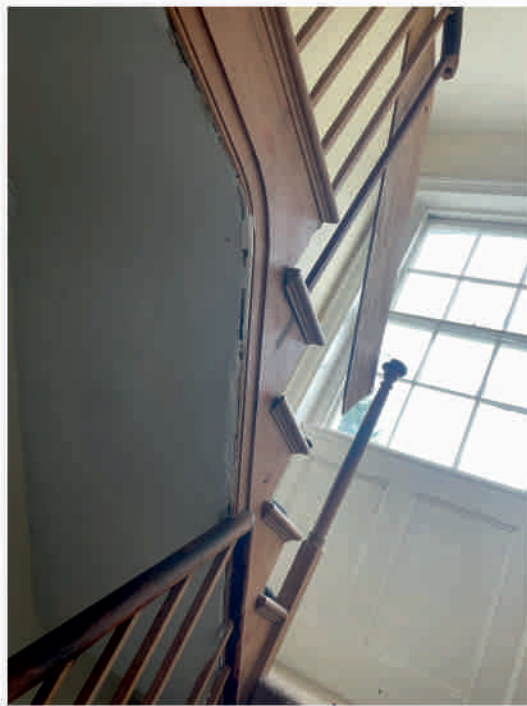
PHOTOGRAPH 5  
Showing original stair intact up to second floor landing level but damaged

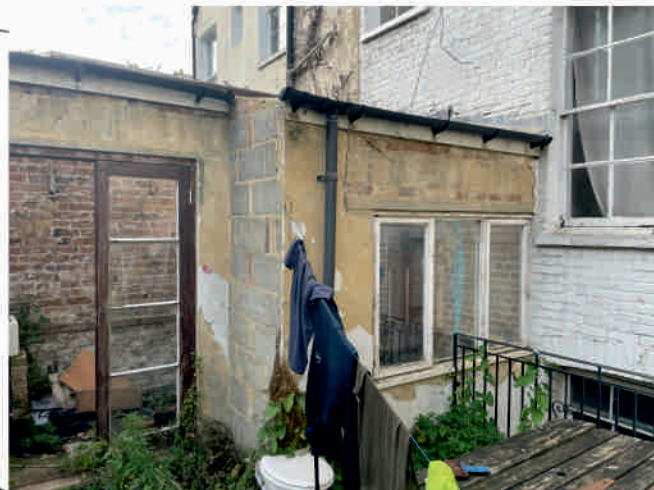
PHOTOGRAPH 2  
Showing extension at first floor it can be seen it is poor condition with a collapsed roof. The walls are single skin rendered black work and non-original. It also shows that existing facing brickwork to the rear has been painted white.

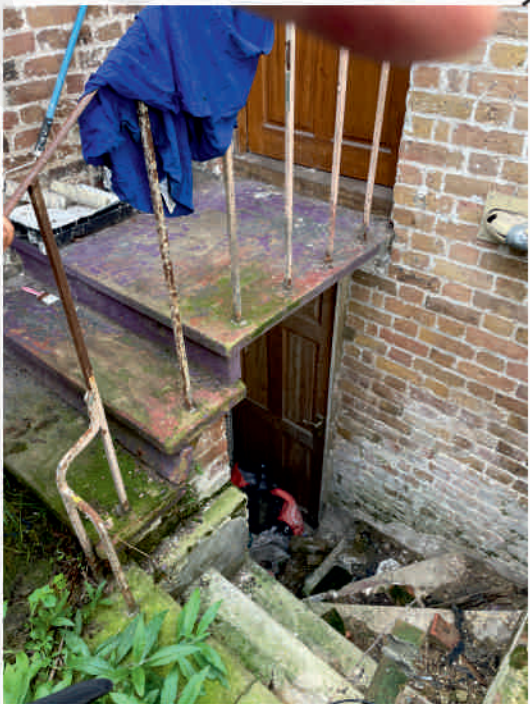
PHOTOGRAPH 1  
Showing original rear steps from first floor to ground floor to probably former coal hole

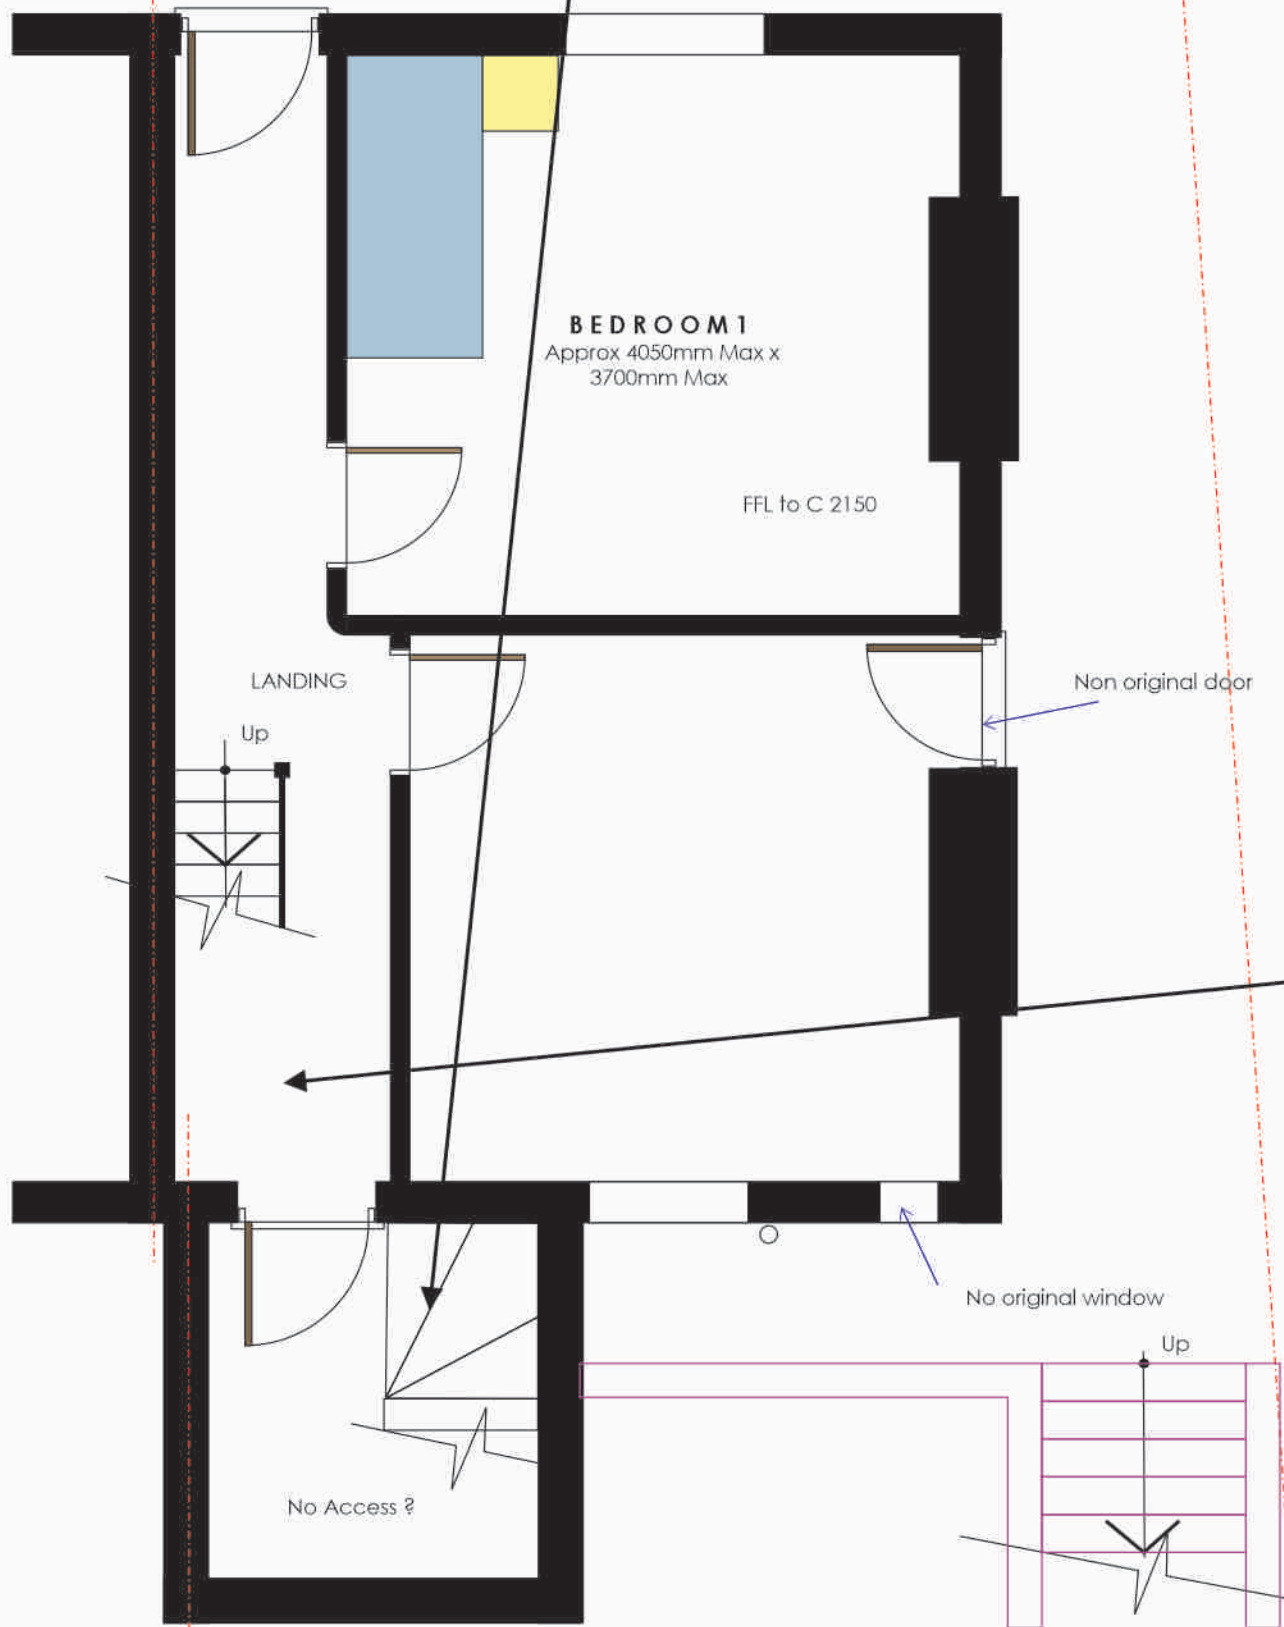
Existing Ground Floor Plan - 1:50  
Lower Ground Front

- Existing walls of original origin
- Existing walls not of original origin

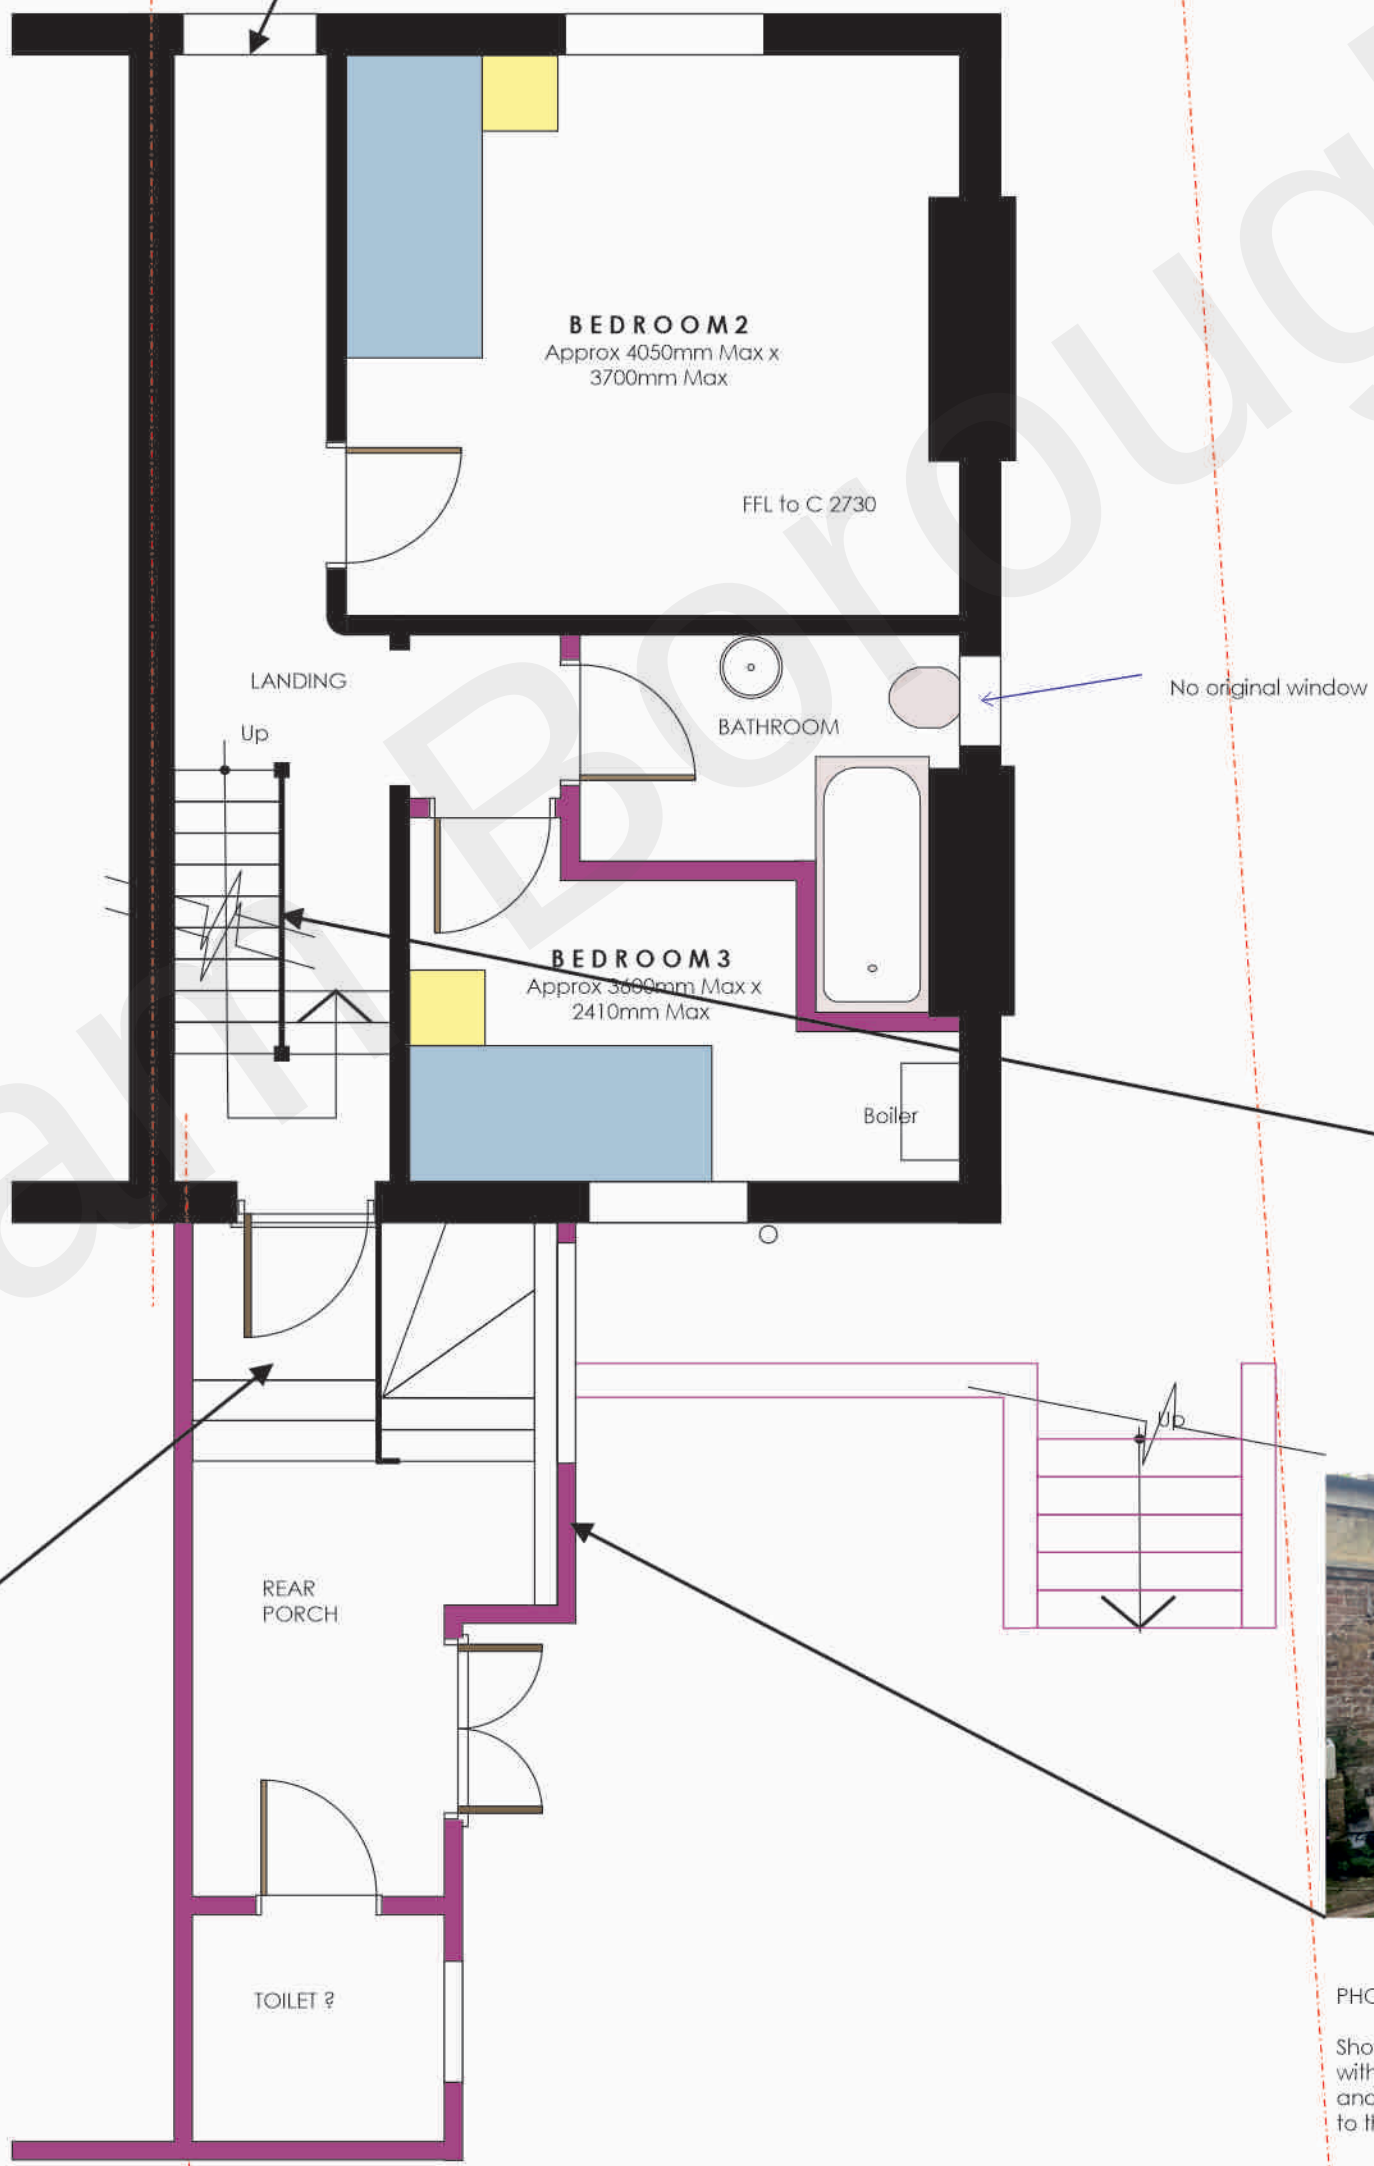
Existing First Floor Plan - 1:50  
Upper Ground Rear

6. The proposal is to retain all the existing bedrooms as original removing all non-original walls on the first floor returning bedroom 3 to its original proportions, removing the non-original flank window and making good.
