## Statement of Significance

#### St Peter & St Paul's Church, Milton, Gravesend

**Statement of Needs**

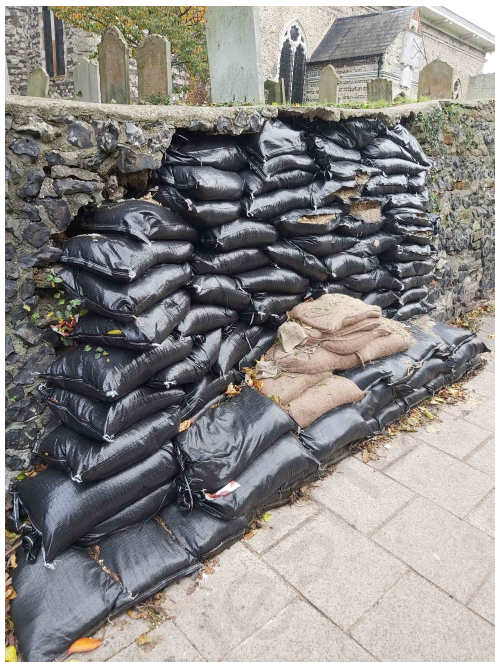
Part of the boundary wall to the churchyard that faces Milton Road East has failed. There is evidence that the wall has been repaired multiple times over the years. Originally, the wall would have been built with flint bedded in lime mortar. Over time brick courses have been introduced and lastly repointing has been carried out in cementitious mortar. Over time the cementitious mortar has weakened the wall as water is unable to escape through the mortar and can only do so around the flint and through the brick.

Furthermore, the structural integrity of wall would have been weakened by the roots of trees growing relatively close to the wall. The trees have been removed but the damage has been done.

A large section of the boundary wall has collapsed and urgently needs to be rebuilt to prevent further collapse and the graves behind the wall being disturbed. Affecting the historic graveyard and putting the health and safety of the public at risk.

The collapsed section of boundary wall

The proposal is to demolish a section of the boundary wall as shown on drawing 5268/GA/100 while carefully protecting the graves and minimising the disturbance to the graveyard. Retaining wall foundation and wall are to be constructed, a land drain

laid and backfilled. The retaining wall will be faced in knapped flints to match the 14<sup>th</sup> Century tower.
