**Church Street, Higham**  
Rural Conservation Area Appraisal  
**Supplementary Planning Document**

## **CHURCH STREET, HIGHAM - RURAL CONSERVATION AREA APPRAISAL 2016**

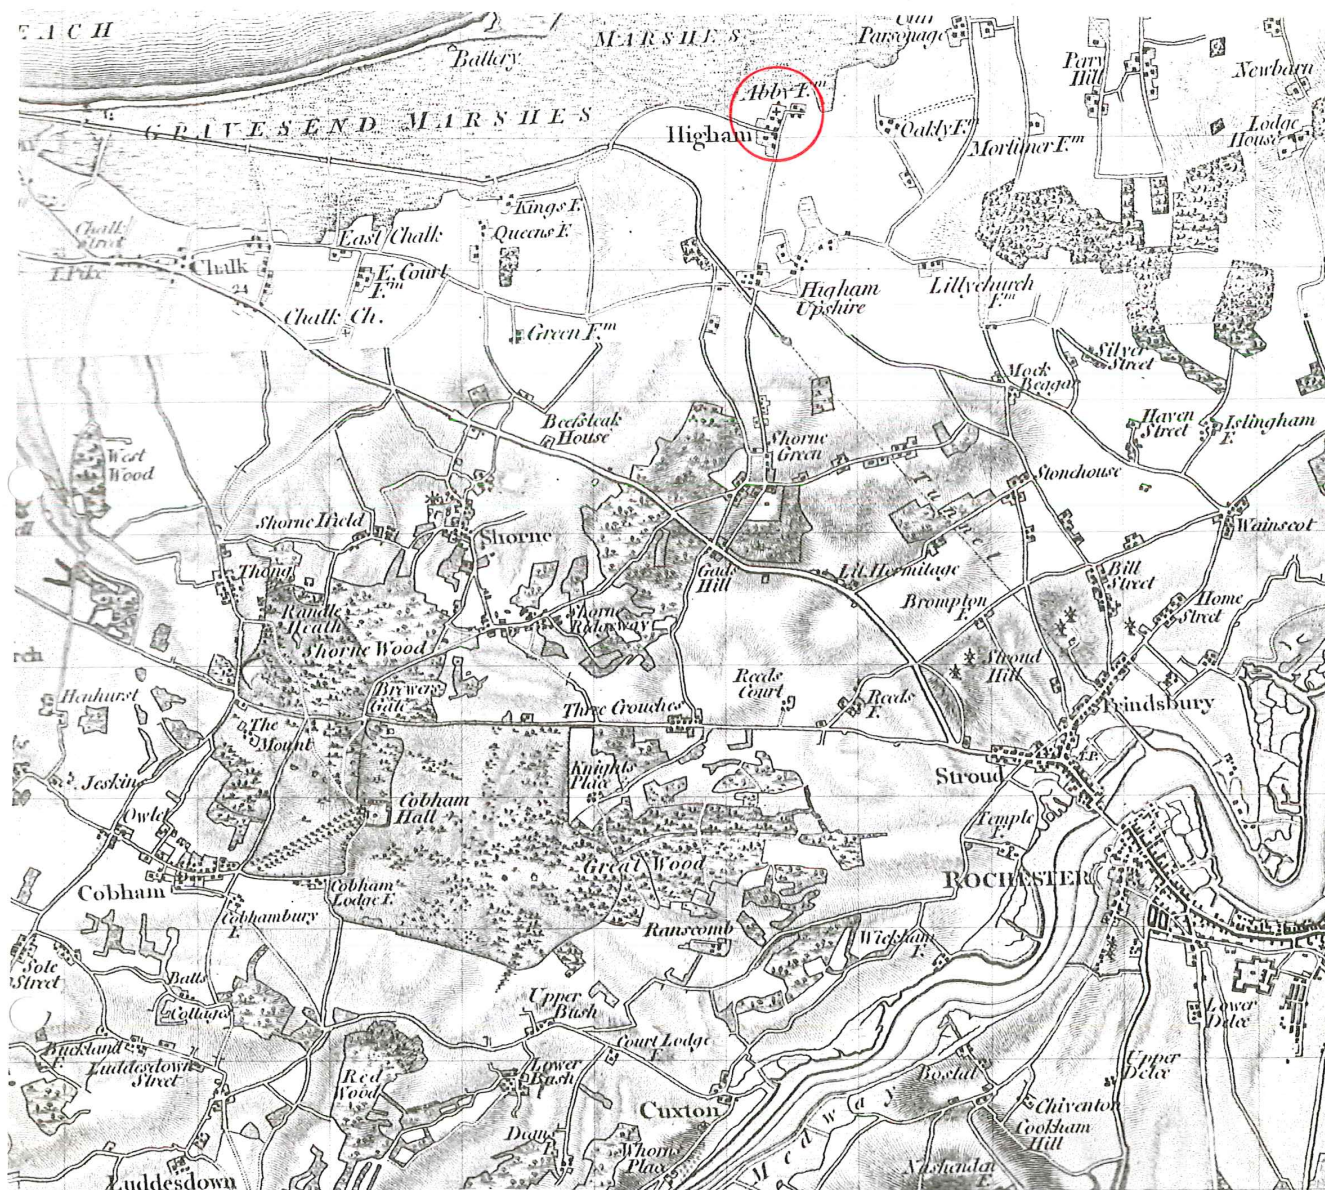
**Figure 5**

**3.4 First OS, 1819**

Para 3.4. First OS, 1819.

There is one small difference between development shown on the modern OS map and on the first, 1819, OS map. On the latter map a pair of dwellings is shown interposed between the church and the houses fronting the north side of the west running section of Church Street. Today the position of the church lychgate and an abrupt change in back garden boundary line in the graveyard show where these extra houses once stood.
