**DESIGN, ACCESS STATEMENT AND HERITAGE STATEMENT**

Vehicle impact repair works

32 Harmer Street, Gravesend, Kent, DA12 2AX

November 2024

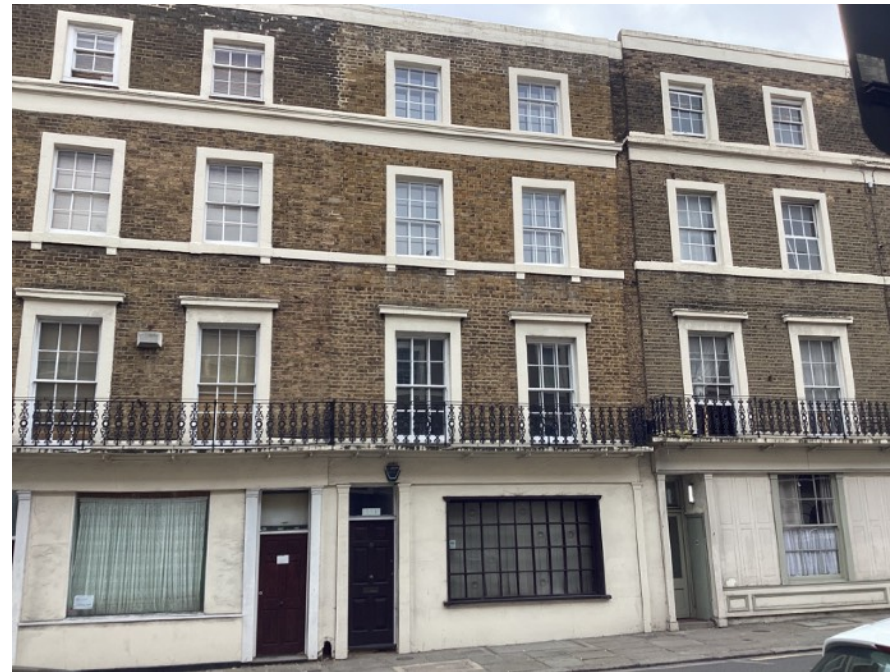
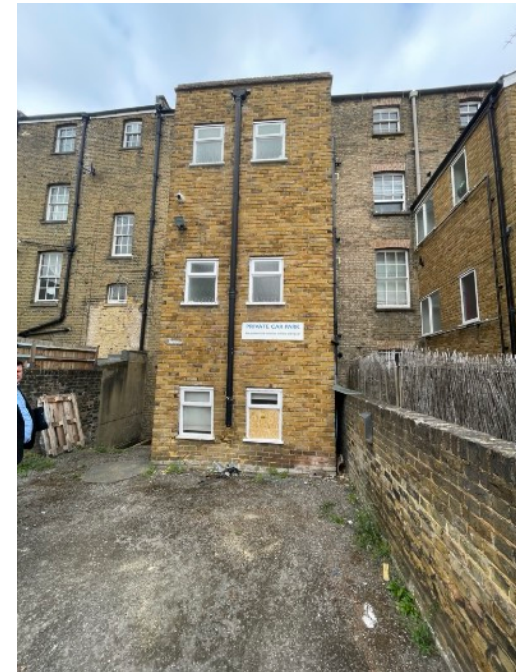
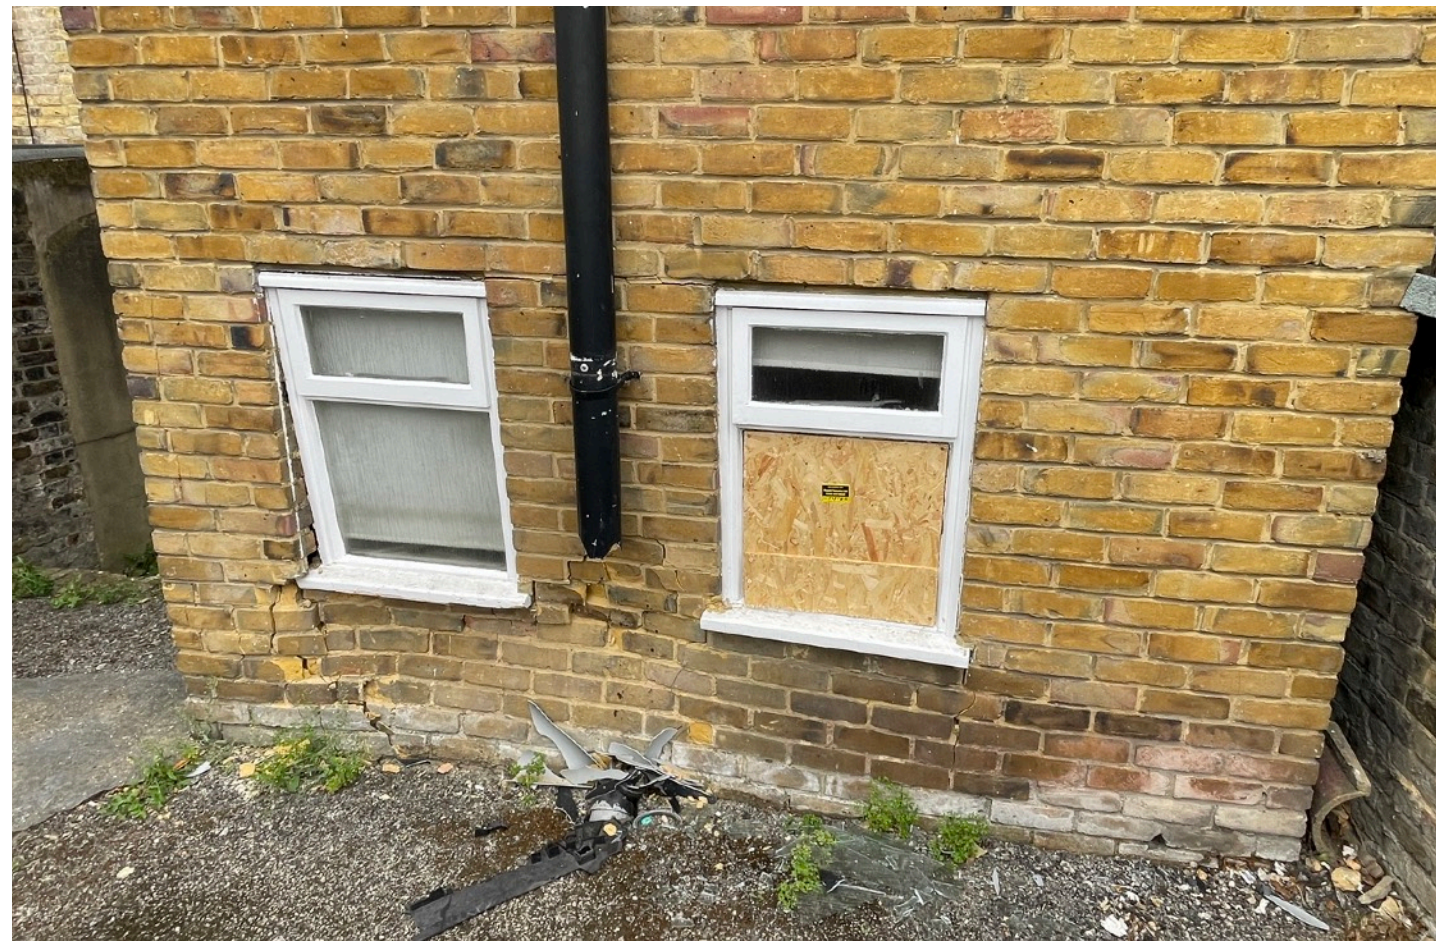
## Site Photos

The property recently suffered from vehicle impact to the rear elevation. The impact was approximately central to the rear extension, and has caused structural damage to the east and west elevations.

The making good works submitted for planning review only extend to the more recent rear extension to the original turn of the century building, which remains unaffected by these proposals.

The repairs required include the rebuilding the rear section of wall from internal ground level to two courses above ground floor window lintel level, and the partial rebuild of the west elevation, to make the building structurally safe.

All repair work will be carried out using the original bricks or bricks matching the size and colour of original bricks and mortar like-for like. The two ground floor windows on the rear elevation will be replaced like-for-like.
