Project GAD'S HILL SCHOOL, HIGHAM  
GAD'S HILL PLACE REPAIRS

Title CUPOLA REPAIRS  
EXISTING FRONT ELEVATION  
Drawing No. 5284/PL/133  
T: 01634 573 017  
www.clayarchitecture.com  
E: design@clayarchitects.com

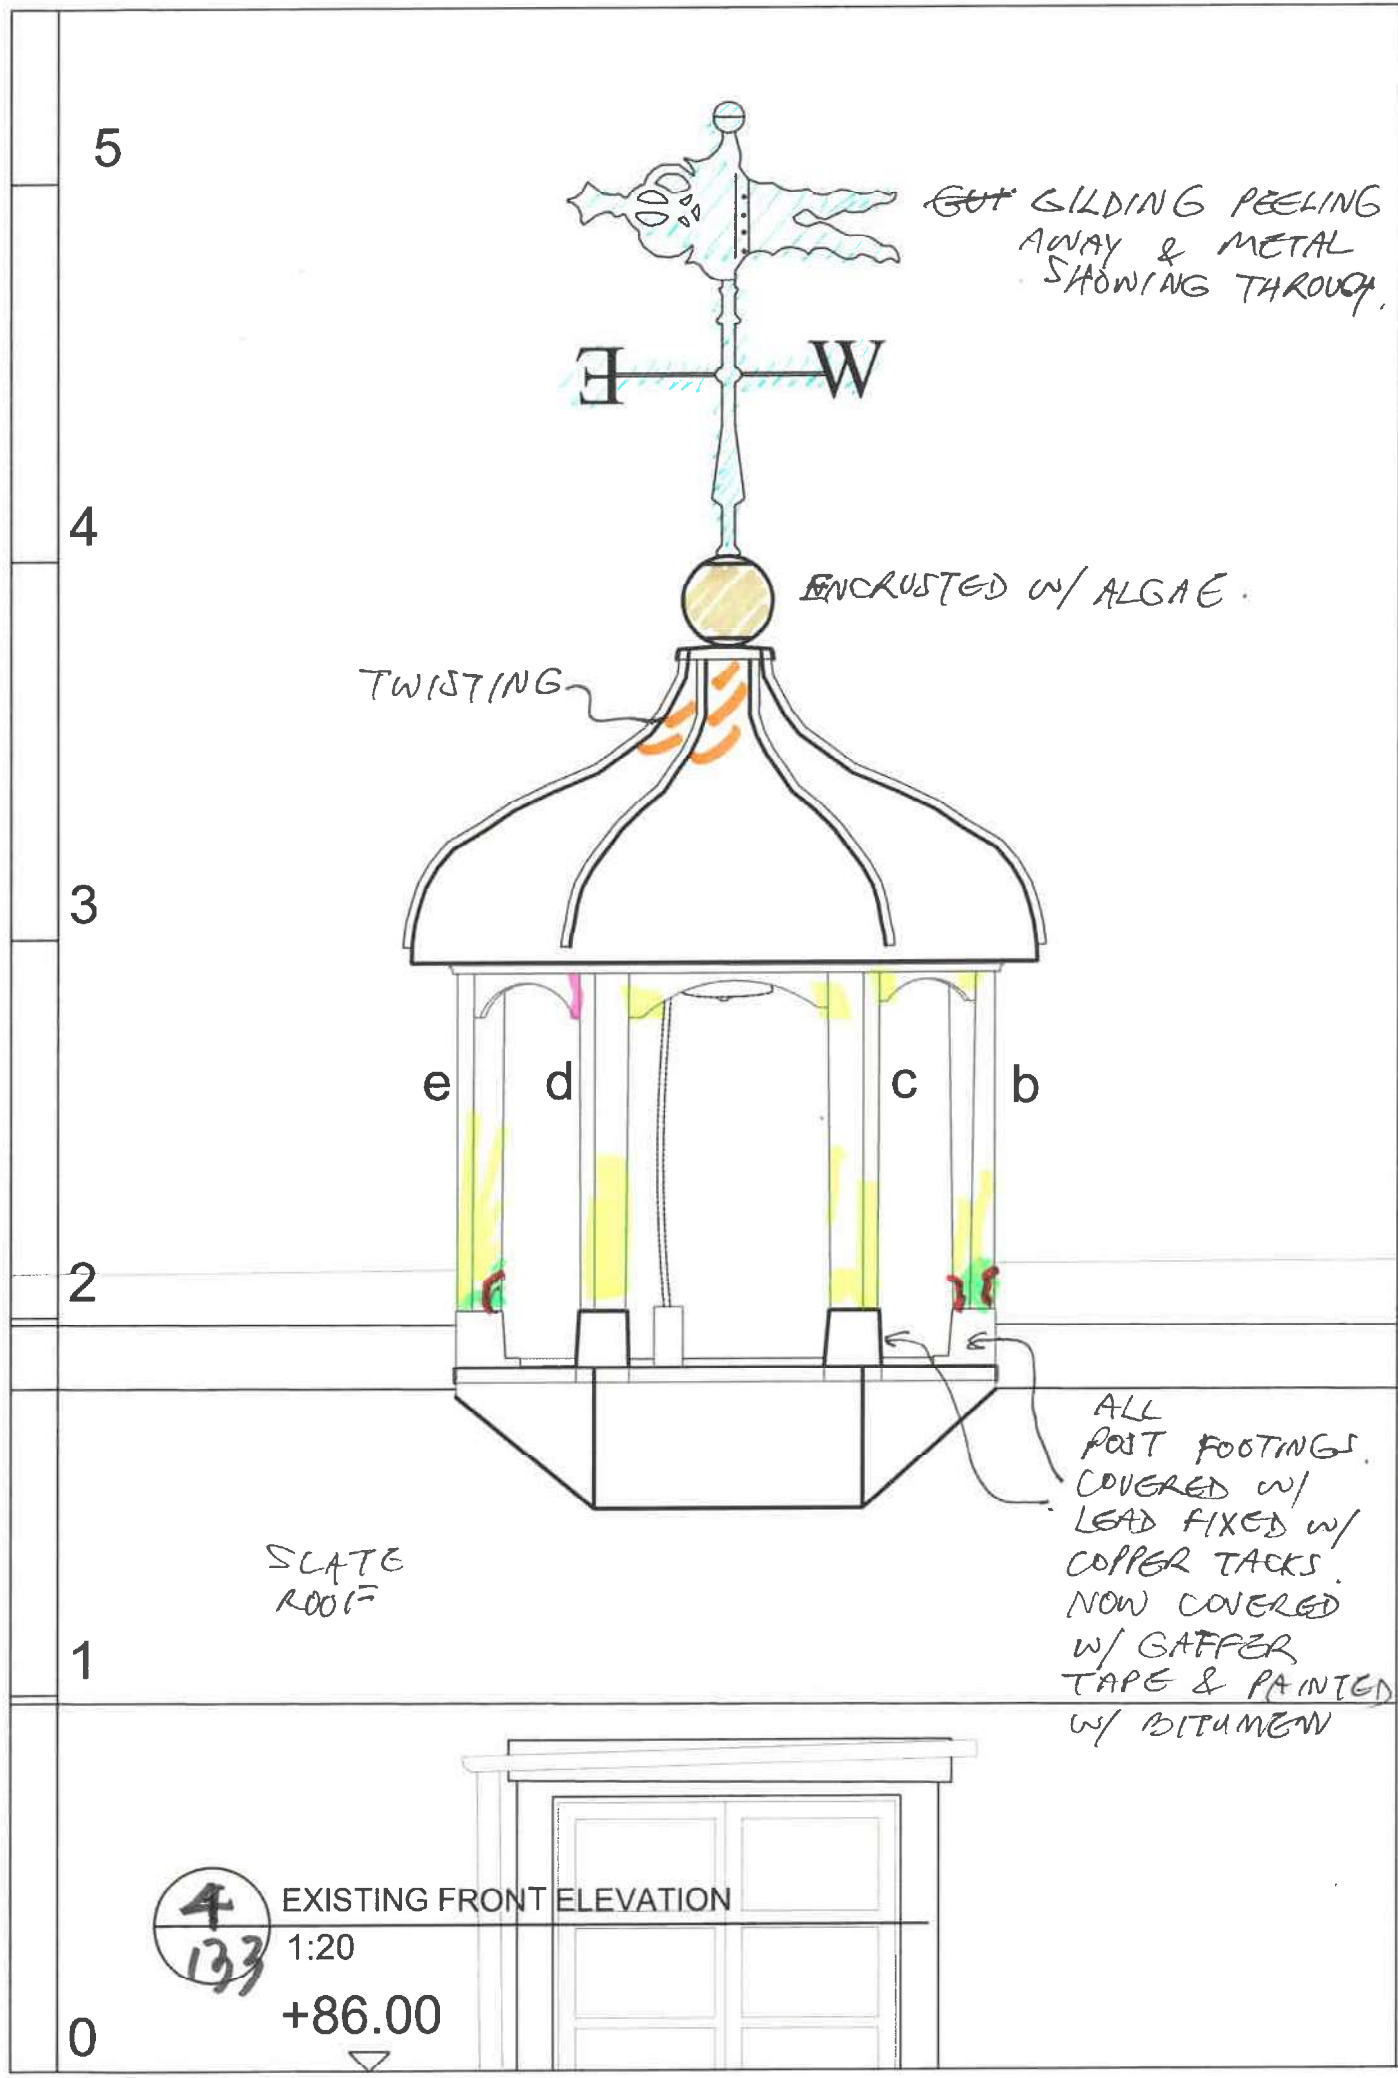
EXISTING FRONT ELEVATION

SPLIT.

CRAACKED & PEELING PAINT. EXPOSED TIMBER.

3 ROTTED REMAINING STRUCTURE

ALL POST FOOTINGS COVERED W/ LEAD FIXED W/ COPPER TACKS. NOW COVERED W/ GAFFER TAPE & PAINTED W/ BITUMEN

ENCRUSTED W/ ALGAE

TWISTING

GUT GILDING PEELING AWAY & METAL SHOWING THROUGH
