196 & 197 PARROCK STREET  
UNDER CEILING EXTRACTION  
DUCTS IN BASEMENT

Scale 1:50 @ A3  
Drawing Number PSH 061  
Revision 0  
Date 31/01/2024

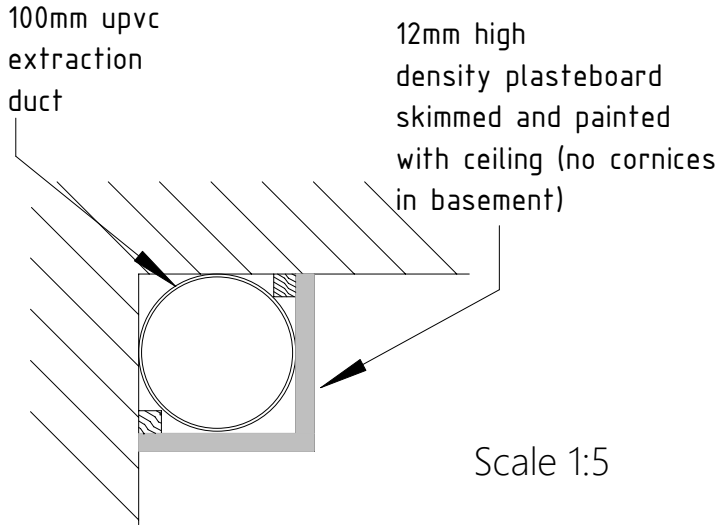
THERE ARE NO EXISTING CORNICES IN THE BASEMENT

DETAIL OF VERTICAL SECTION THROUGH DUCT SHOWING PLASTER ENCASEMENT

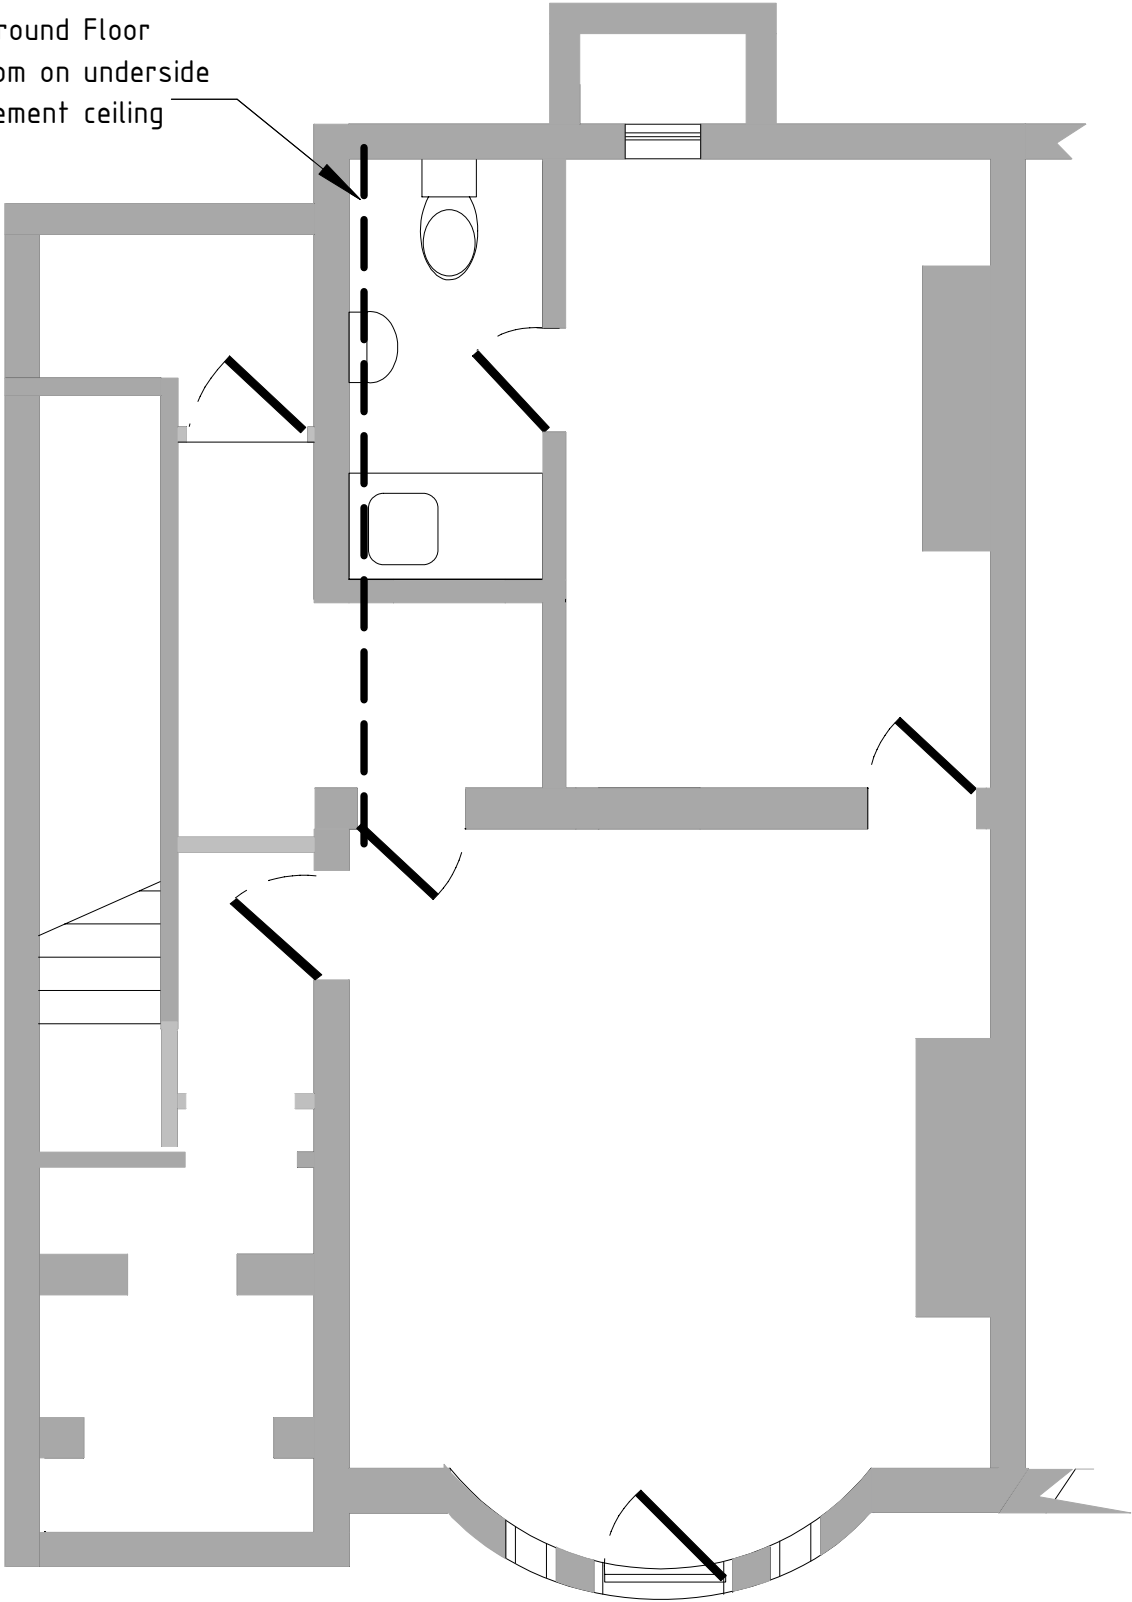
Air extraction duct from Ground Floor bathroom on underside of basement ceiling
