196 & 197 PARROCK STREET  
UNDER CEILING EXTRACTION  
DUCTS IN FIRST FLOOR

Scale 1:50 @ A3  
Drawing Number PSH 063  
Revision 0  
Date 31/01/2024

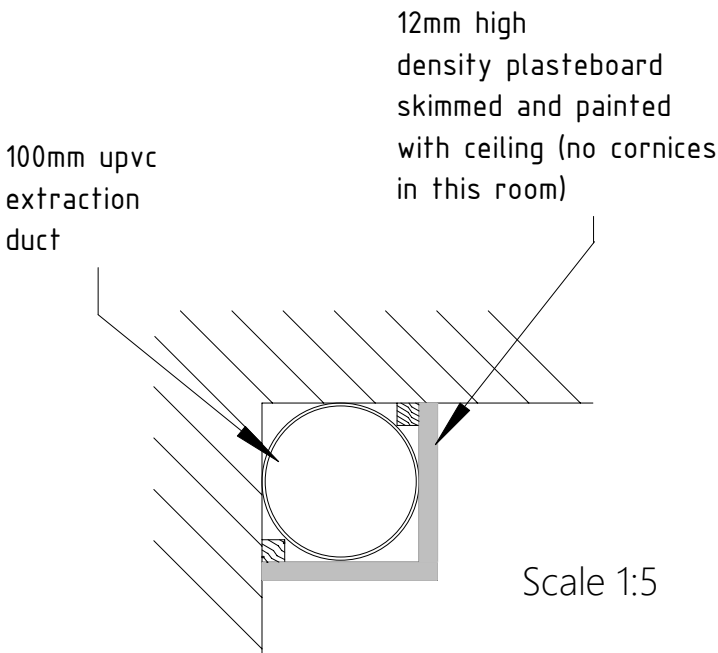
THERE ARE NO AIR  
EXTRACTION DUCTS  
IN FRONT ROOMS  
AND NO EXISTING  
CORNICES IN REAR  
ROOMS
