## 8 Appendices

## Appendix A.4 – Surface Water Management Calculations

## Appendix A.5 – Indicative Drainage Layout

A ground investigation is required in order to determine the geotechnical properties of the ground conditions at the site ahead of its proposed development. It is understood that the proposed development comprises the demolition of the existing structures and redevelopment to provide a sixty-two bedroom care home (Use Class C2) together with associated access, car and cycle parking, structural landscaping, and amenity space provision. A proposed development layout is presented as Appendix I.

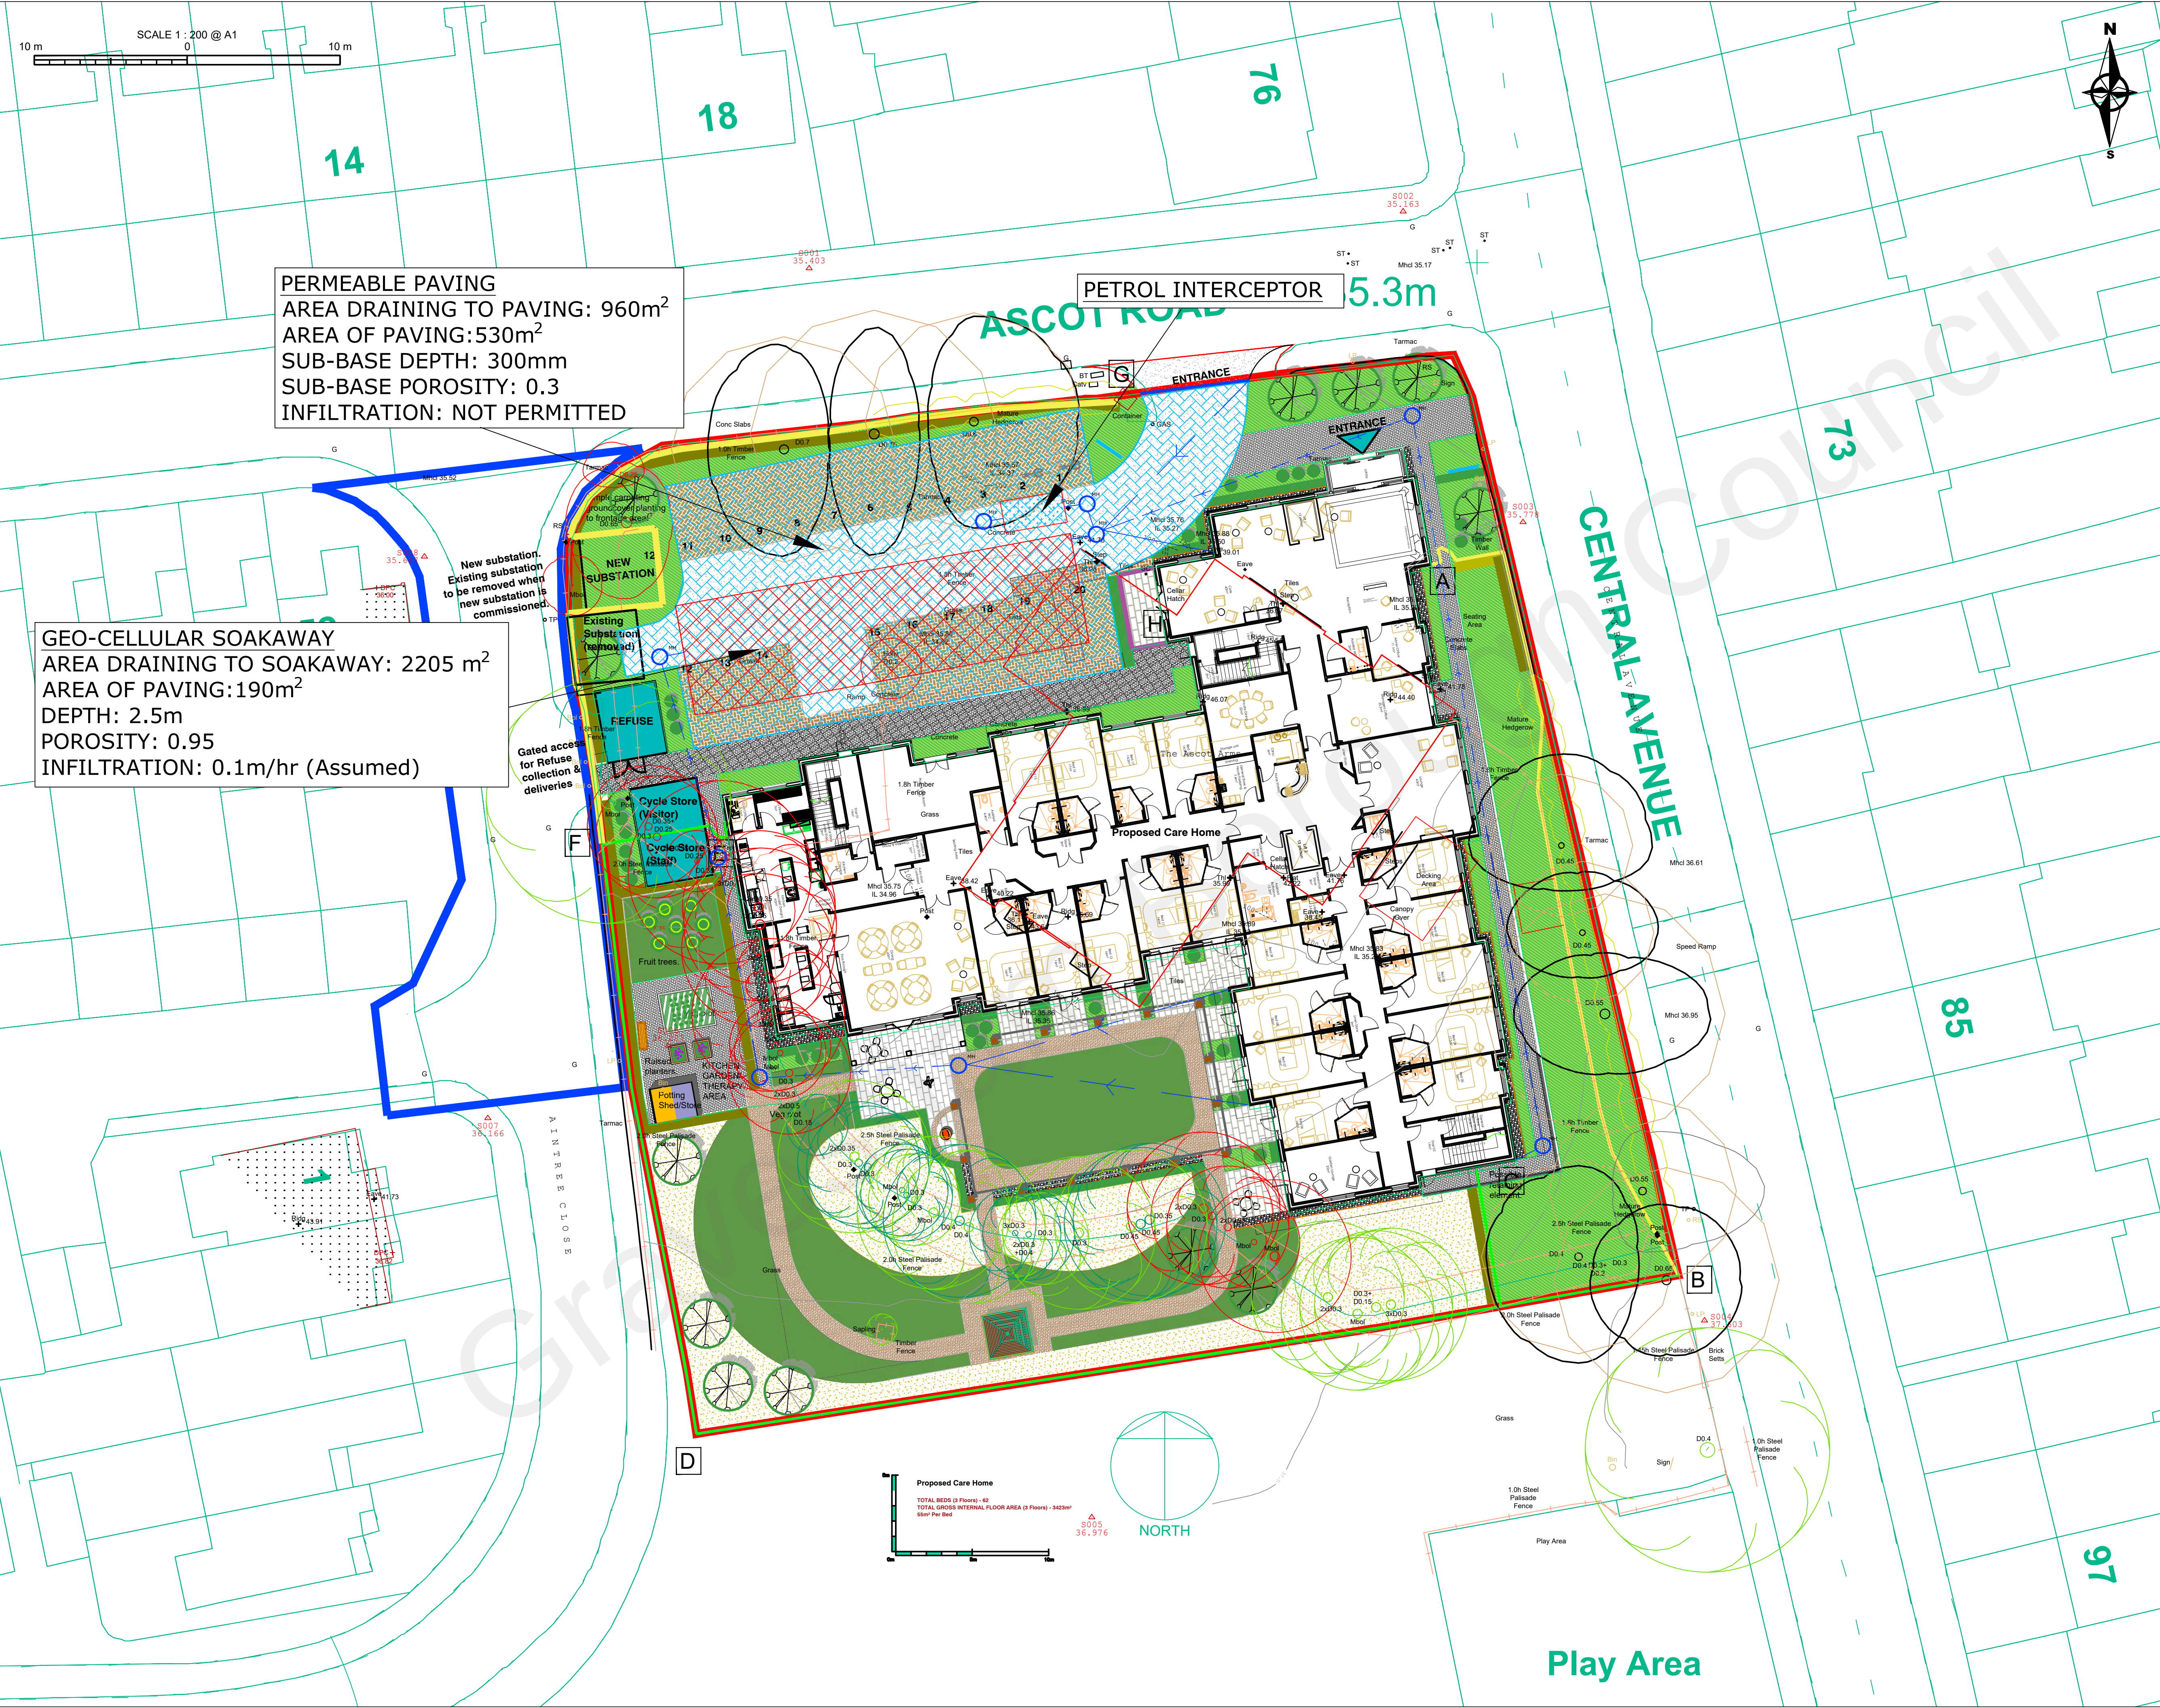
PERMEABLE PAVING  
AREA DRAINING TO PAVING: 960m<sup>2</sup>  
AREA OF PAVING: 530m<sup>2</sup>  
SUB-BASE DEPTH: 300mm  
SUB-BASE POROSITY: 0.3  
INFILTRATION: NOT PERMITTED

GEO-CELLULAR SOAKAWAY  
AREA DRAINING TO SOAKAWAY: 2205 m<sup>2</sup>  
AREA OF PAVING: 190m<sup>2</sup>  
DEPTH: 2.5m  
POROSITY: 0.95  
INFILTRATION: 0.1m/hr (Assumed)

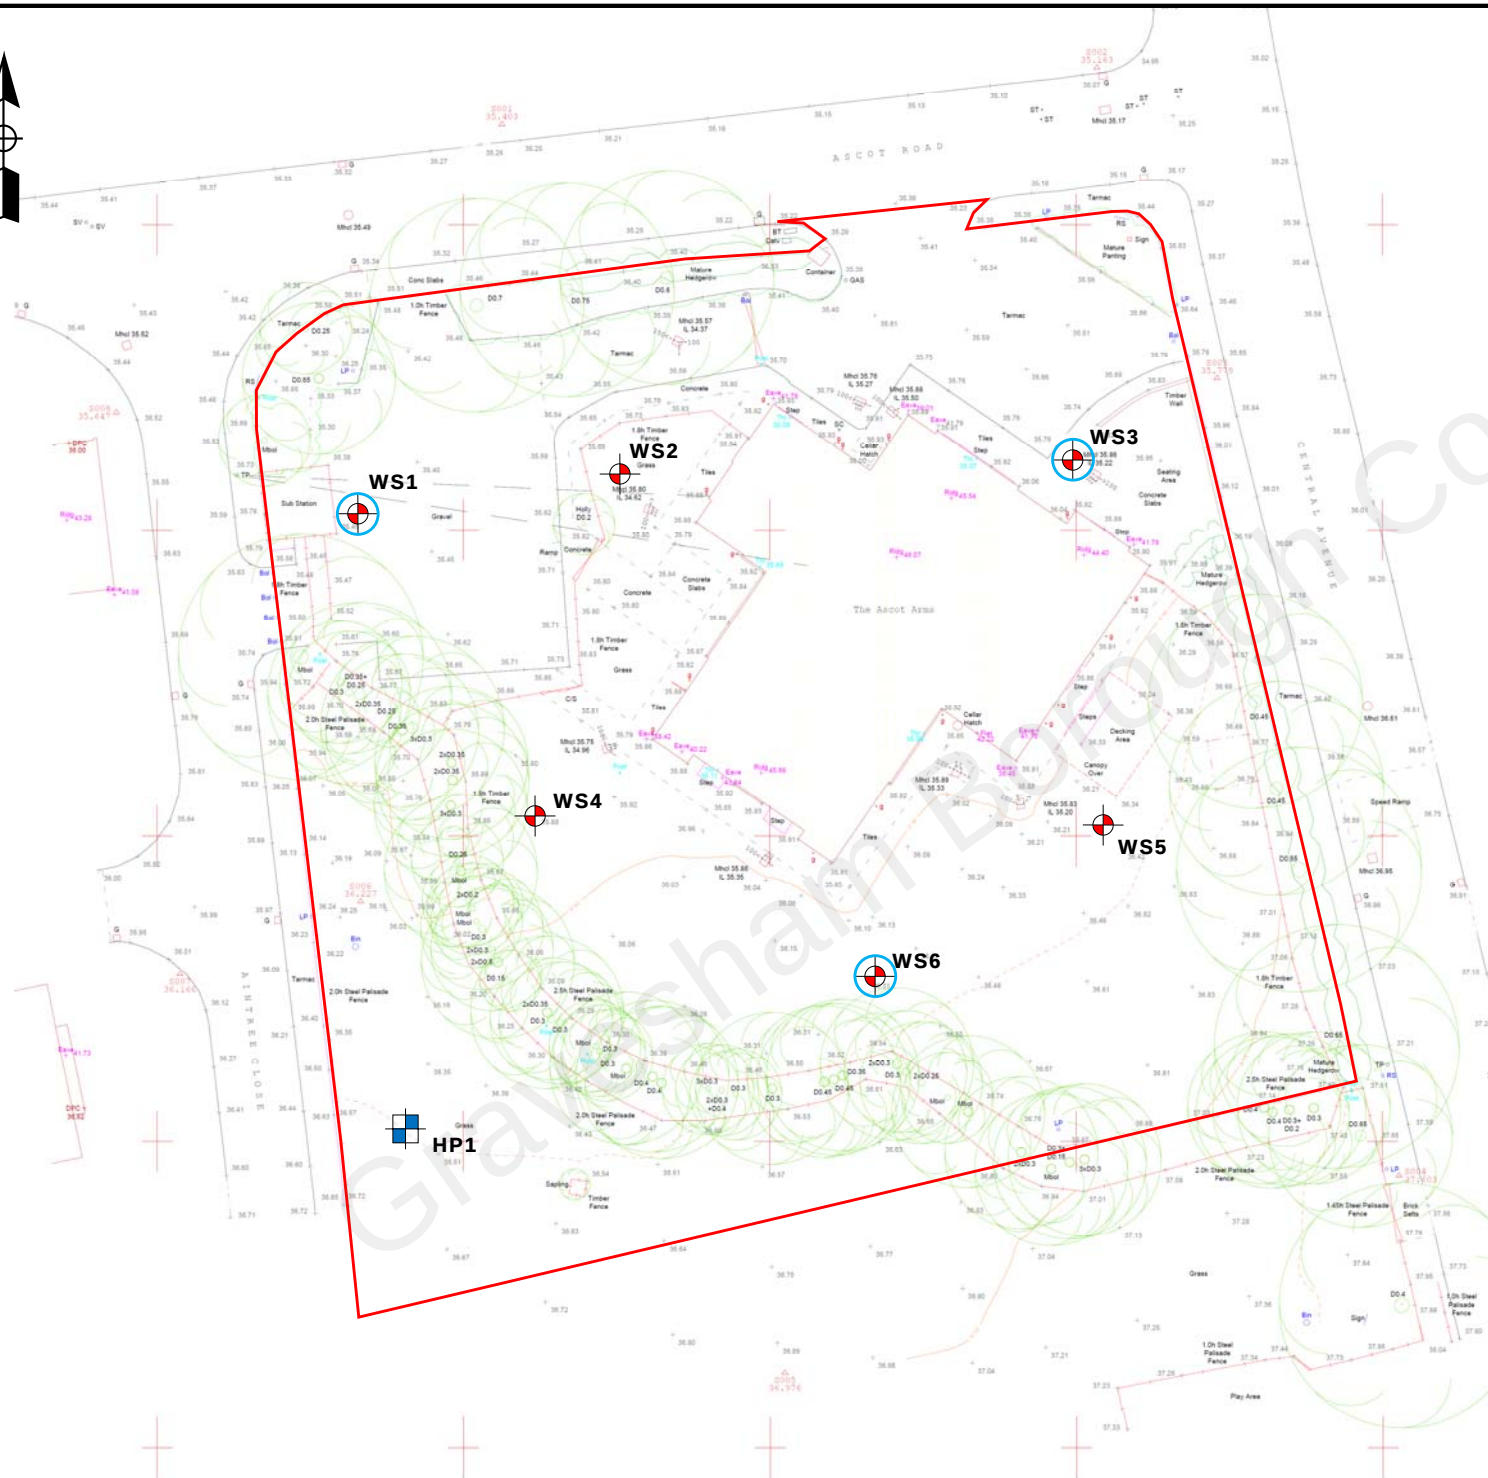
- Windowless Sample Borehole Location
- Hand excavated Trial Pit
- Monitoring Installation
- Approximate Site Boundary

The scope of works was defined for the project by ASL and comprised six windowless sample boreholes and one hand dug trial pit. The intrusive investigation was designed to target the location of the proposed development, to target potential sources of contamination and to provide general site coverage within accessible areas. The investigation was completed to obtain information relating to the contaminative status of the site and the geotechnical properties of the underlying ground conditions. It should be noted that the locations of exploratory locations have been limited by the presence of existing structures. The positions of the exploratory holes have been surveyed and plotted approximately on Figure 2. The investigation works were completed under the supervision of a UXO specialist who cleared all exploratory locations.

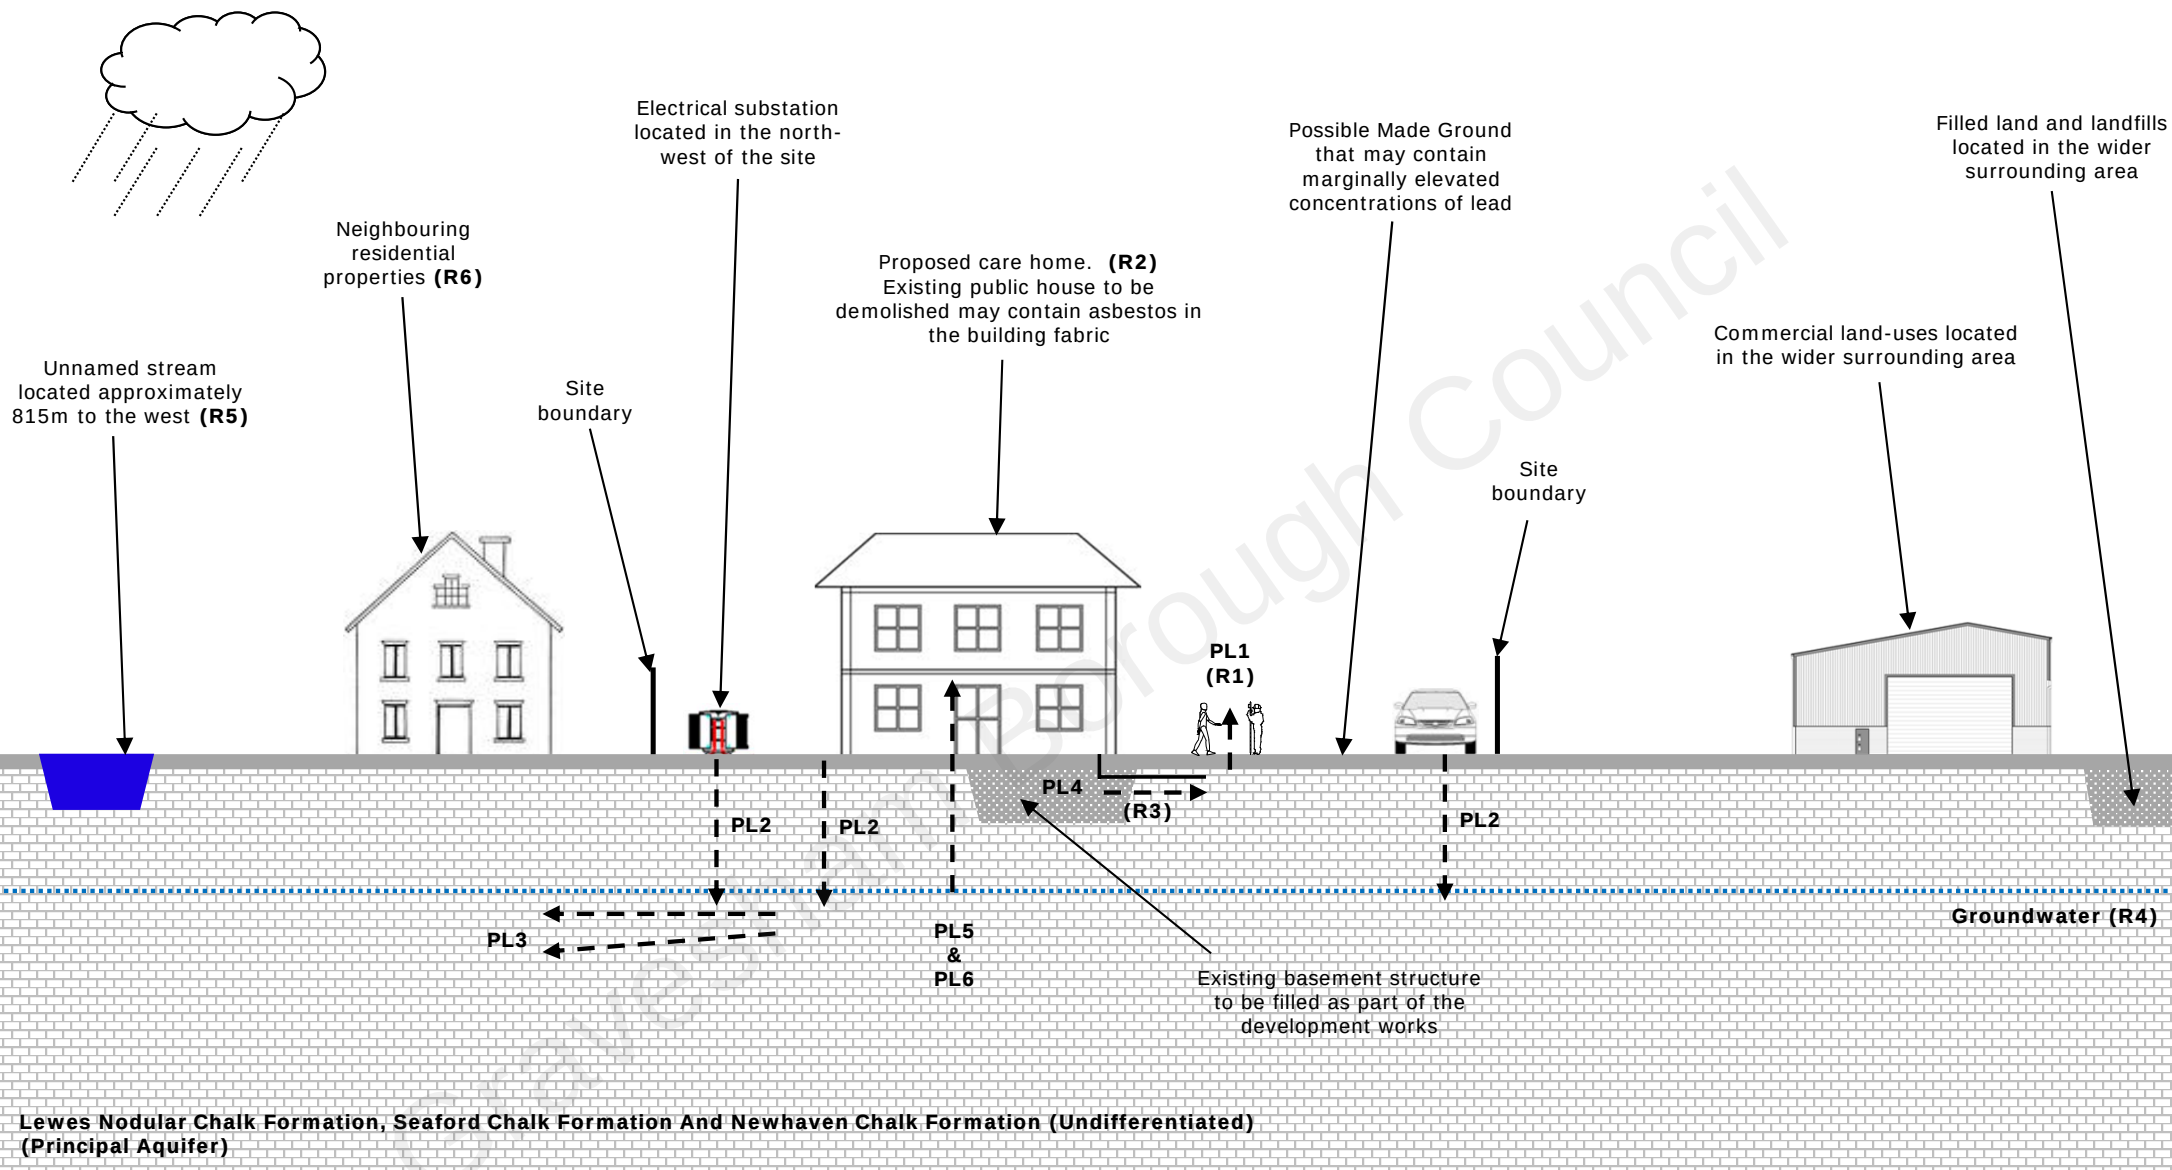
| Drawing No. | Figure 3 |

| Drawing Name | Conceptual Site Model |

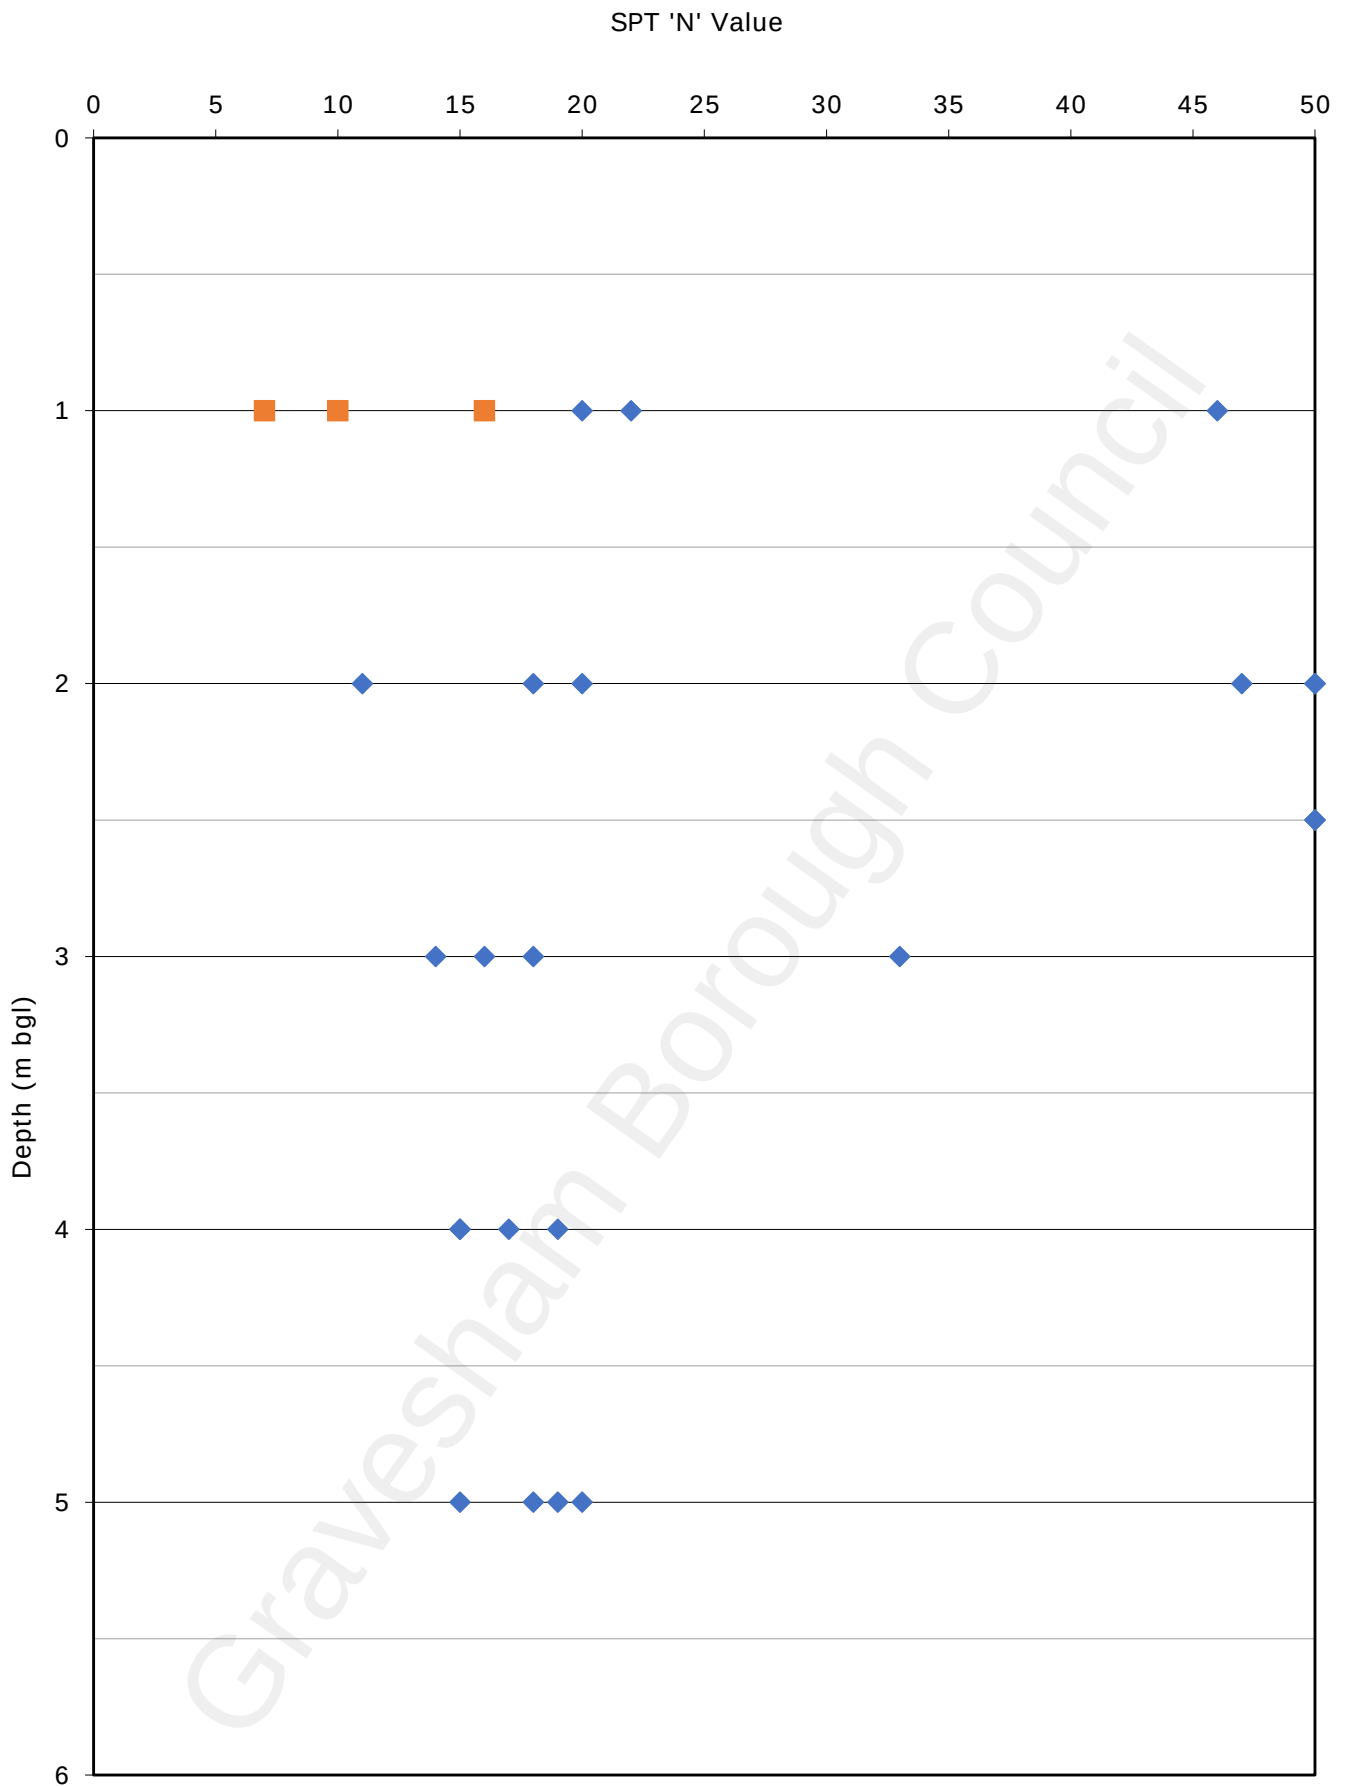
| Drawing Name | <b>SPT 'N' Value Versus Depth Below Ground Level</b> | | | |

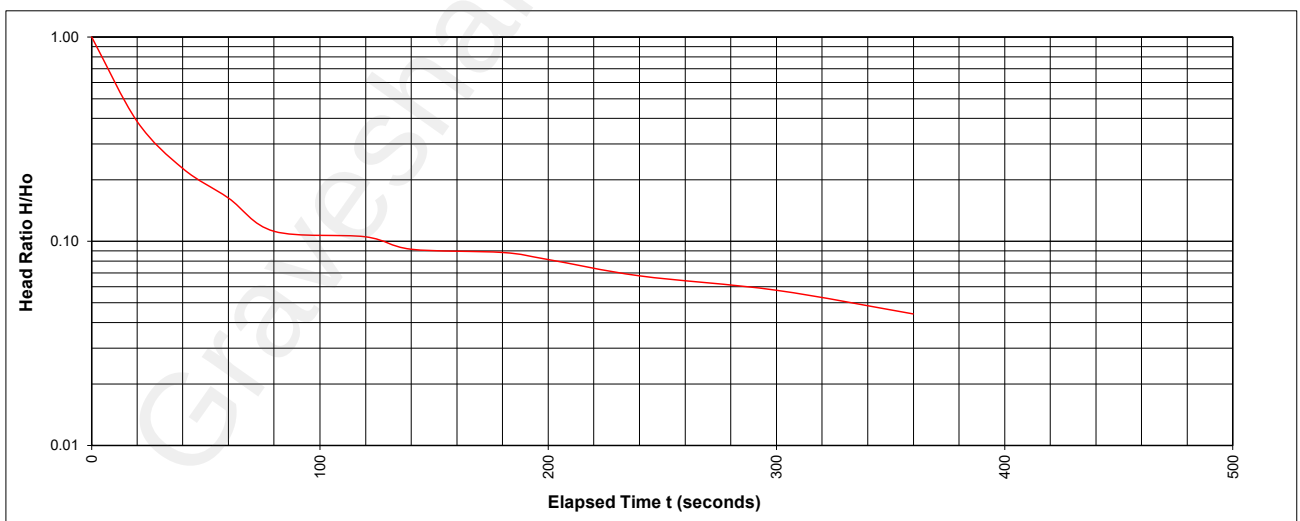
| Permeability (k) - General Method | 4.22E-06 | m / s |

**Installation surcharged with approximately 30 litres of water in approximately 160 seconds.**

The falling head permeability tests recorded infiltration rates between  $4.22 \times 10^{-6}$  m/s and  $1.58 \times 10^{-4}$  m/s at WS1 and WS6 respectively.

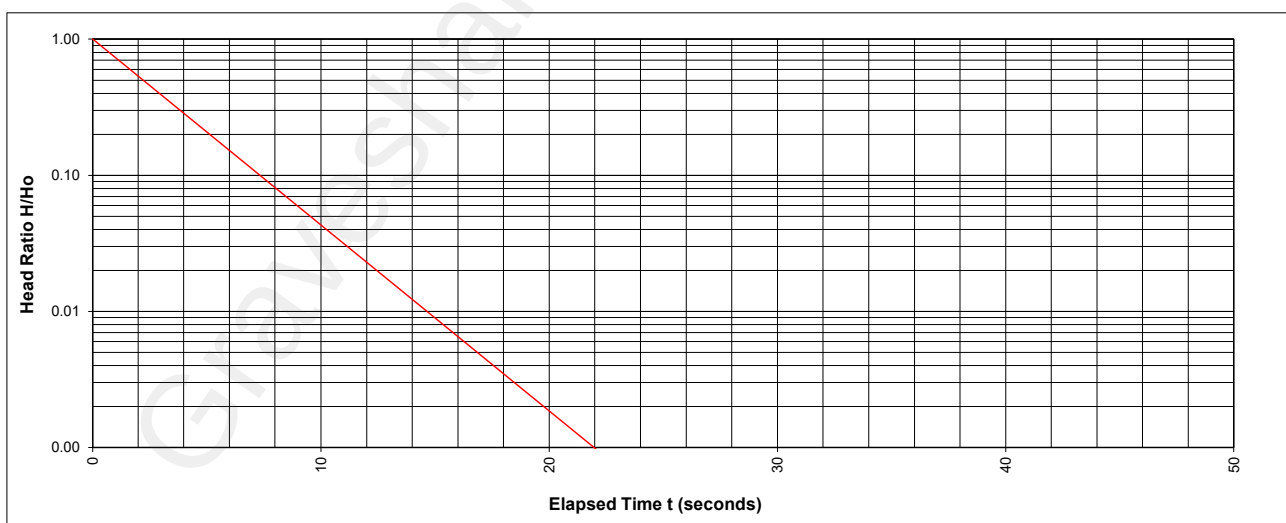
| Permeability (k) - General Method | 1.58E-04 | m/s |

**Installation surcharged with approximately 30 litres of water in approximately 160 seconds.**

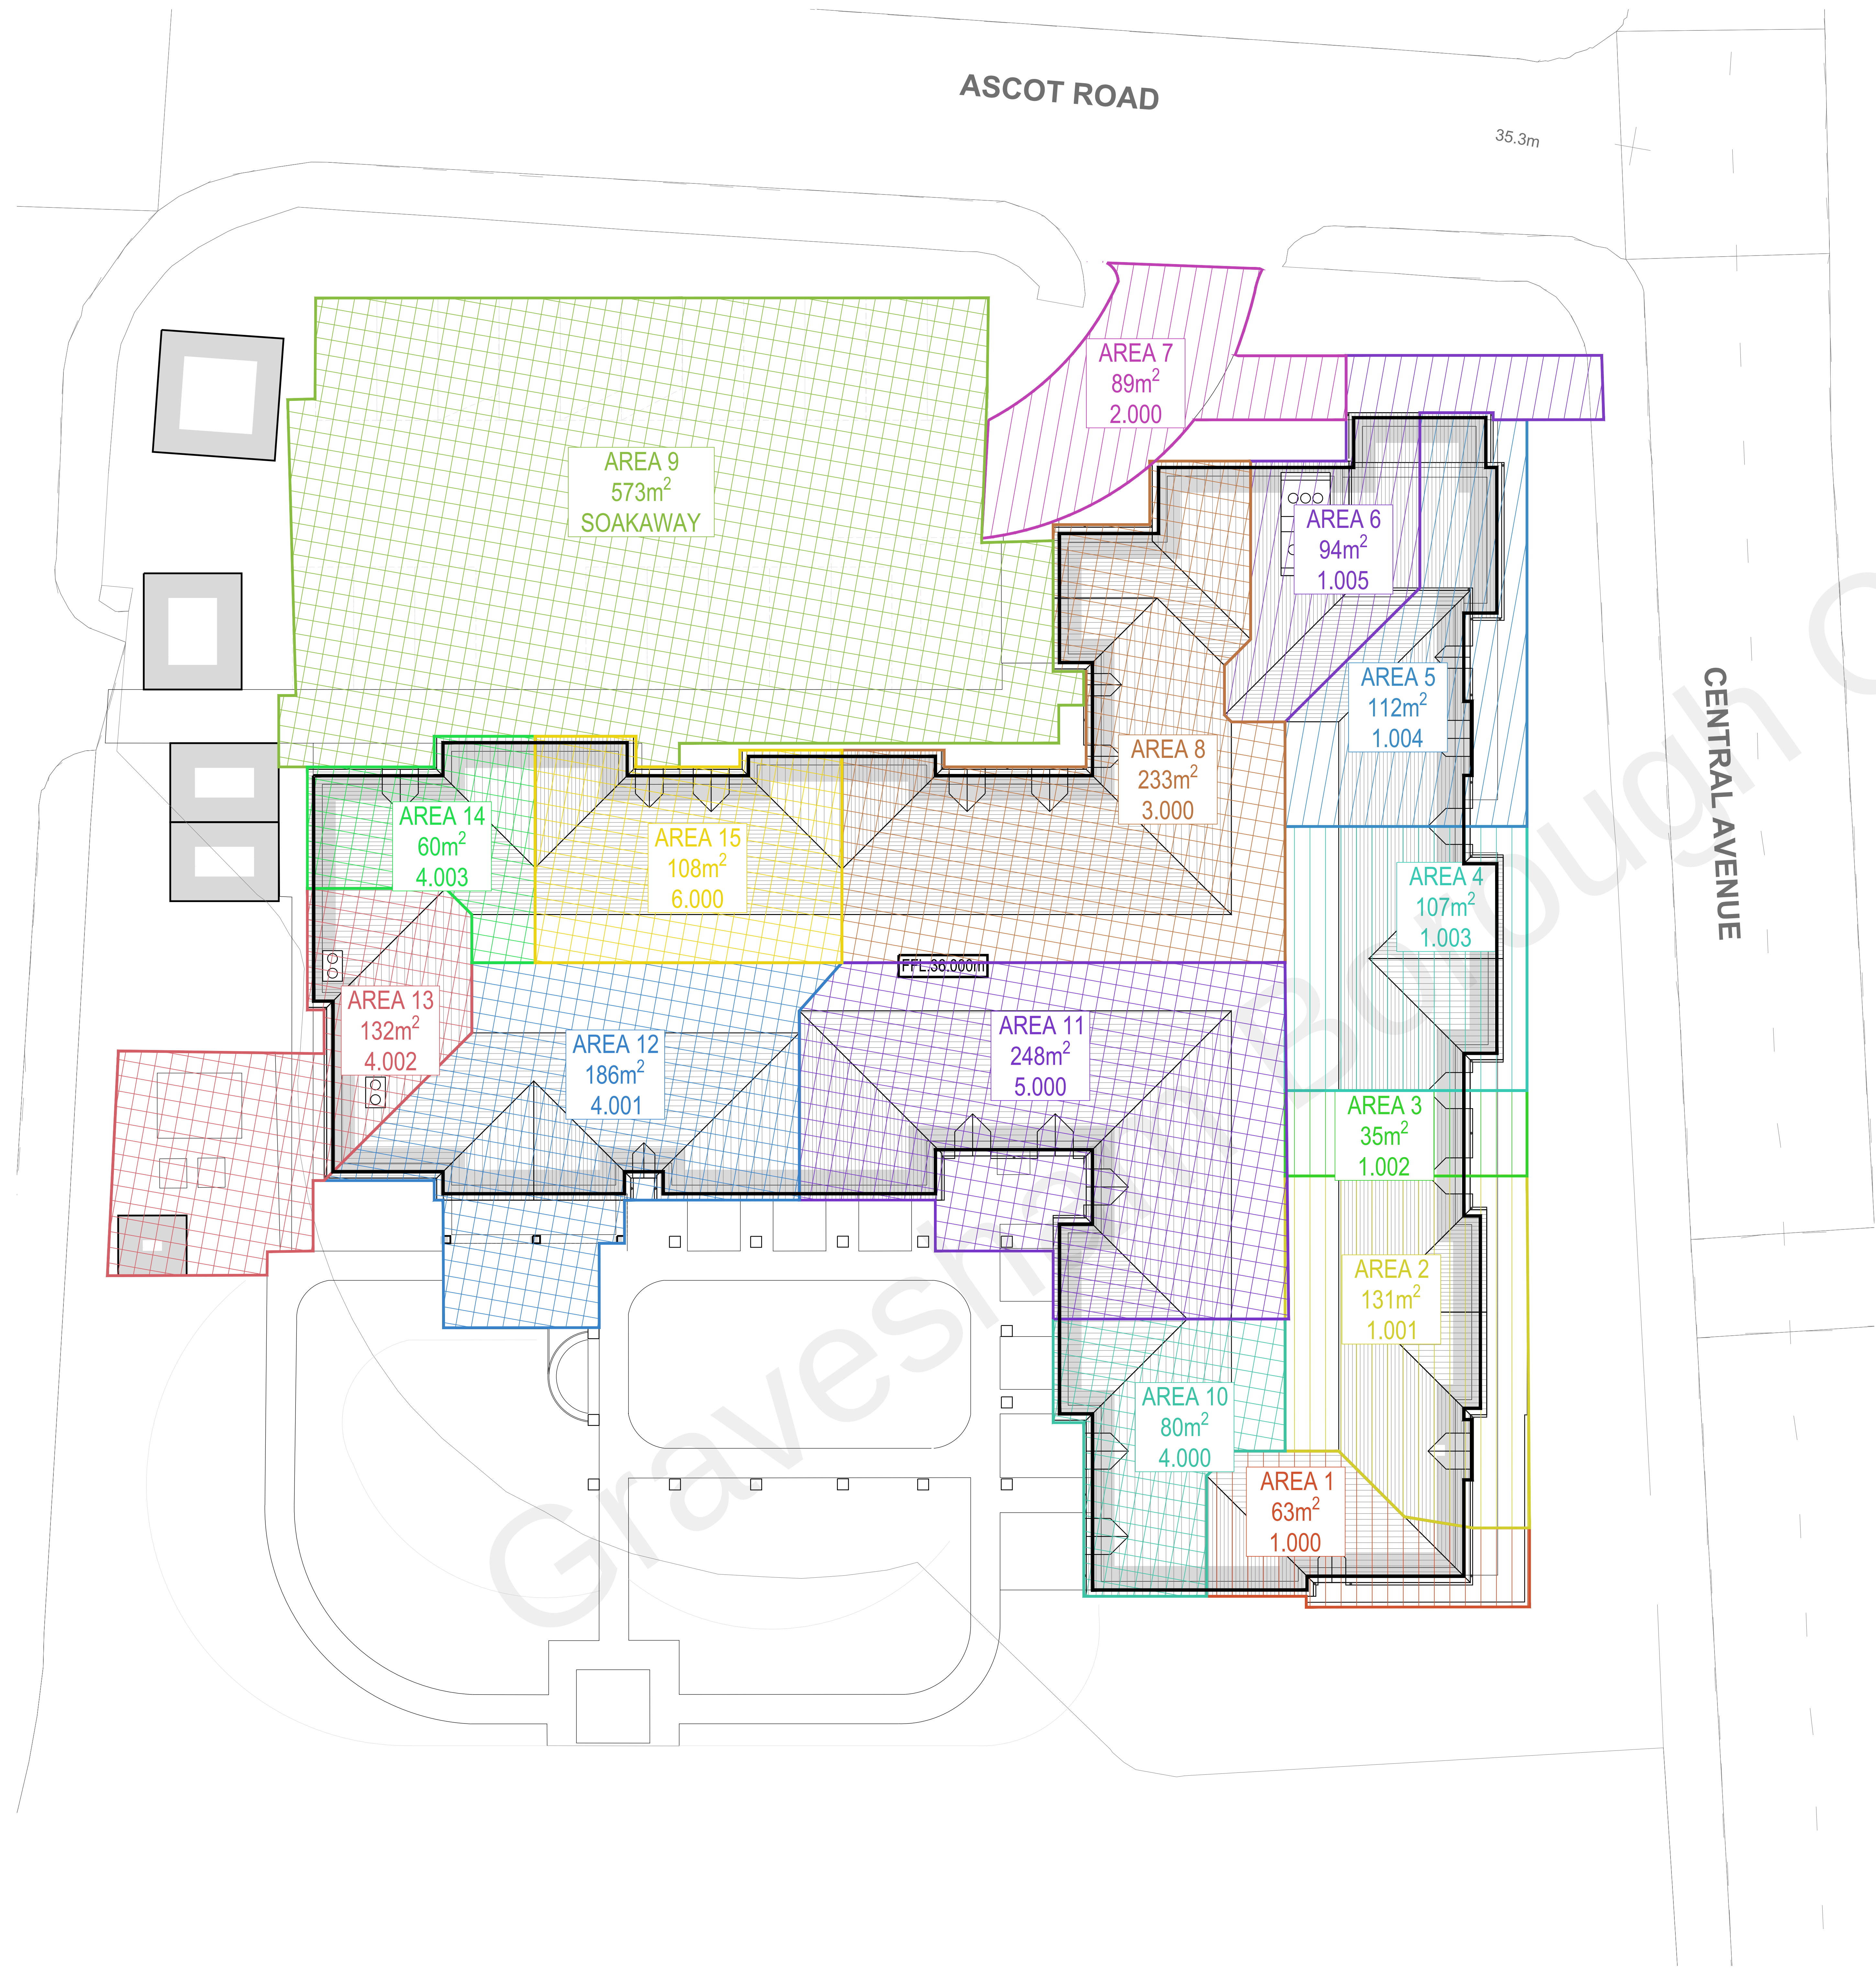
**APPENDIX D – MICRO DRAINAGE DESIGN CALCULATIONS AND  
DRAINAGE AREA PLAN**

- DRAINAGE AREA 1 - 1.000 - 63m<sup>2</sup>
- DRAINAGE AREA 2 - 1.001 - 131m<sup>2</sup>
- DRAINAGE AREA 3 - 1.002 - 35m<sup>2</sup>
- DRAINAGE AREA 4 - 1.003 - 107m<sup>2</sup>
- DRAINAGE AREA 5 - 1.004 - 112m<sup>2</sup>
- DRAINAGE AREA 6 - 1.005 - 94m<sup>2</sup>
- DRAINAGE AREA 7 - 2.000 - 89m<sup>2</sup>
- DRAINAGE AREA 8 - 3.000 - 233m<sup>2</sup>
- DRAINAGE AREA 9 - SOAKAWAY - 573m<sup>2</sup>
- DRAINAGE AREA 10 - 4.000 - 80m<sup>2</sup>
- DRAINAGE AREA 11 - 5.000 - 248m<sup>2</sup>
- DRAINAGE AREA 12 - 4.001 - 186m<sup>2</sup>
- DRAINAGE AREA 13 - 4.002 - 132m<sup>2</sup>
- DRAINAGE AREA 14 - 4.003 - 60m<sup>2</sup>
- DRAINAGE AREA 15 - 6.000 - 108m<sup>2</sup>

TOTAL - 2251m<sup>2</sup>
