## **SUMMARY DRAINAGE REPORT**

## **APPENDIX B – GROUND INVESTIGATION REPORT**

# **GROUND INVESTIGATION LAND AT CENTRAL AVENUE GRAVESEND**

**ASL Report No. 002-21-719-10**

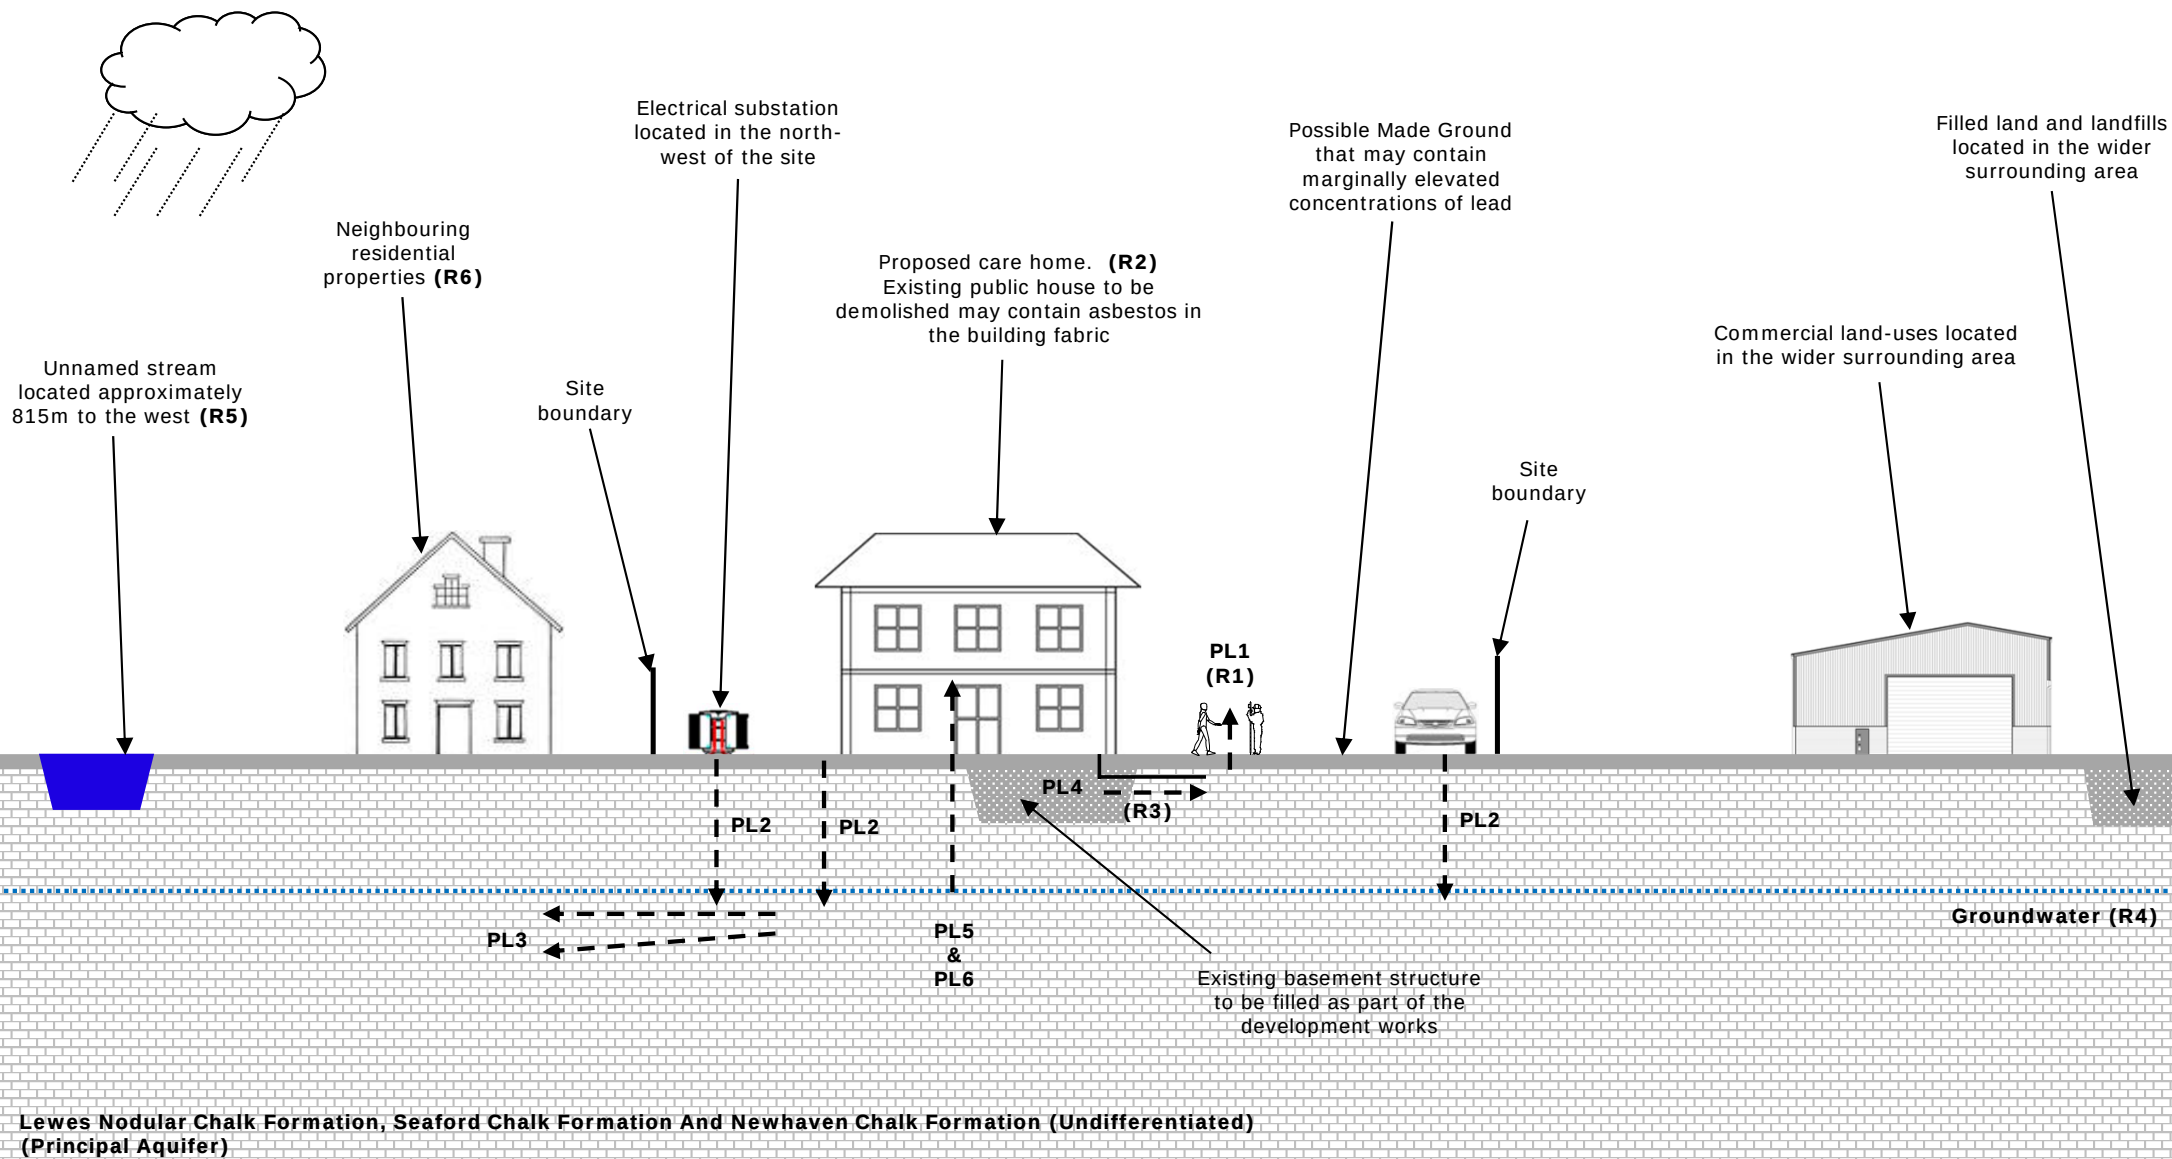
| Drawing No. | Figure 3 |

| Drawing Name | Conceptual Site Model |

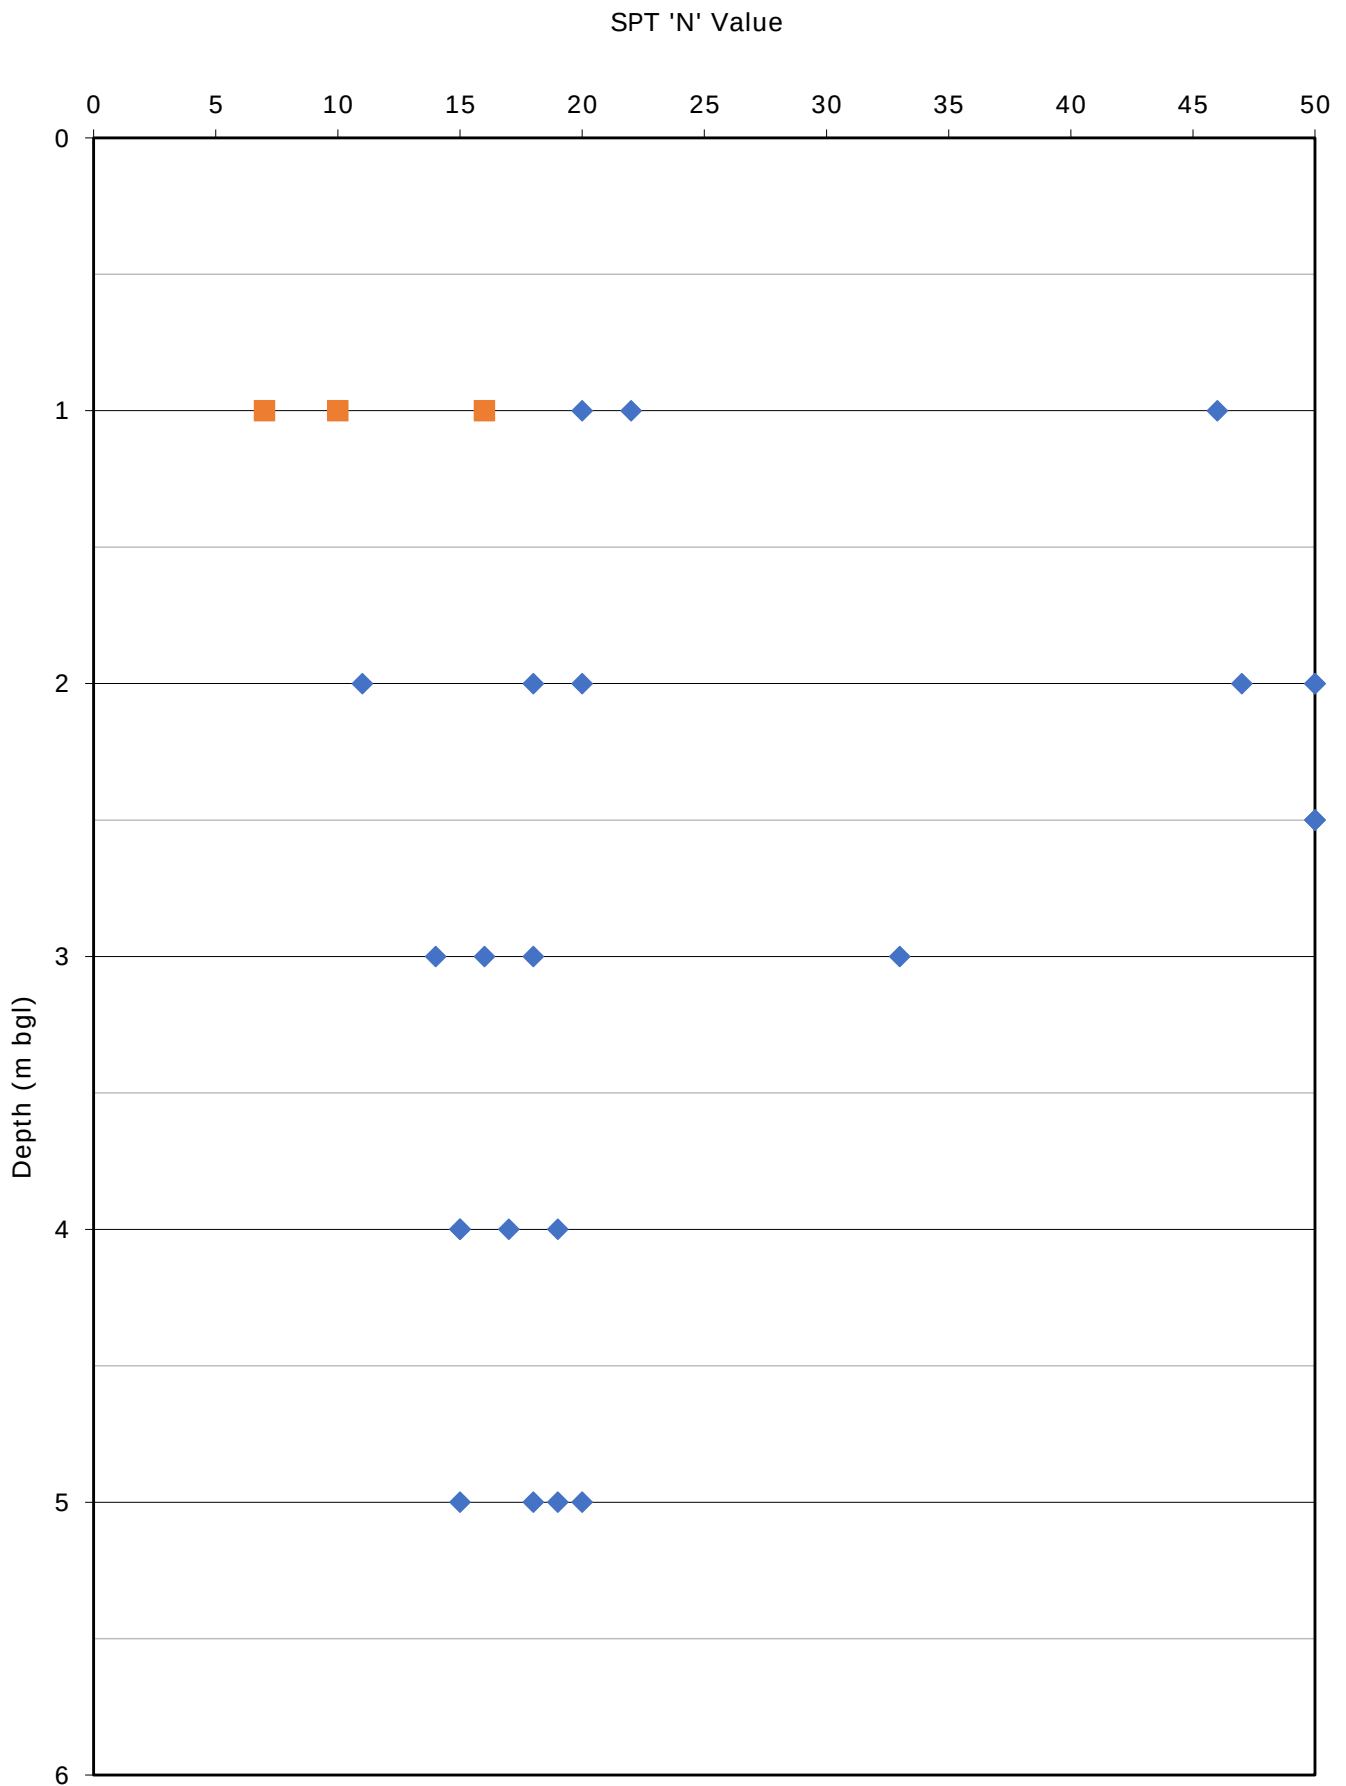
| Drawing Name | <b>SPT 'N' Value Versus Depth Below Ground Level</b> | | | |

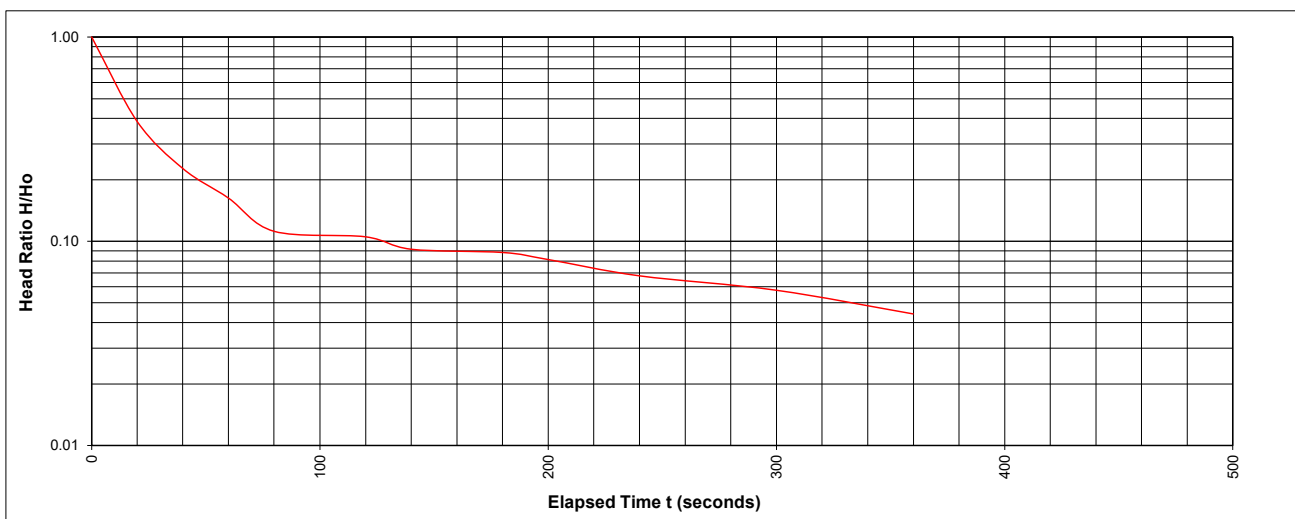
| Permeability (k) - General Method | 4.22E-06 | m / s |

**Installation surcharged with approximately 30 litres of water in approximately 160 seconds.**

The falling head permeability tests recorded infiltration rates between  $4.22 \times 10^{-6}$  m/s and  $1.58 \times 10^{-4}$  m/s at WS1 and WS6 respectively.

Falling head permeability tests were completed at all monitoring installations on 10<sup>th</sup> March 2022. The falling head permeability tests recorded infiltration rates between  $4.22 \times 10^{-6}$  m/s and  $1.58 \times 10^{-4}$  m/s at WS1 and WS6 respectively.

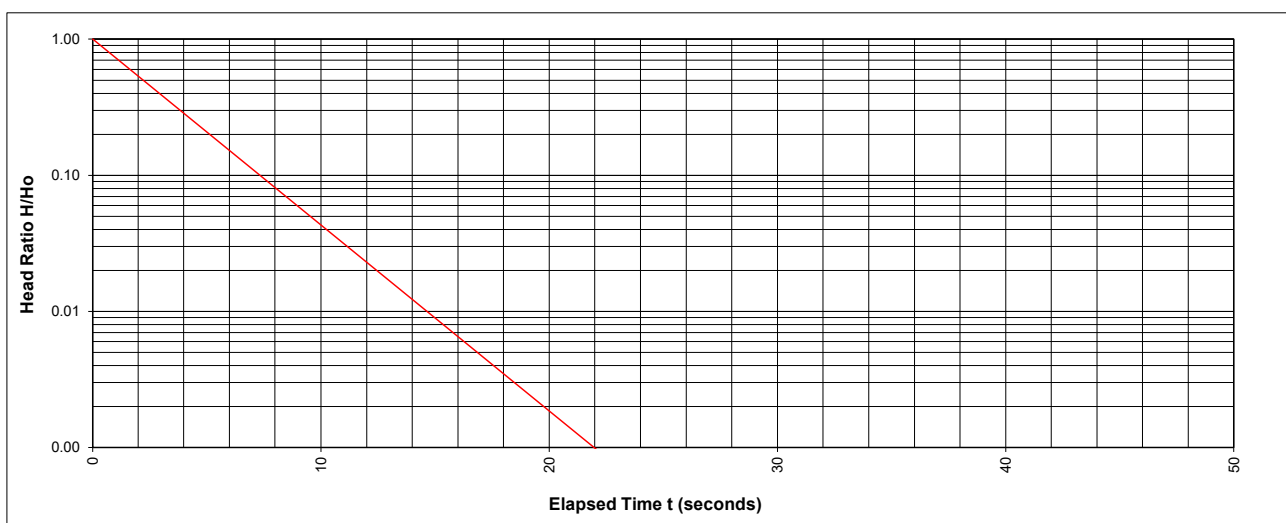
| Permeability (k) - General Method | 1.58E-04 | m/s |

**Installation surcharged with approximately 30 litres of water in approximately 160 seconds.**

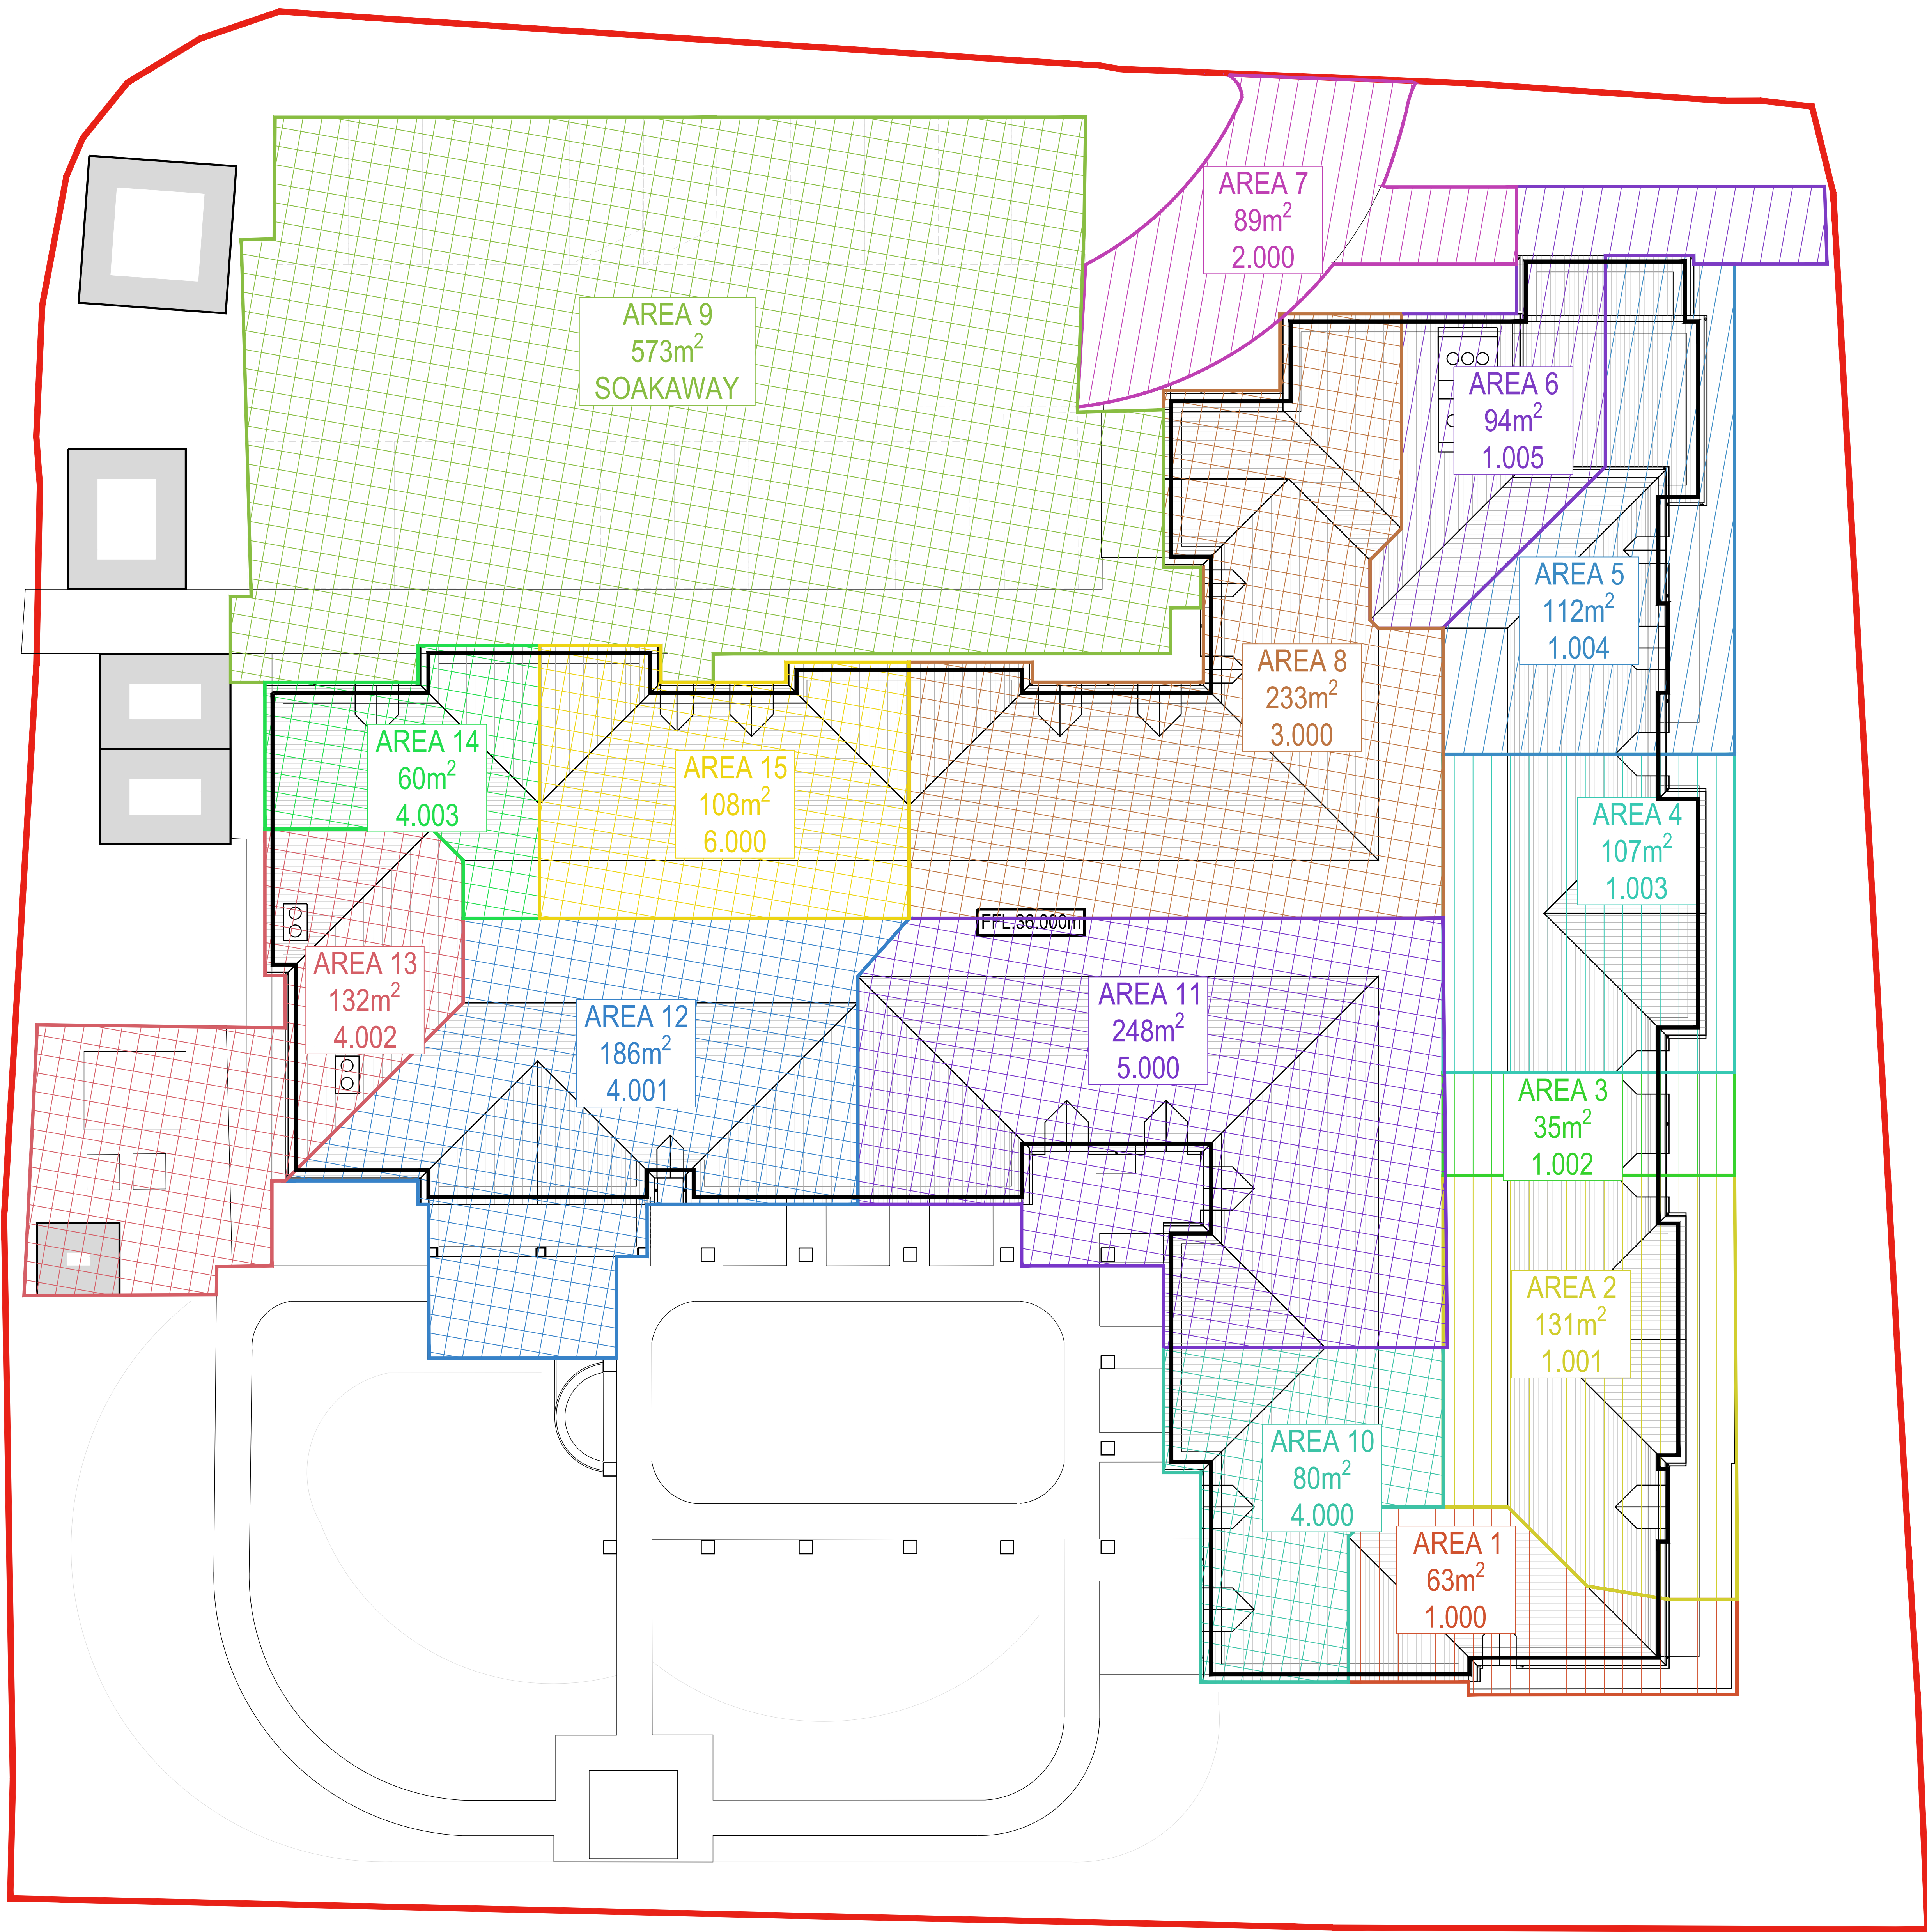
22 026 - ARC - XX - XX - DR - D - 0503 - T2

- DRAINAGE AREA 1 - 1.000 - 63m<sup>2</sup>
- DRAINAGE AREA 2 - 1.001 - 131m<sup>2</sup>
- DRAINAGE AREA 3 - 1.002 - 35m<sup>2</sup>
- DRAINAGE AREA 4 - 1.003 - 107m<sup>2</sup>
- DRAINAGE AREA 5 - 1.004 - 112m<sup>2</sup>
- DRAINAGE AREA 6 - 1.005 - 94m<sup>2</sup>
- DRAINAGE AREA 7 - 2.000 - 89m<sup>2</sup>
- DRAINAGE AREA 8 - 3.000 - 233m<sup>2</sup>
- DRAINAGE AREA 9 - SOAKAWAY - 573m<sup>2</sup>
- DRAINAGE AREA 10 - 4.000 - 80m<sup>2</sup>
- DRAINAGE AREA 11 - 5.000 - 248m<sup>2</sup>
- DRAINAGE AREA 12 - 4.001 - 186m<sup>2</sup>
- DRAINAGE AREA 13 - 4.002 - 132m<sup>2</sup>
- DRAINAGE AREA 14 - 4.003 - 60m<sup>2</sup>
- DRAINAGE AREA 15 - 6.000 - 108m<sup>2</sup>

TOTAL - 2251m<sup>2</sup>

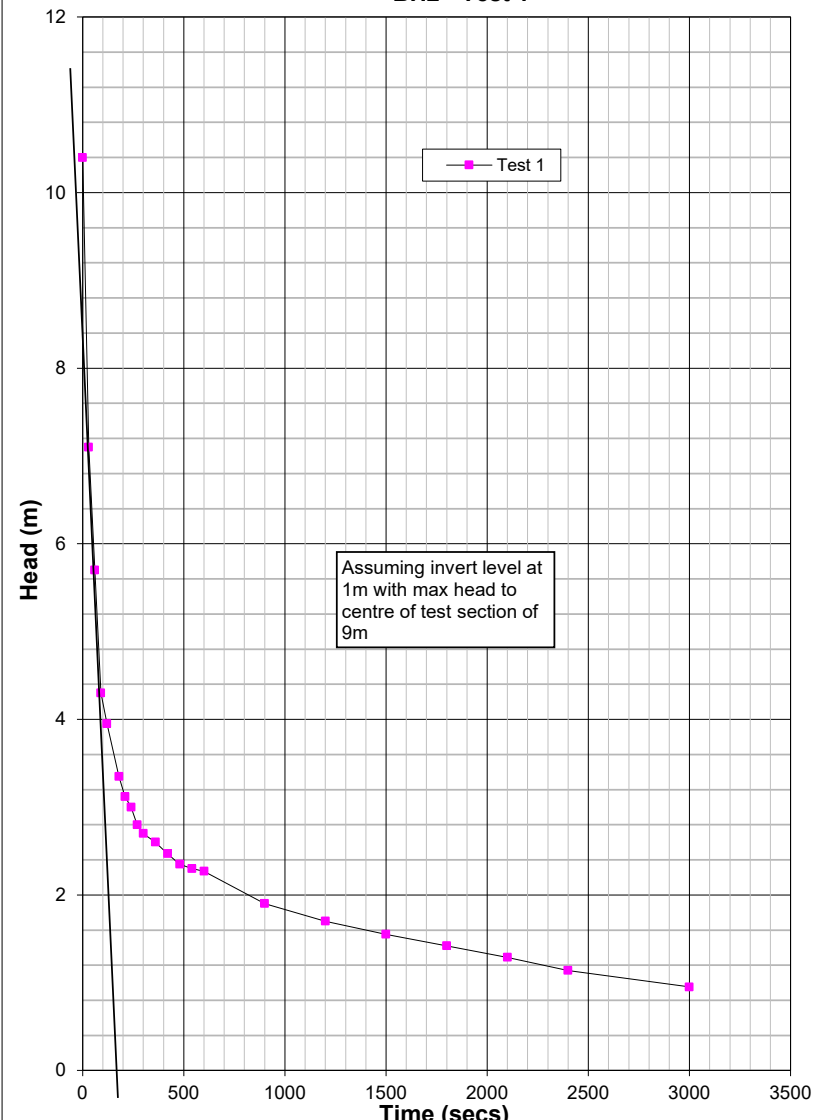
**BH2 - Test 1**

| METHODOLOGY IN ACCORDANCE WITH KCC SOAKAWAY DESIGN GUIDE, JULY 2000. | | | | | | | | | |
| <b>Soakage Rate:</b> | $250 \cdot H_p \cdot d^2$ | <b>Hp</b> | 9.2 | m | <b>th</b> | 3 | mins | | |

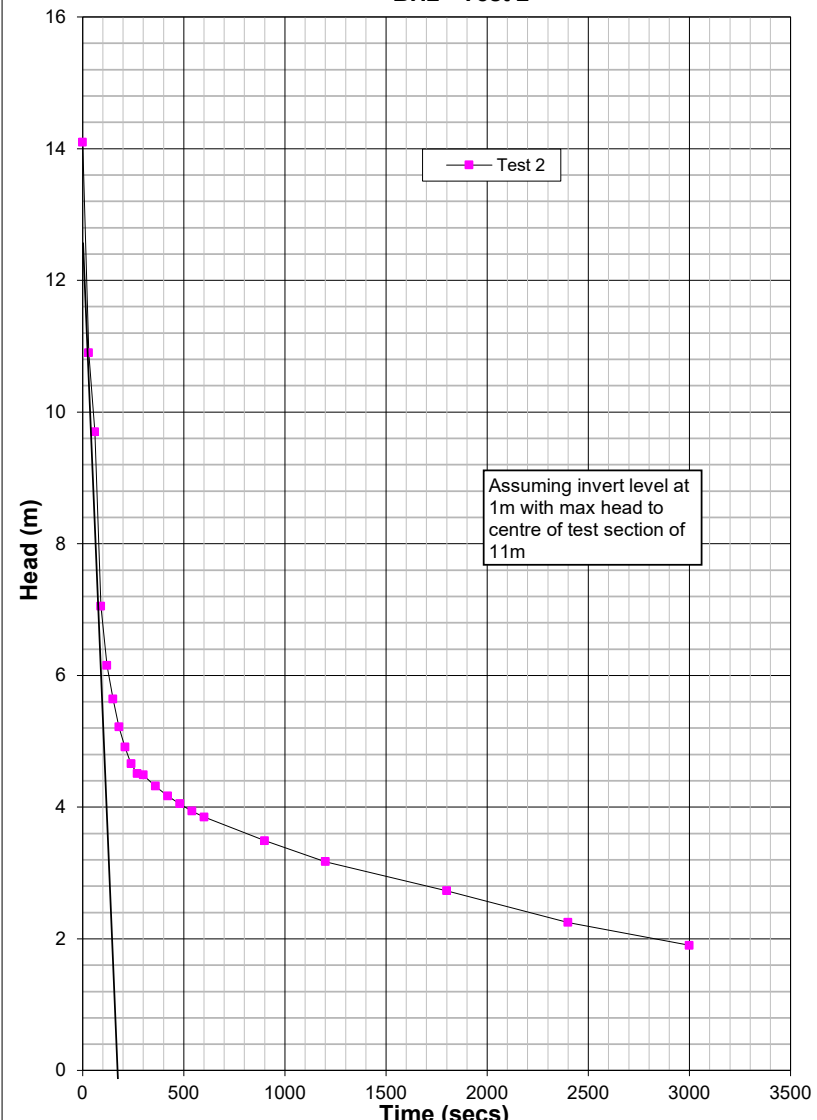
**BH2 - Test 2**

METHODOLOGY IN ACCORDANCE WITH KCC SOAKAWAY DESIGN GUIDE, JULY 2000.

| <b>Soakage Rate:</b> | $250 \cdot H_p \cdot d^2$ | $H_p$ | 12 | m | th | 3.5 | mins |
