**CUSTOM HOUSE, THE TERRACE, GRAVESEND, DA12 2BW**

**REPAIR WORKS TO SPINE WALL IN CONNECTION WITH DEMOLITION OF WORKSHOP BUILDING**

This statement formally sets out the methodology details of all repair works to the spine wall following the demolition of the adjoining workshop building.

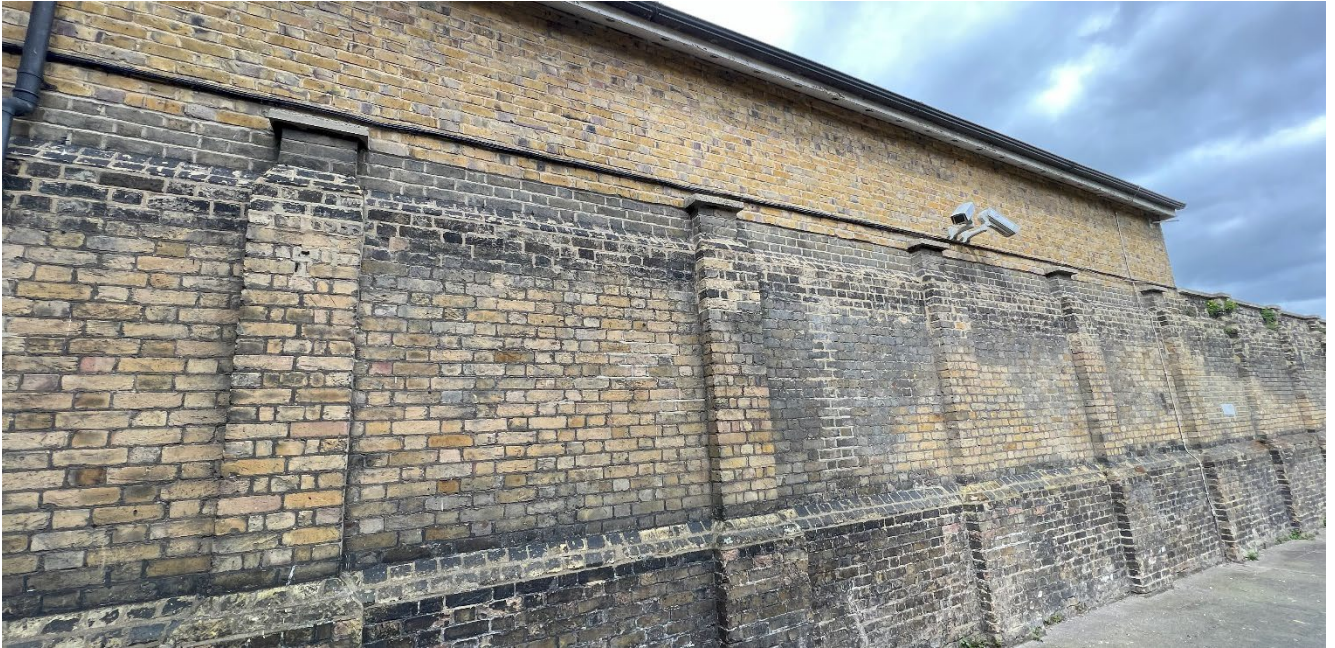
*Image of existing workshop built off the spine wall. Clear delineation between existing spine wall and workshop building.*

Carefully demolish all works connected to the spine wall as per demolition drawing information provided.

Carefully dismantle the brickwork built on top of the existing spine brickwork wall down to existing wall level.

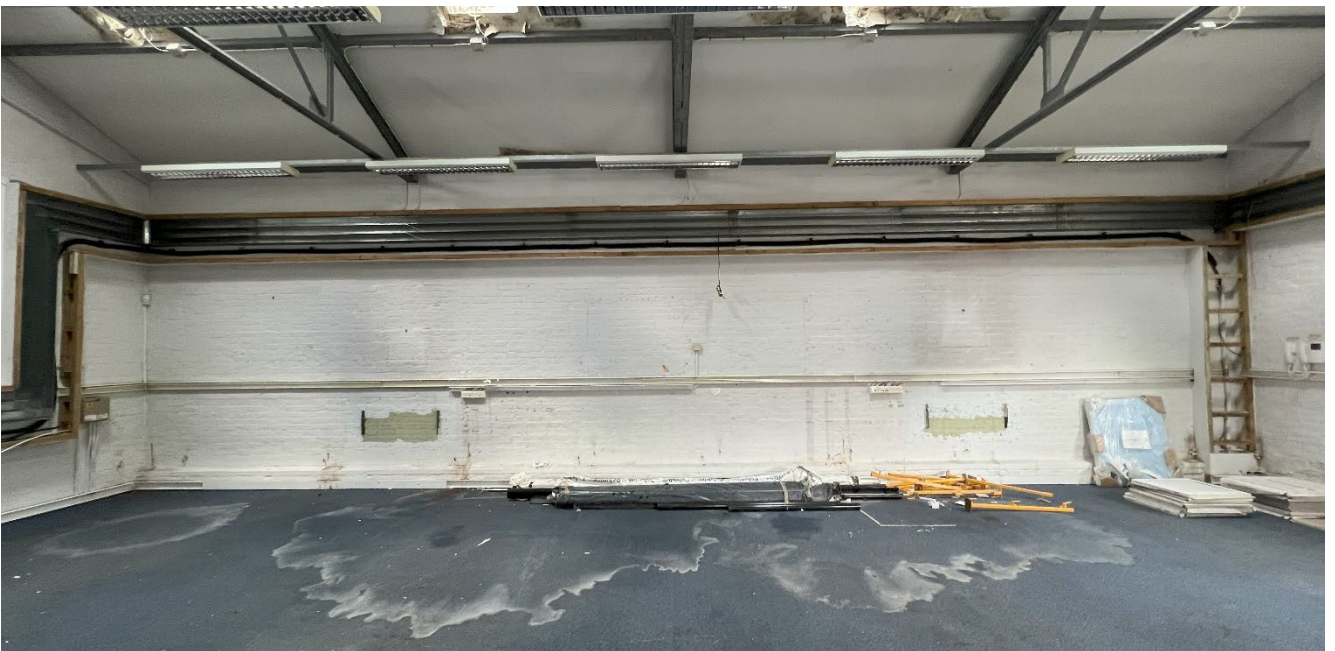
*Image of spine wall from inside workshop building.*

Once workshop building has been demolished and wall over the spine wall is dismantled to existing level, a full inspection of the wall from the workshop side is to be undertaken.

Existing wall to be cleaned of any debris and build up of dirt to fully establish condition of wall. Wire brush or similar to be utilised to gauge extent of paint removing required.

Following cleaning and inspection, a paint removal treatment is required to remove the white painted section of wall to original brick colour. Types of paint removal listed below in order of abrasiveness:

Dependant on stubbornness of the white paint, it is intended to use the least abrasive option to remove it, to maintain the integrity of the existing brickwork and avoid any further damage to the wall during the cleaning process.

Once clear of paint, the brickwork can be re-inspected to establish if any cracked or broken brickwork needs to be cut out and replaced with matching brickwork bedded in lime mortar to match existing.

Areas of old/ damaged mortar that requires repointing to have old mortar joints raked out. After removal of existing mortar, joints to be thoroughly cleaned and wetted immediately before filling. Mortar joint finish to be as per existing appearance of spine wall.

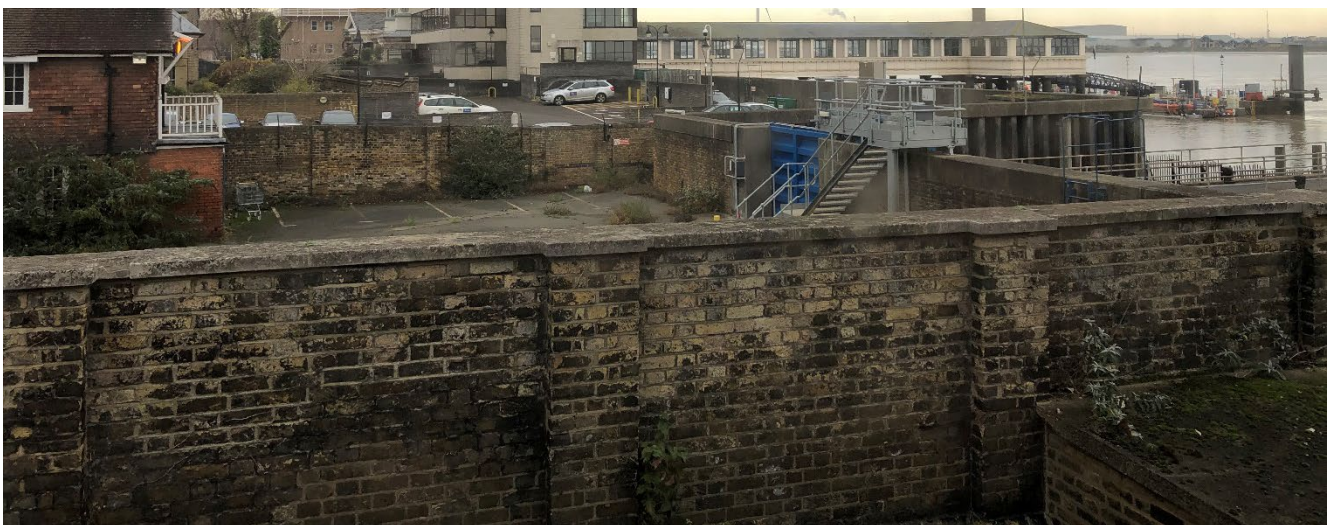
*Image of stone coping to spine wall.*

New Portland stone coping to match rest of spine wall to be installed on top of this section of wall.
