**Planning Statement and Design & Access Statement**  
**Refurbishment works to Royal Terrace Pier,**  
**Royal Pier Road, Gravesend**

**November 2022**

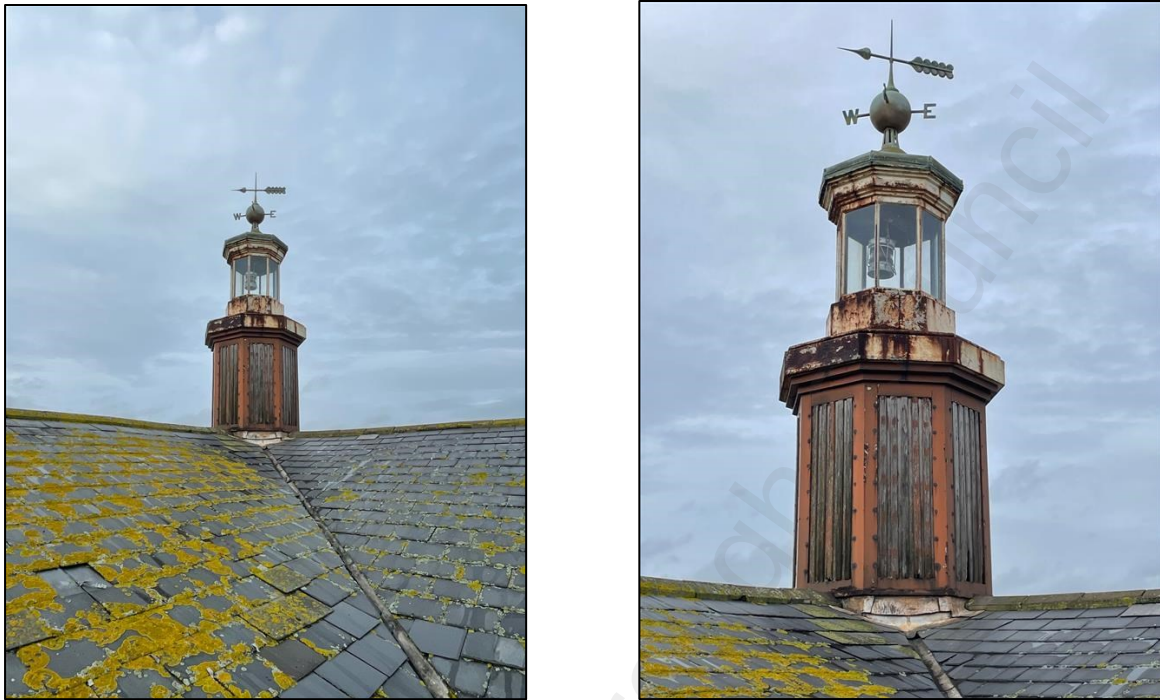
**Figure 1: Images of existing condition of Turret**

4.1. The existing lighthouse turret is in urgent need of repair and it is proposed for refurbishment and redecoration to be carried out.

4.2. It is therefore proposed to carry out the following works:

- The existing weather vane will be carefully removed and set aside for repair and reinstallation;
- The existing copper sheet roof will be replaced with like for like new copper sheeting;
- The lighthouse cast iron cornice will be repaired and redecorated, this includes the cast iron window lintels, mullions and cills. The turret plinth cast iron posts, lintels and cill panels will also be repaired and redecorated, with new corrugated steel sheet infill panels to match the existing.; and
- Existing fittings, electrical wiring and accessories inside the Turret will be disconnected, removed and reinstalled once refurbishment is completed.

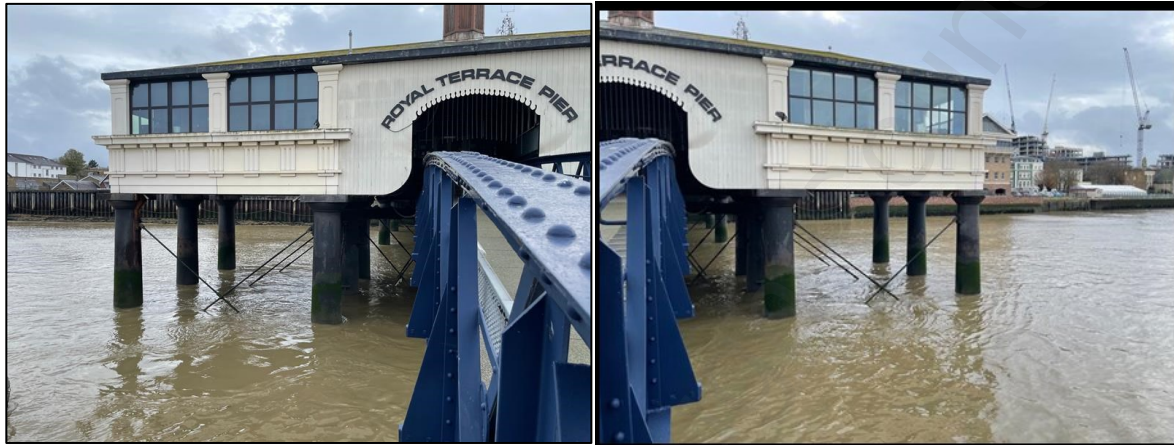
**Figure 2: Proposed netting area.**

5.1. New anti-bird netting is proposed to be installed as part of the refurbishment works. During the works the existing anti-bird netting currently installed above the deck will be maintained whilst the below deck works are carried out to deter dislodged pigeons from entering the Pier Head, once the new netting is installed the redundant netting will be removed.

5.2. It is therefore proposed that stainless steel netting as a complete enclosure with sides, spanning between the main iron girders from the bays on the line of the stairs to the river end of the Pier will be installed as shown on drawings 353006/EX/107, supported on new stainless steel perimeter carrier wires and cleats, in order to prevent pigeons roosting on exposed ledges.

5.3. The pigeon deterrent netting will be provided to the following areas of the Pier Head: soffit excluding moving gangway; side galleries & soffit of roof, with zip access provided to galleries. Netting to be fabricated in 316 grade stainless steel suitable for the semi-marine environment.

5.3. The existing anti-pigeon spikes will remain in place unless they interfere with the installation of the new frames and prior to the works all guano will be cleared from the work area. Perimeter support wires will be fixed at the level of the bottom flange of the main girders and on top of the existing column capitals and cross braces. The location of the proposed netting will therefore prevent pigeons roosting on exposed ledges.

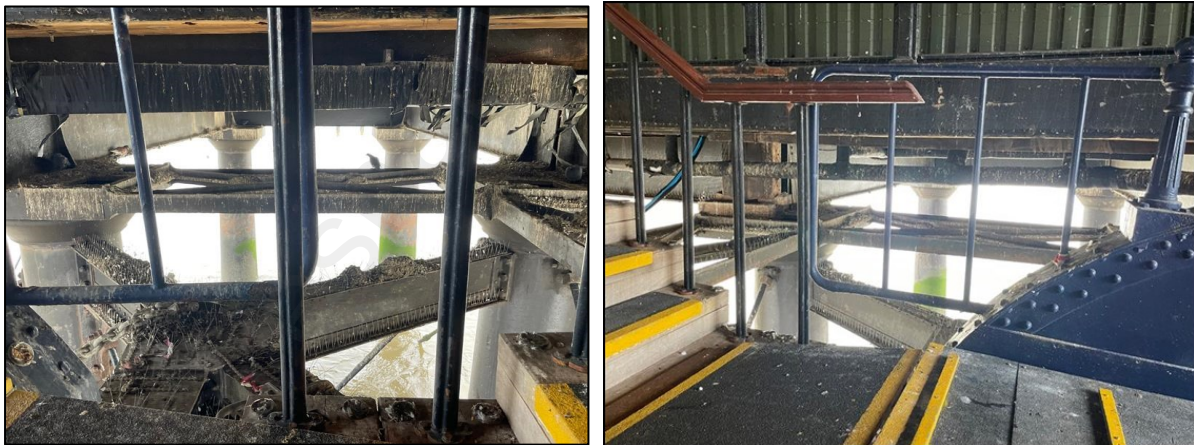
**Figure 3: Existing condition underside of pier 1**

5.2 This is required as the proposed areas are in a poor state, partly due to the open access which has resulted in some health and safety concerns, as can be seen from the images below:

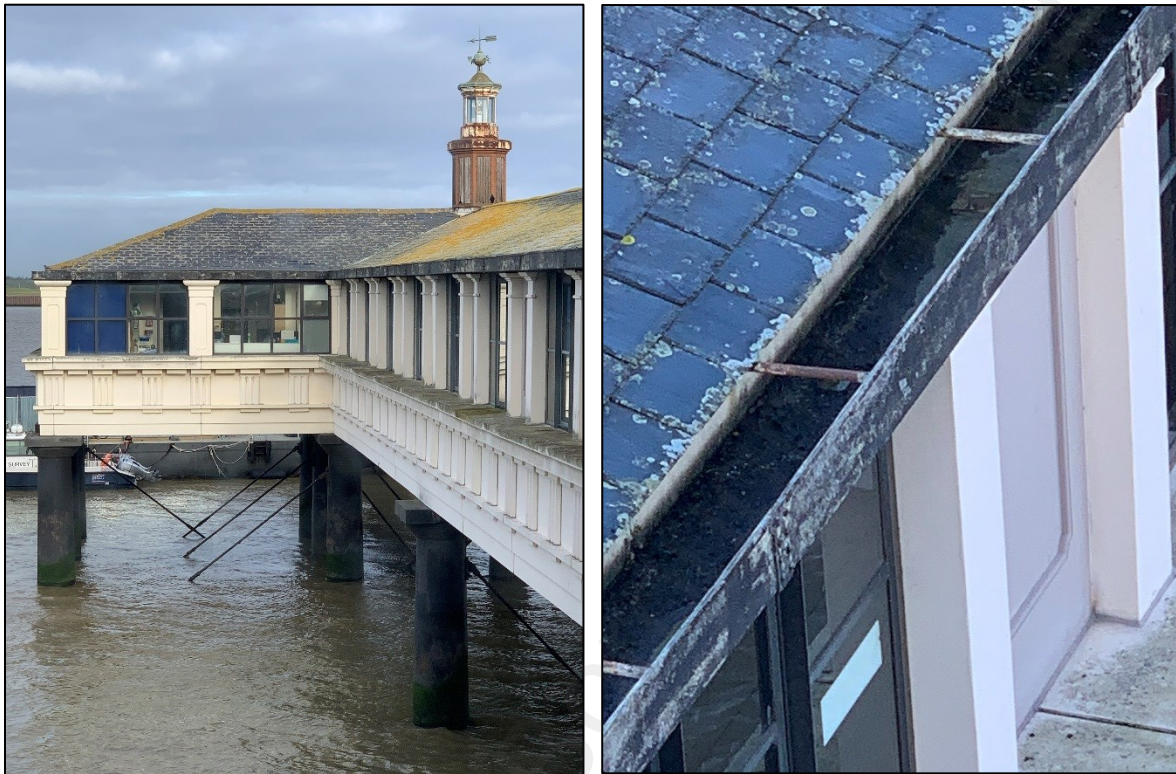
**Figure 5. Royal Terrace Pier existing design**

enable an operative to work externally over river/foreshore with considerable tidal range in a semi-marine environment. There are existing fall arrest fixings located in the underside of the cast iron gutter. However, these are not considered to be structurally adequate to attach a harness or other potentially load bearing equipment. The images below highlight how the site construction constrains what can be done:

6.3. These show there are ties across the top of the gutter at regular intervals that would prevent the safety line from running uninterrupted if the support cable was inside the gutter. It is also considered that a support cable running above the gutter and supported on brackets would not be sufficiently stable. A further consideration is that the support cable needs to be in a place where it is possible to reach it safely to attach and detach the safety harness. A location inside or above the gutter precludes this.

6.4. An alternative option was to potentially locate the support cable on the soffit of the gutter but it has been considered that this would be intrusive, interrupting views of the column head and capital on the promenade cladding.

6.5. It is therefore proposed to add a continuous horizontal rail mounted on the outer vertical face of galvanized steel box gutter to provide access to perimeter of the pier (180m). Access to the rail from land at the east end of pier on north and south sides and via 8No transfer anchor points and windows.

The fall arrest system will be formed of 3M Unirail system Black powder coated aluminium rail in 3m long sections attached to front face of black finish galvanized steel gutter to allow access for gutter & window cleaning & facade maintenance. A black powder coated finish has been proposed for the support cable and fixing cleats, so that these have minimal impact when seen against the backdrop of the gutters and it is considered that this reflects the optimal solution at the pier.
