**Window Schedule v2 March 2026**

**Boughurst Farm, Meopham** ( refer to elevations for window locations and joinery details)

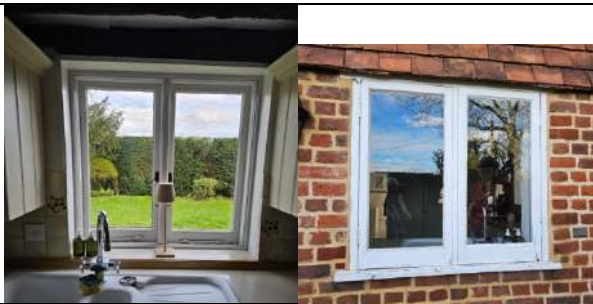
| Item no. | Image | Description | Proposed development |
|---|---|---|---|
| WG01<br>Existing kitchen | | Mullioned timber 2-light casement<br>2 opening<br>Single glazed<br>Circa mid-late C20th<br>No evidence in brickwork of Queen's closers | To be removed and enlarged to form doorway |

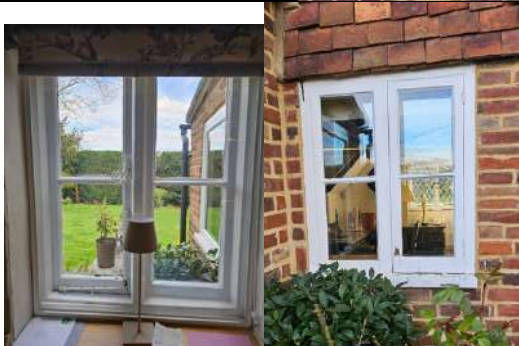
| Item no. | Image | Description | Proposed development |
|---|---|---|---|
| WG02<br>Existing dining room | | Mullioned timber 2-light casement<br>1 fixed, 1 opening<br>Single glazed<br>Single horizontal glazing bar<br>Circa mid-late C20th<br>No evidence in brickwork of Queen's closers | Retain and board over to both sides |

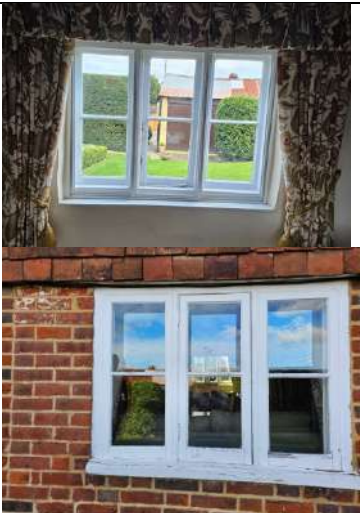
| <p>WG03<br/>Existing living room</p> | | | <p>Mullioned timber 3-light casement<br/>2 fixed, 1 opening<br/>Single glazed<br/>Single horizontal glazing bar<br/>Circa C19th<br/>No evidence in brickwork of Queen's closers<br/>Evidence of earlier openings in brickwork</p> | <p>Retain and refurbish</p> |

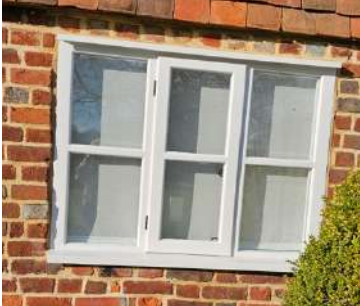
| <p>WG04</p> | | | <p>Mullioned timber 3-light casement<br/>2 fixed, 1 opening<br/>Single glazed<br/>Single horizontal glazing bar<br/>Circa late C20th<br/>No evidence in brickwork of Queen's closers</p> | <p>No change</p> |

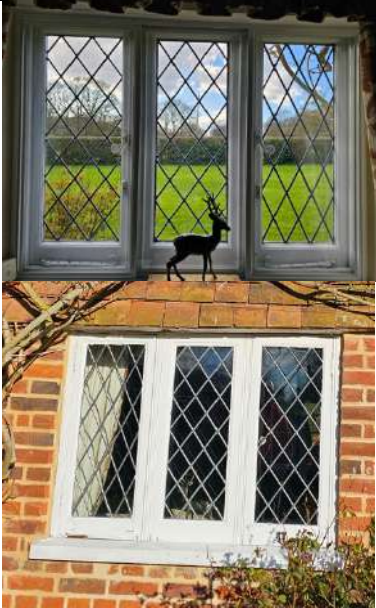
| WG05 | | | <p>Mullioned timber 3-light casement<br/> 2 opening, 1 fixed<br/> Single glazed with leaded lights diamond pattern<br/> Circa C19th timber frame with mid C20th timber casements containing diamond pattern leaded lights<br/> Queen's closers suggest original opening contemporary to brickwork?</p> | <p>Replace with hardwood frame with metal casements with diamond pattern leaded lights</p> |

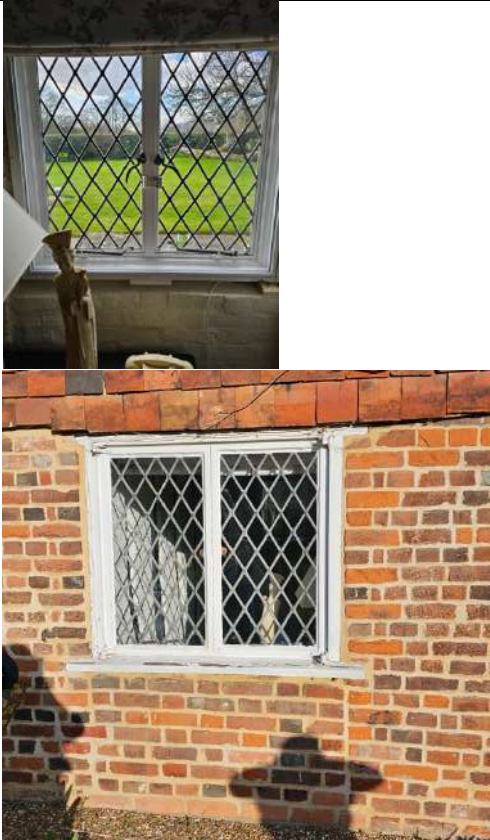
| <p>WG06</p> | | <p>Mullioned 2-light steel Crittall-style casement in timber sub-frame<br/> 2 opening lights<br/> Single glazed with leaded lights diamond pattern<br/> Circa early to mid C20th<br/> Rebuilt brickwork with Queen's closers and evidence of earlier door opening suggests position not original .</p> | <p>Reposition centrally in room with hardwood frame with metal casements with diamond pattern leaded lights</p> |

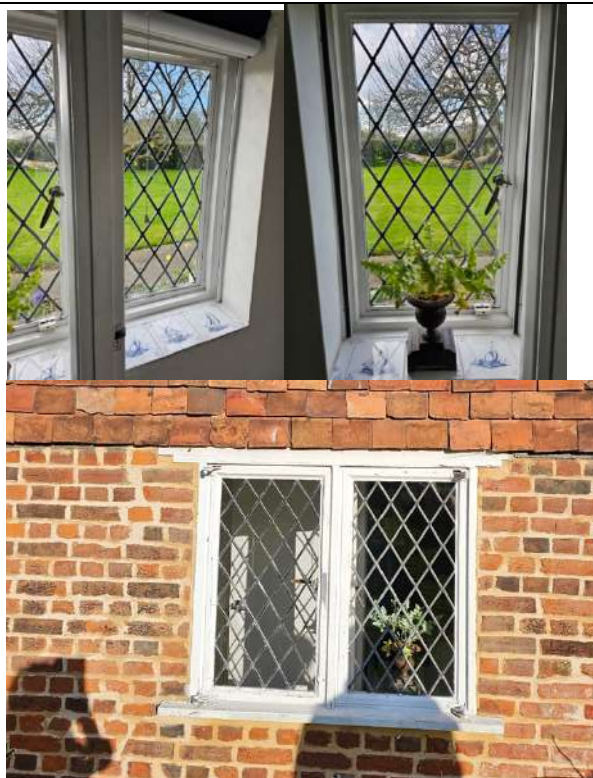
WG07

Mullioned 2-light steel Crittall-style  
casement in timber sub-frame  
2 opening lights  
Single glazed with leaded lights diamond  
pattern  
Circa early to mid C20th  
Partition wall set at mullion  
Not evident in early C20th photographs

Replace with hardwood  
frame with metal  
casements with diamond  
pattern leaded lights

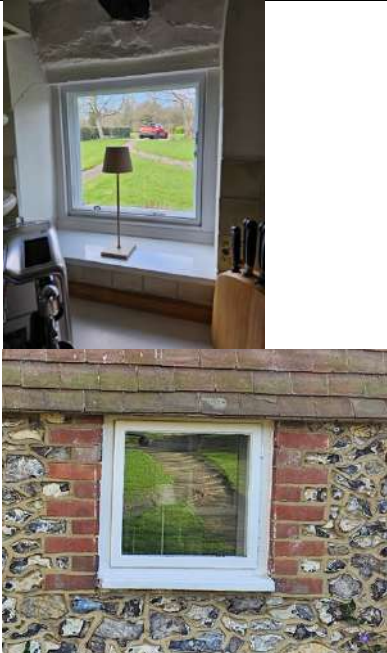
| WG08 | | <p>1-light timber casement in timber sub-frame</p> <p>Single glazed</p> <p>Circa mid-to late C20th or later</p> <p>In brick dressings in flint – evidence of alteration</p> | <p>Replace with new joinery to details</p> |

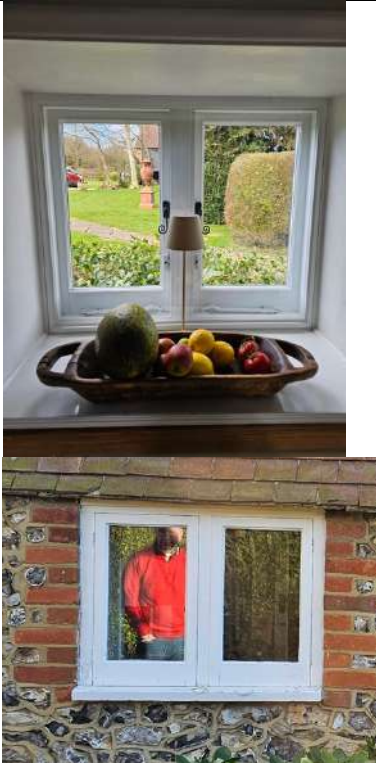
| WG09 | | | <p>2-light mullioned timber casement in timber sub-frame</p> <p>Single glazed</p> <p>Circa mid-to late C20th or later</p> <p>In brick dressings in flint – evidence of alteration. Not evident in mid C20th photos</p> | <p>Replace with new joinery to details</p> |

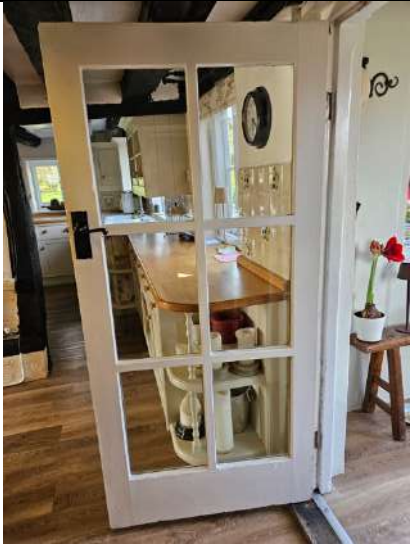
| DG01 | | Modern internal door (porch mid-late C20th) | To be removed |

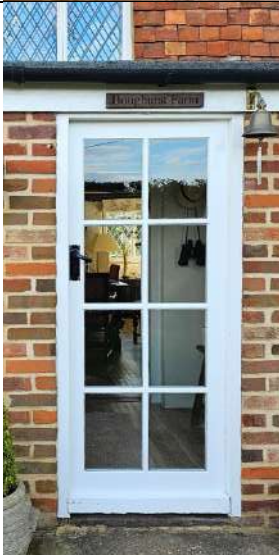
| DG02 | | Modern external door (porch mid-late C20th) | Porch and door to be removed |

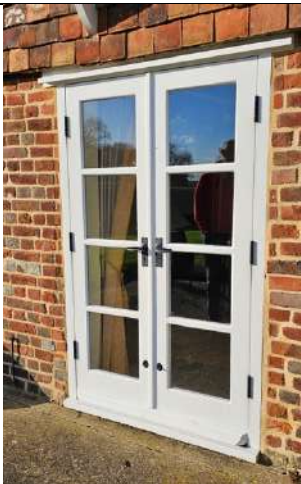
| DG03 | | | Modern French doors | To be retained |

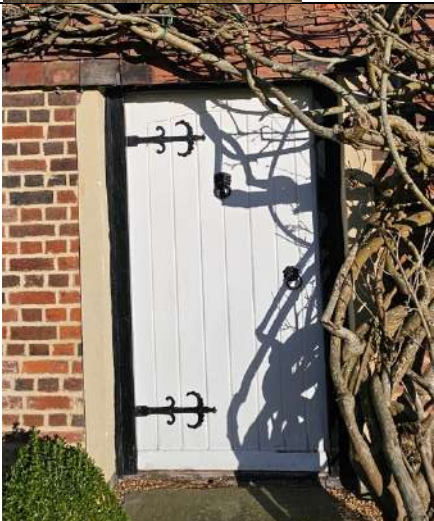
| DG04 | | | Early-mid C20th framed, ledged and boarded external door with forged cockshead hinges | To be retained |

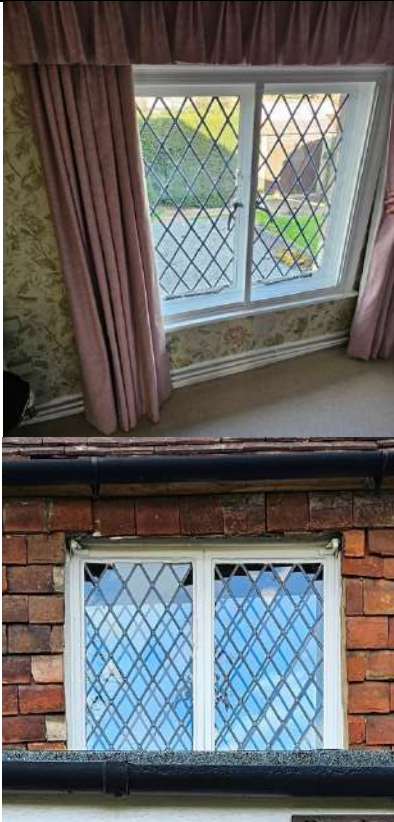
| WF01 | | <p>Mullioned 2-light steel Crittall-style casement in timber sub-frame</p> <p>2 opening lights</p> <p>Single glazed with leaded lights diamond pattern</p> <p>Circa early to mid C20th</p> <p>No evidence of timber framing surrounding opening internally</p> | <p>Remove and extend to form new door opening at first floor level</p> |

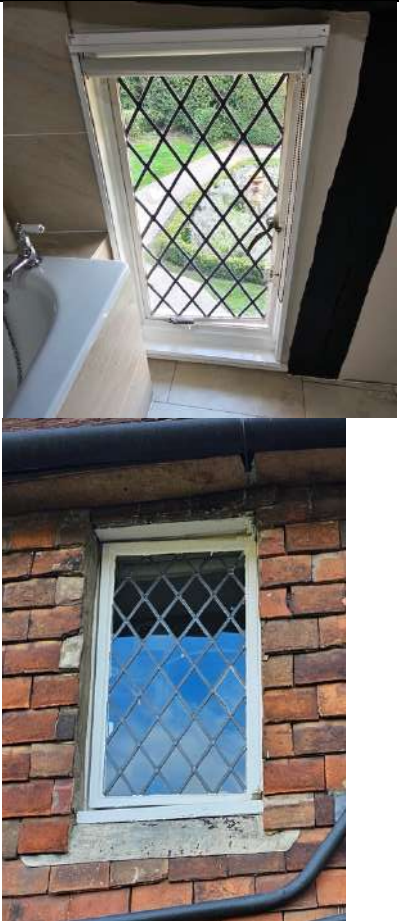
| WF02 | | | <p>1-light steel Crittall-style casement in timber sub-frame<br/> 1 opening light<br/> Single glazed with leaded lights diamond pattern<br/> Circa early to mid C20th<br/> Adjacent exposed timber framing</p> | <p>Replace with new joinery to details</p> |

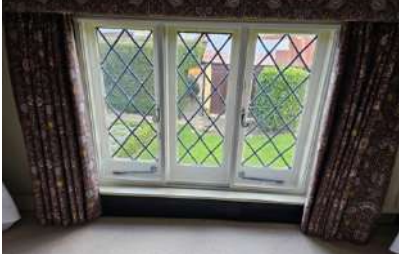
| WF03<br>Bedroom 2 | | | <p>Mullioned timber 3-light casement<br/> 2 opening, 1 fixed<br/> Single glazed with leaded lights diamond pattern<br/> Circa mid-late C20th<br/> Set under wall plate, no wall posts adjacent</p> | <p>Replace with new joinery to details</p> |

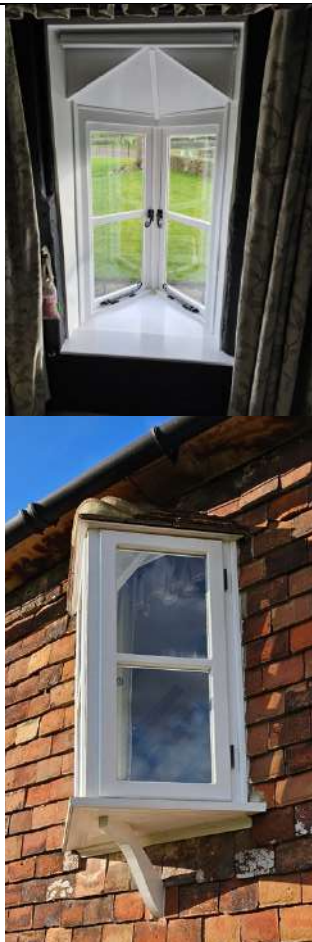
| <p>WF04<br/>Bedroom 1</p> | | | <p>Modern circa late C20th/early C21st oriel window</p> | <p>To be retained</p> |

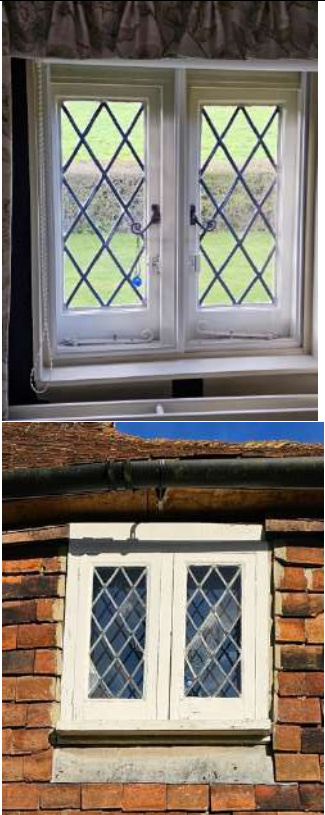
| <p>WF05<br/>Bedroom 1</p> | | <p>Mullioned timber 2-light casement<br/>2 opening<br/>Single glazed with leaded lights diamond pattern<br/>Circa mid-late C20th<br/>Queen's closers suggest original opening<br/>adjacent wall post no framing to cill</p> | <p>Replace with hardwood frame with metal casements with diamond pattern leaded lights</p> |

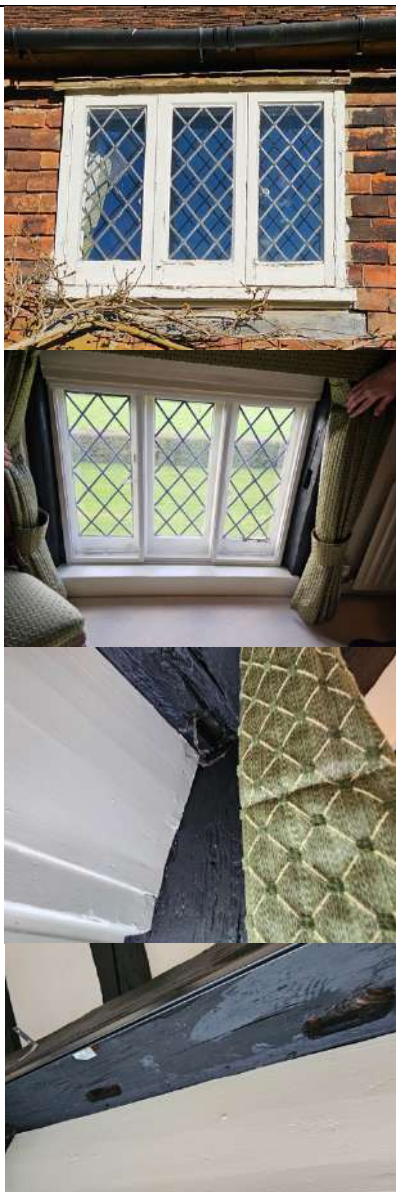
WF06  
Study

Mullioned timber 3-light casement  
2 opening, 1 fixed  
Single glazed with leaded lights diamond  
pattern  
Circa mid-late C20th  
Evidence of mortices for window mullions  
underside wall plate suggestive of former  
opening (possibly principal hall window),  
posts extant either side although right side  
possibly repositioned

Replace with hardwood  
frame with metal  
casements with diamond  
pattern leaded lights

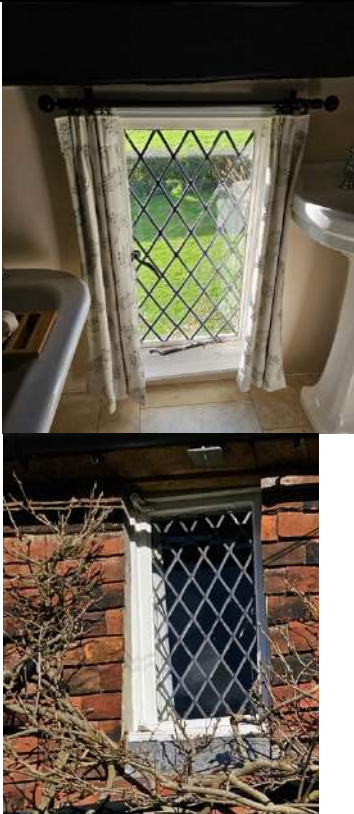
| WF07 | | | <p>1-light steel Crittall-style casement in timber sub-frame</p> <p>1 opening light</p> <p>Single glazed with leaded lights diamond pattern</p> <p>Circa early to mid C20th</p> <p>Below exposed timber framing</p> | <p>Replace with hardwood frame with metal casements with diamond pattern leaded lights</p> |

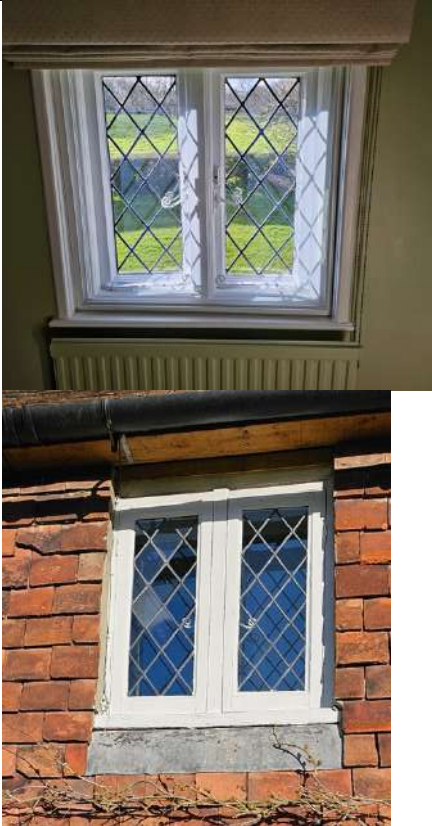
| WF08 | | <p>Mullioned timber 2-light casement<br/> 2 opening<br/> Single glazed with leaded lights diamond pattern<br/> Circa mid-late C20th<br/> Wall construction likely C19th</p> | <p>Reposition centrally to new room layout with hardwood frame with metal casements with diamond pattern leaded lights</p> |

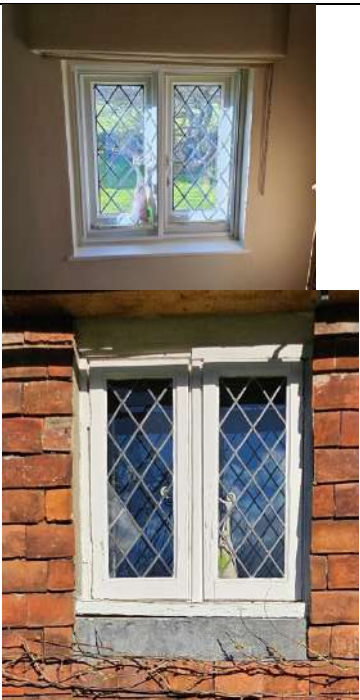
| WF09 | | | <p>Mullioned timber 2-light casement<br/> 2 opening<br/> Single glazed with leaded lights diamond pattern<br/> Circa C19th with later timber casements with diamond pattern leaded lights<br/> Wall construction likely C19th</p> | <p>Replace with hardwood frame with metal casements with diamond pattern leaded lights</p> |

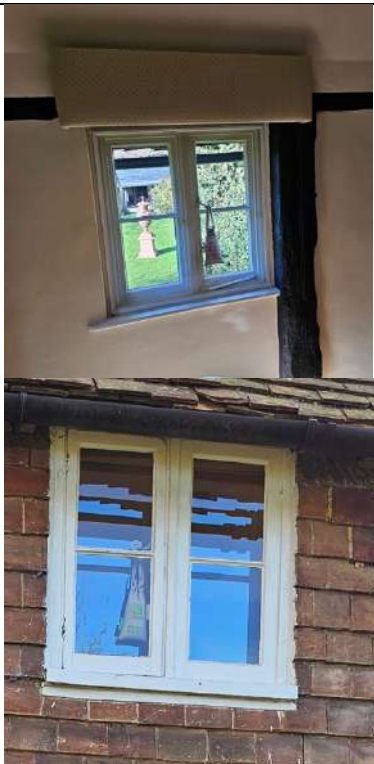
| WF10 | | | <p>Mullioned timber 2-light casement<br/> 2 opening<br/> Single glazed with single horizontal glazing bar<br/> Circa C19th</p> | <p>Retain and refurbish</p> |
