# Piling Risk Assessment

E-Scrap Sample Preparation Plant

Britannia Refined Metals Ltd

SLR Project No.: 402.064683.00001

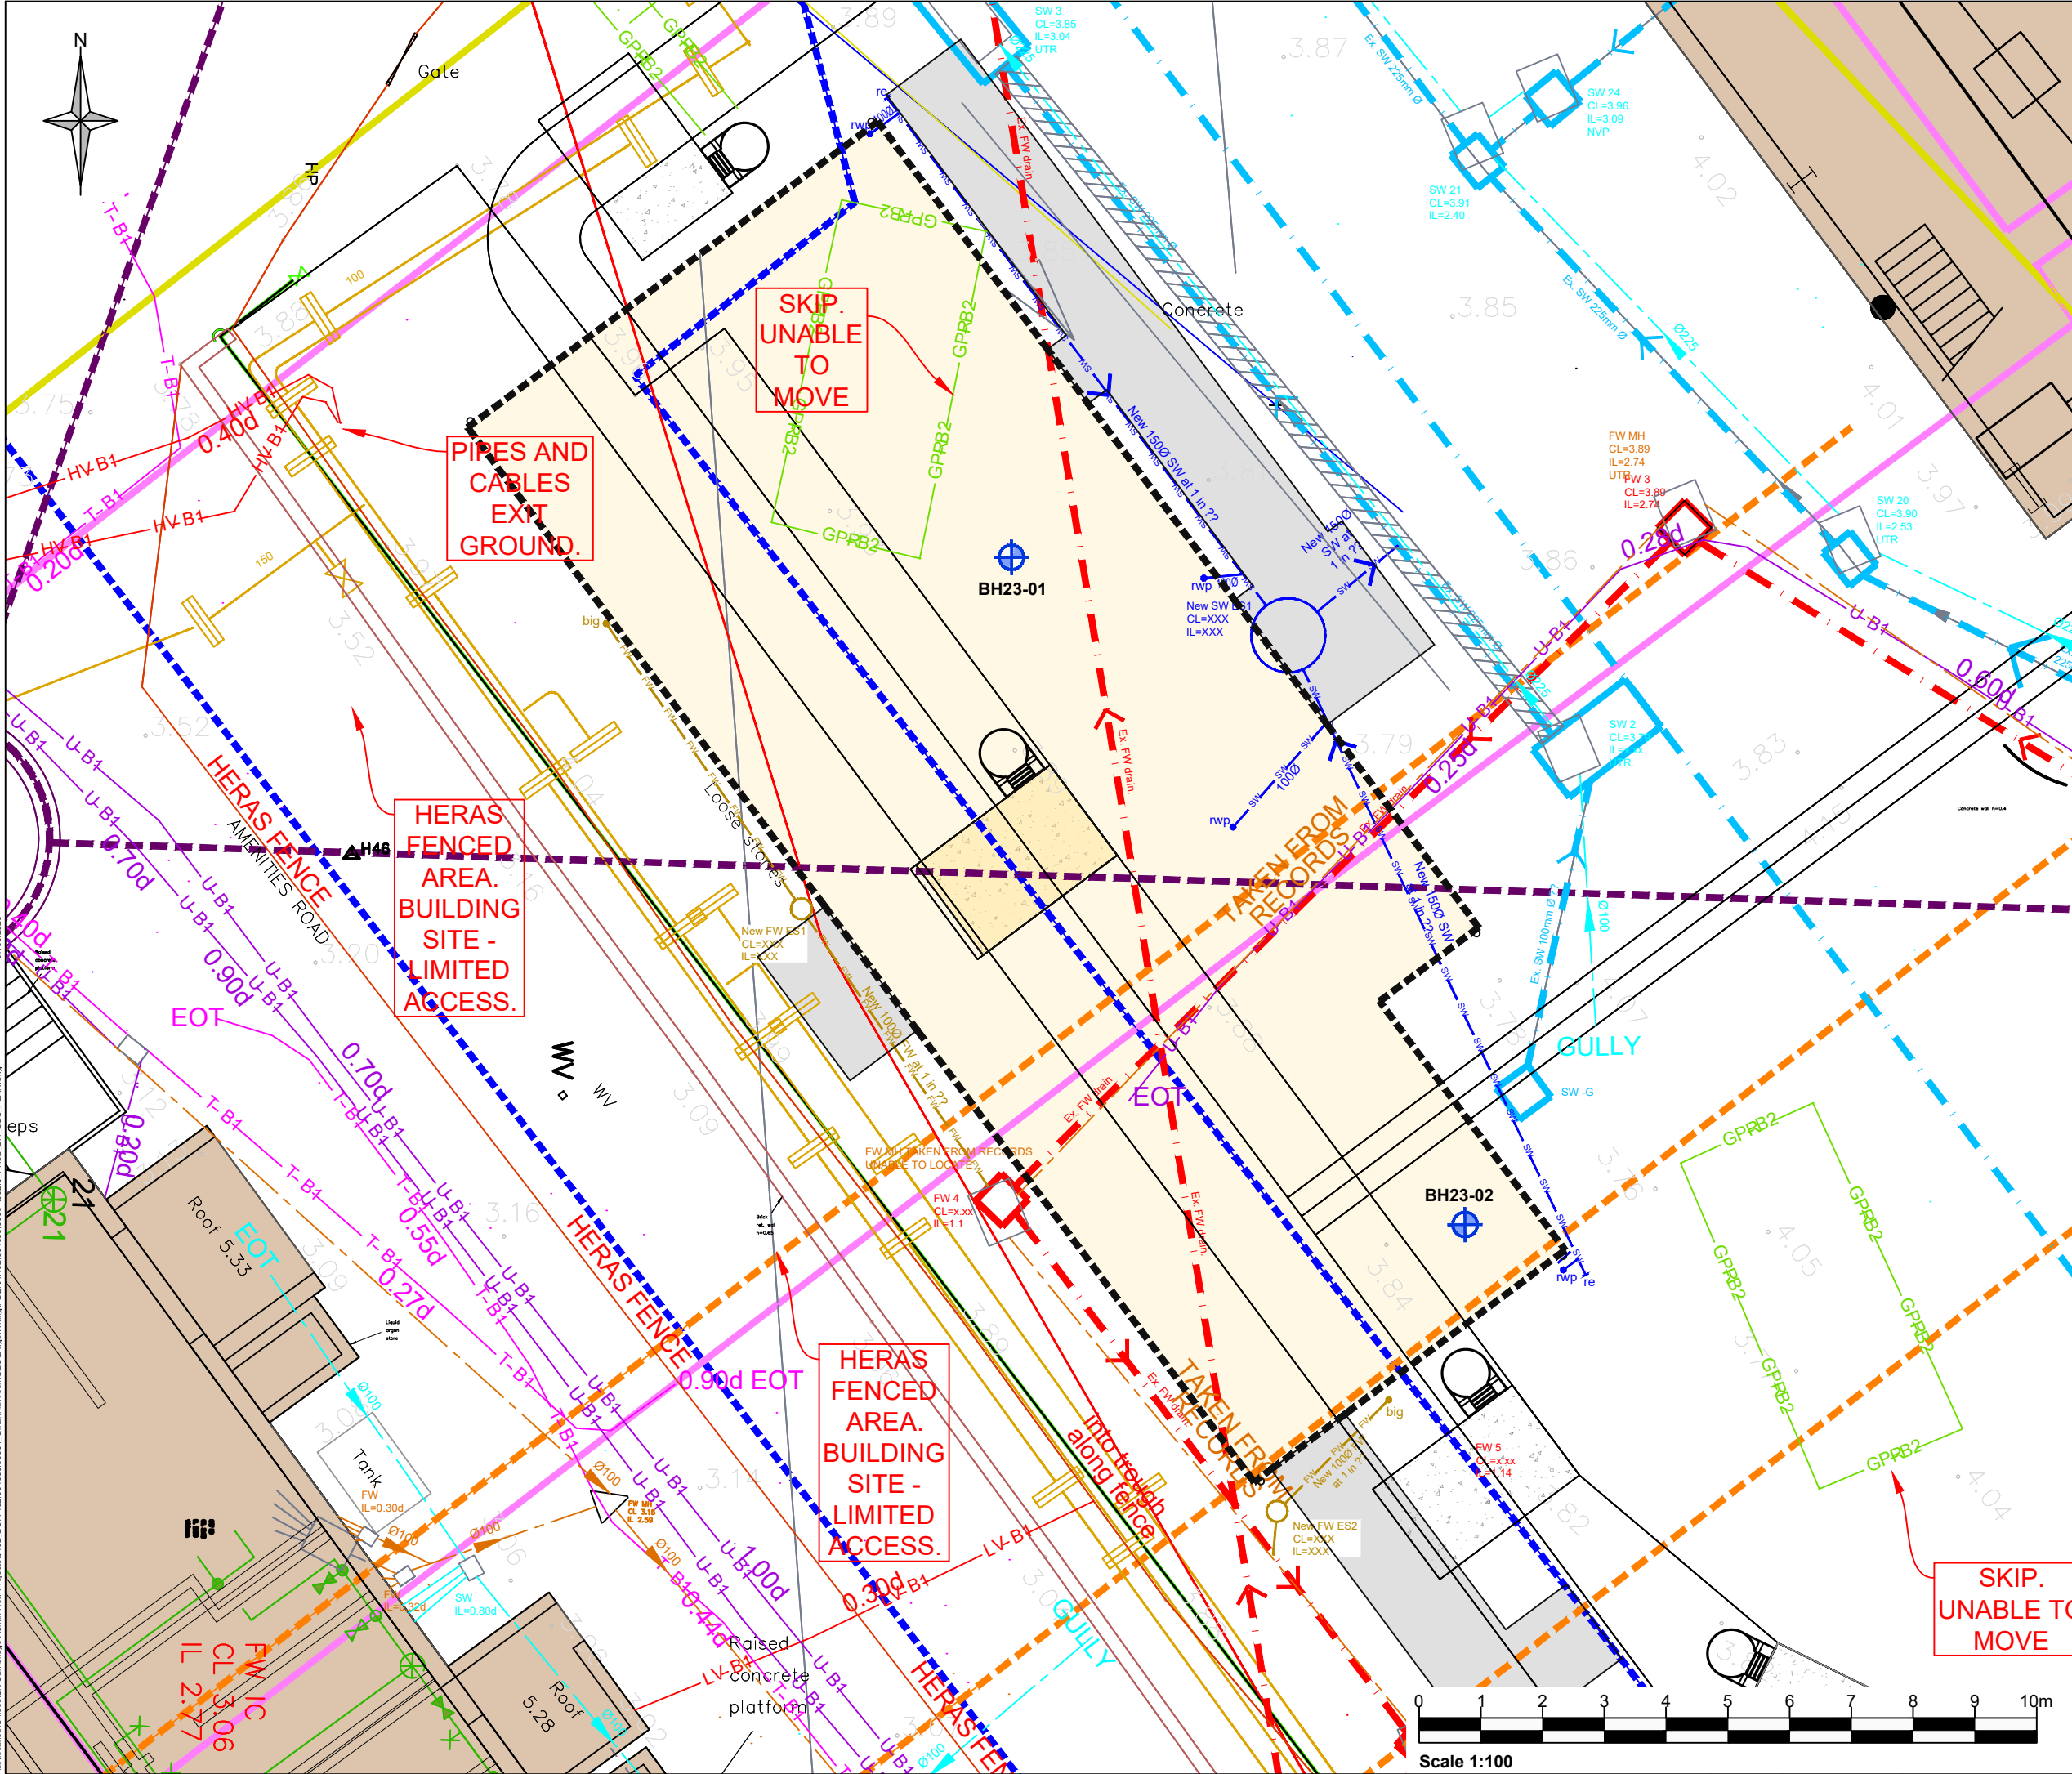
| Figure Number<br>02 | Rev.<br>0 | | |

1. DRAWING IS BASED ON SLR PLANS UTLS-01 P0 AND SITE LAYOUT SINGLE BUILDING OPTION SK01 P5.

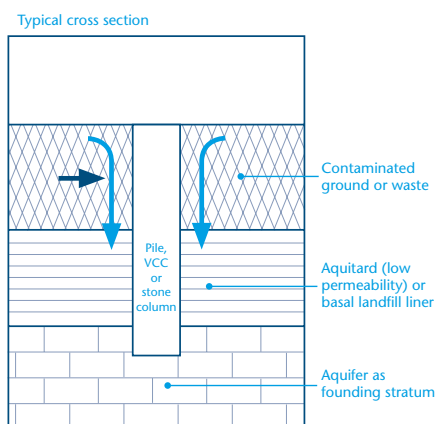
### Pollution Scenario 1

**Creation of preferential pathways through an aquitard to allow potential contamination of an aquifer**

contaminated made ground, waste or contaminated perched groundwater

groundwater in aquifer; typically in solid strata in which pile is founded

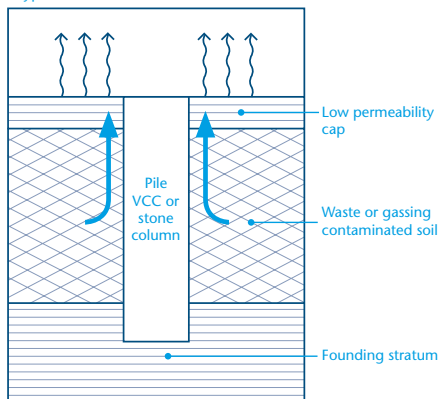
Typical cross section

**Creation of preferential pathways through a low permeability surface layer, allowing migration of landfill gas, soil gas or contaminant vapours to the surface**

gassing landfilled waste or contaminated ground

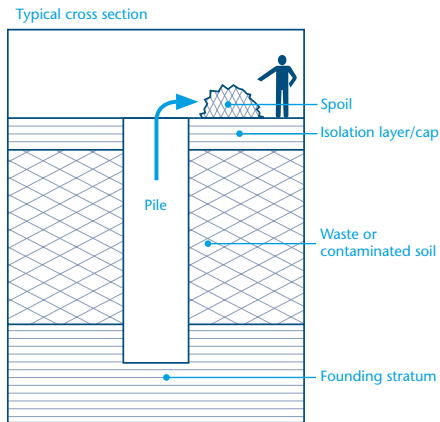
### Pollution Scenario 3

**Direct contact of site workers and others with contaminated soil arisings that have been brought to the surface**

contaminated soil or waste

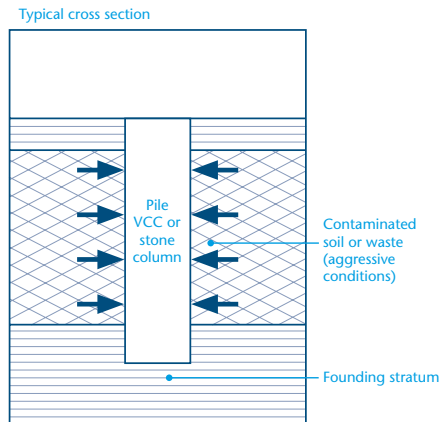
#### Pollution Scenario 4

**Direct contact of the piles or engineered structures with contaminated soil or leachate causing degradation of materials**

contaminated soil, waste or leachate

When considering the history of the site the presence of aggressive chemicals cannot be ruled out at this stage. It should also be noted that hydrocarbon impact can affect the setting and hardening of concrete with a reduction of long-term strength gain of concrete by up to 25%<sup>2</sup>.

When considering the results of the laboratory analysis performed upon both soil and groundwater samples, and that the SLR GIR also provided a geotechnical assessment of aggressive ground conditions and recommended an appropriate design sulphate (DS) and aggressive chemical environment for concrete (ACEC), the risks posed by this specific Pollution Scenario are not judged to be significant.

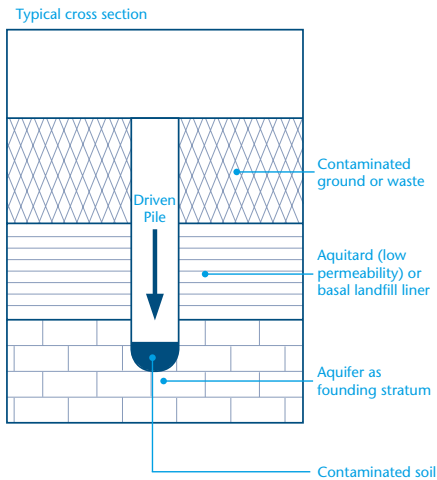
## Pollution Scenario 5

### The pushing of solid contaminants down into an aquifer during pile driving

contaminated soil

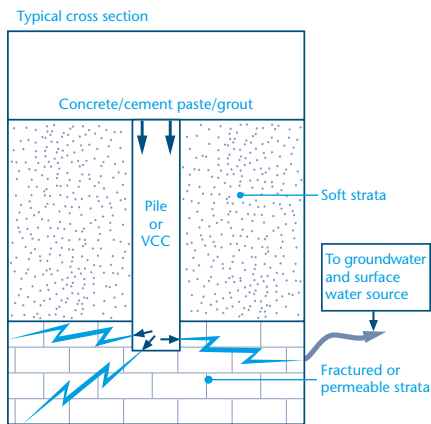
## Pollution Scenario 6

**Contamination of groundwater and, subsequently, surface waters by wet concrete, cement paste or grout**

concrete, cement paste or grout introduced to the ground

Concrete, cement paste or grout may be lost when introduced to the ground via highly permeable or fractured strata. Piling fluids such as polymers and cements can also contain substances which may present a risk to controlled waters.
