## **GROUND INVESTIGATION REPORT**

**FOR  
FORMER CALL BOY PUBLIC HOUSE,  
HARMER STREET,  
GRAVESEND, KENT,  
DA12 2AX**

**PREPARED FOR  
SONY DEVELOPMENTS LIMITED**

**REPORT NO. SE1540B  
GROUND GAS UPDATE  
MAY 2024**

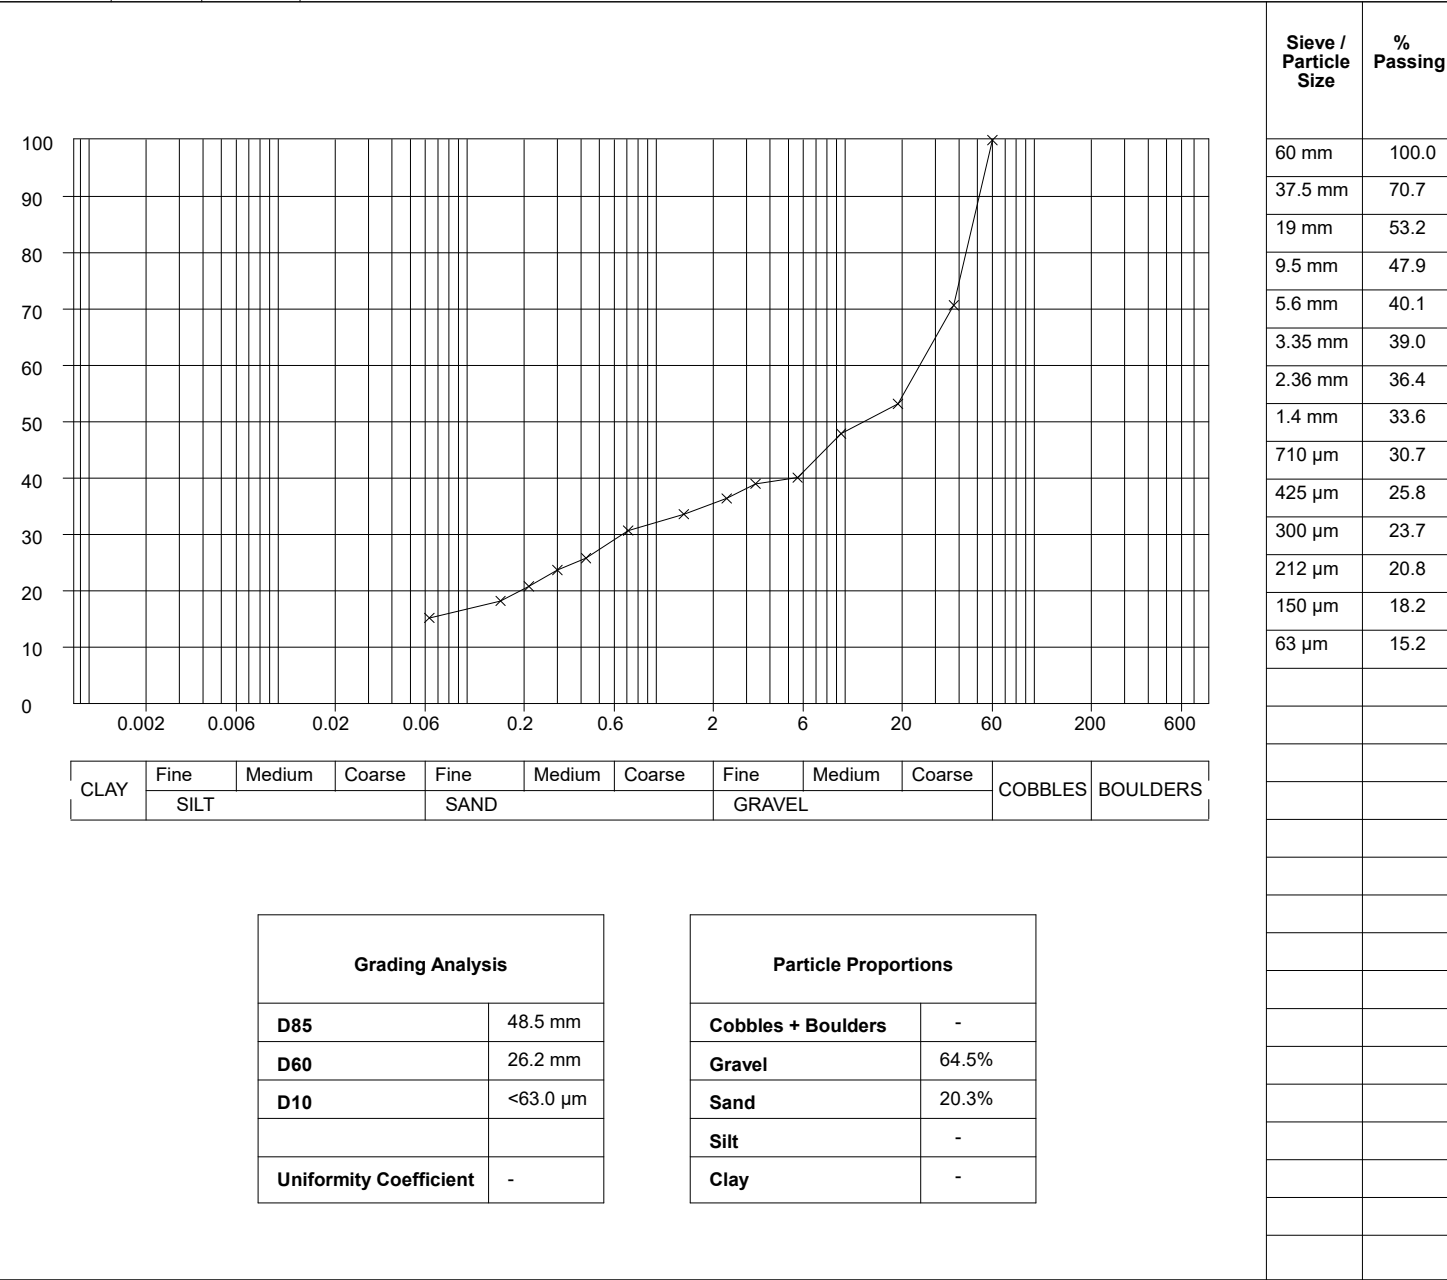
**Method of Preparation** : BS 1377:PART 1:1990:7.3 Initial preparation 1990:7.4.5 Particle size tests

**Method of Test** : BS 1377:PART 2:1990:9 Determination of particle size distribution

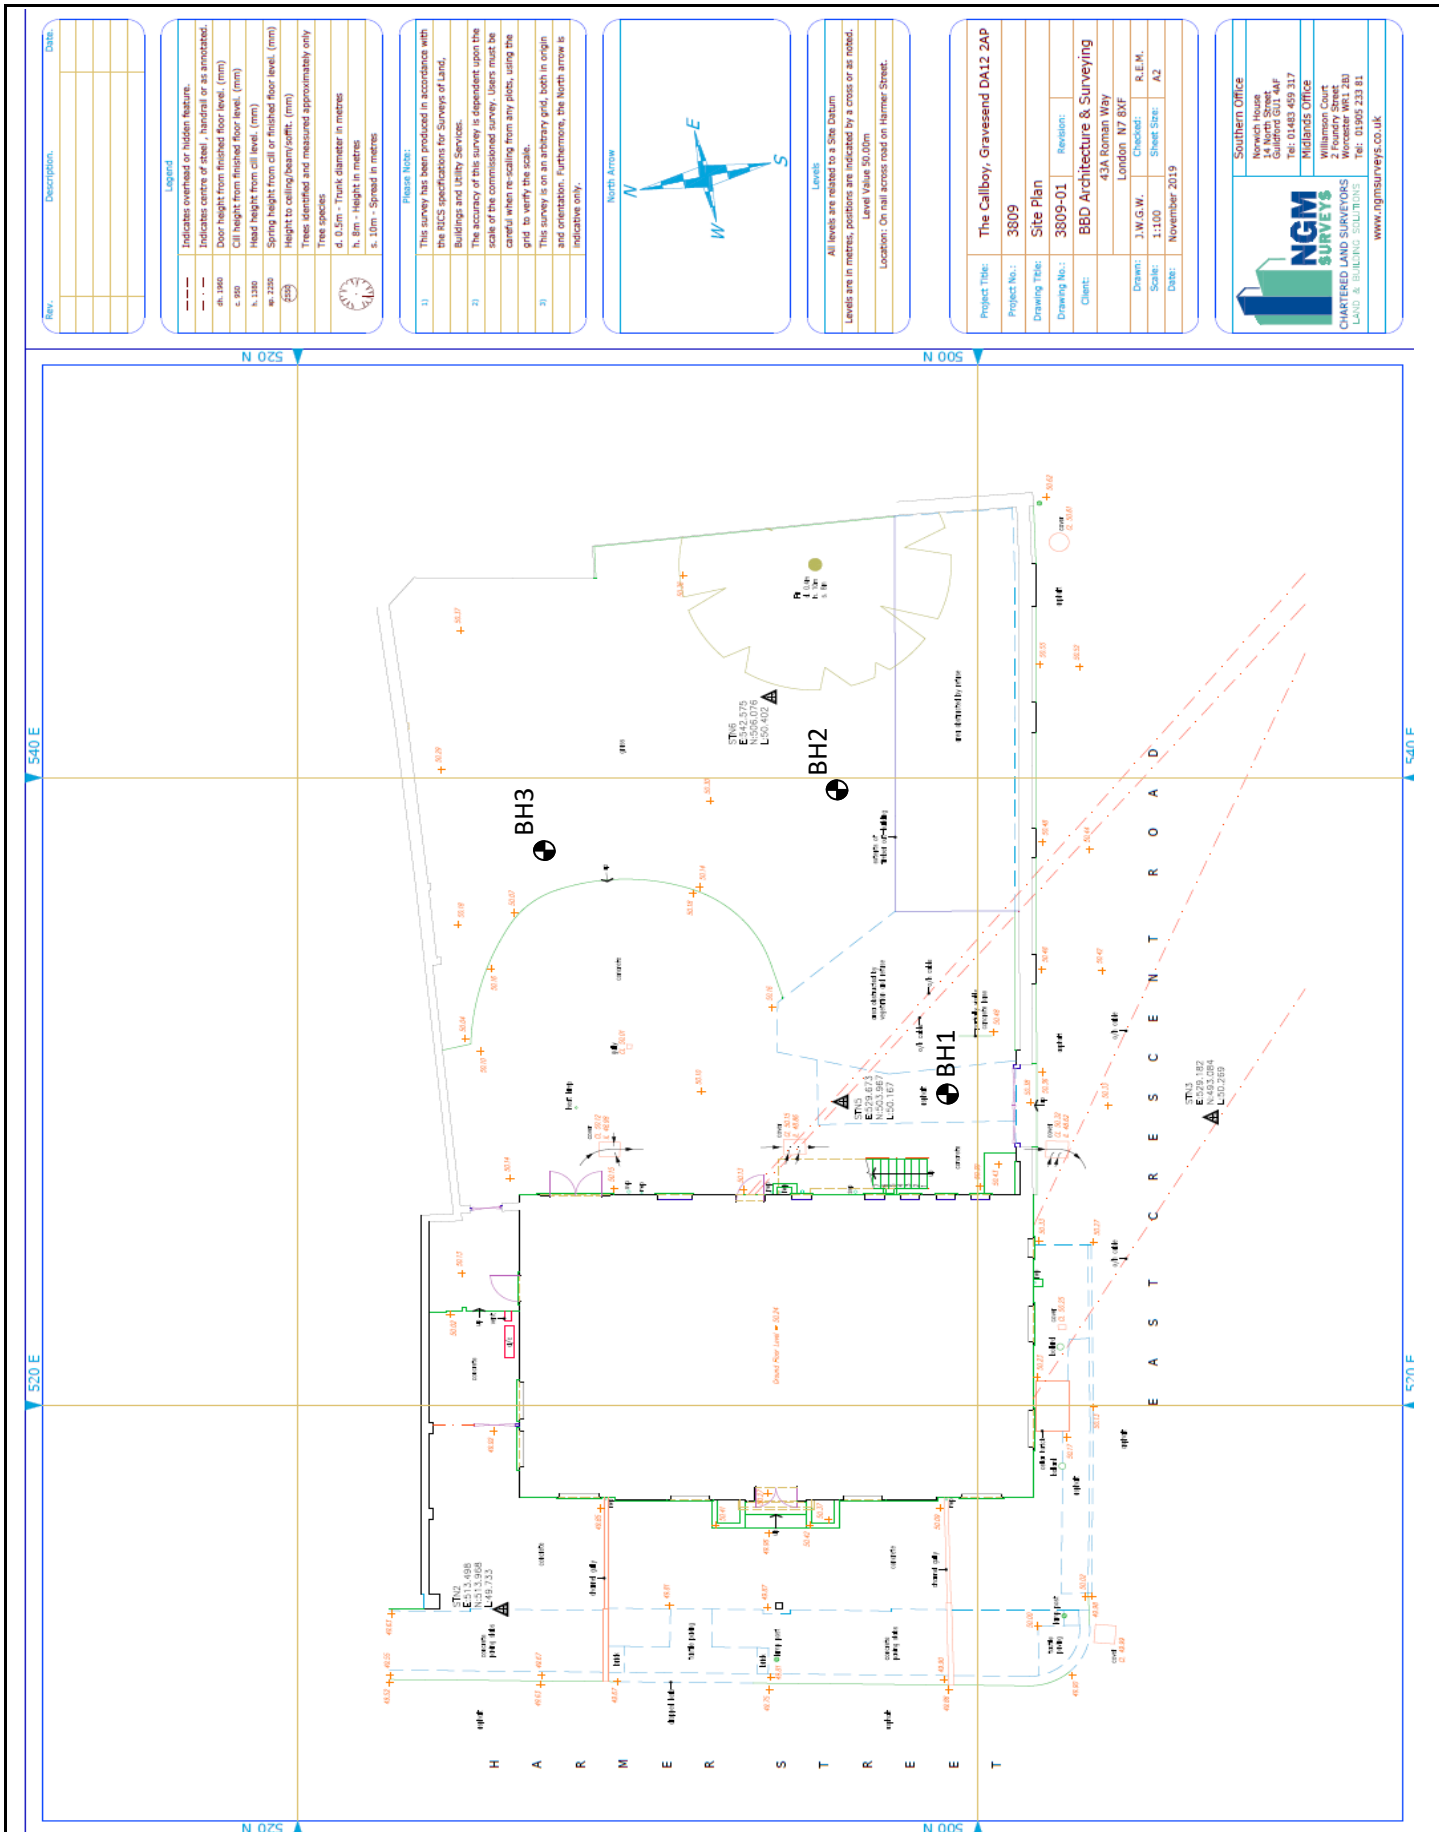
Three 150mm diameter boreholes were put down by cable percussive boring techniques at the positions determined and set out by Sub Surface South East Limited as shown on Figure 2. The boreholes were put down to a depth of 15.45m, samples taken were logged in accordance with BS EN ISO 14688-1: 2002 and BS EN ISO 14689-1: 2003 and the resulting Borehole Records are appended.

As shown on Figure 2, the rectangular shaped about 0.06 hectare site is bounded to the north by the rear garden areas of dwellings situated on Harmer Street and The Terrace, to east is rear gardens situated on East Terrace, to the south is East Crescent Road, to the west is Harmer Street.

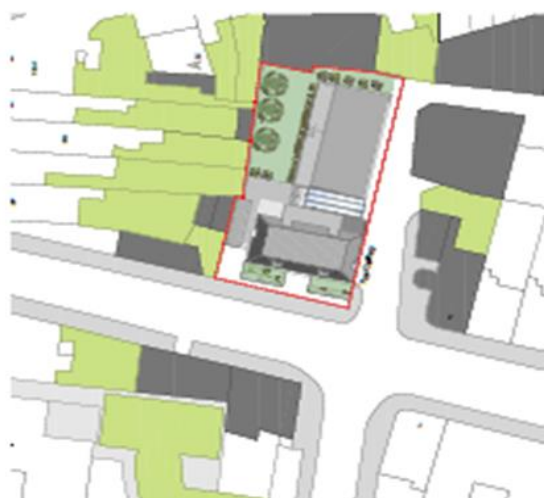
Proposed Block Plan 1:500

We understand that it is proposed to convert the existing Former Public House into a residential dwelling comprising flats and construct a two storey detached mews block comprising flats to the rear with associated garden areas, as shown on Figure 3. However, at the time of writing this report no specific details regarding the proposed foundations and design loadings for the extension were available and consequently the recommendations given are in general terms only.

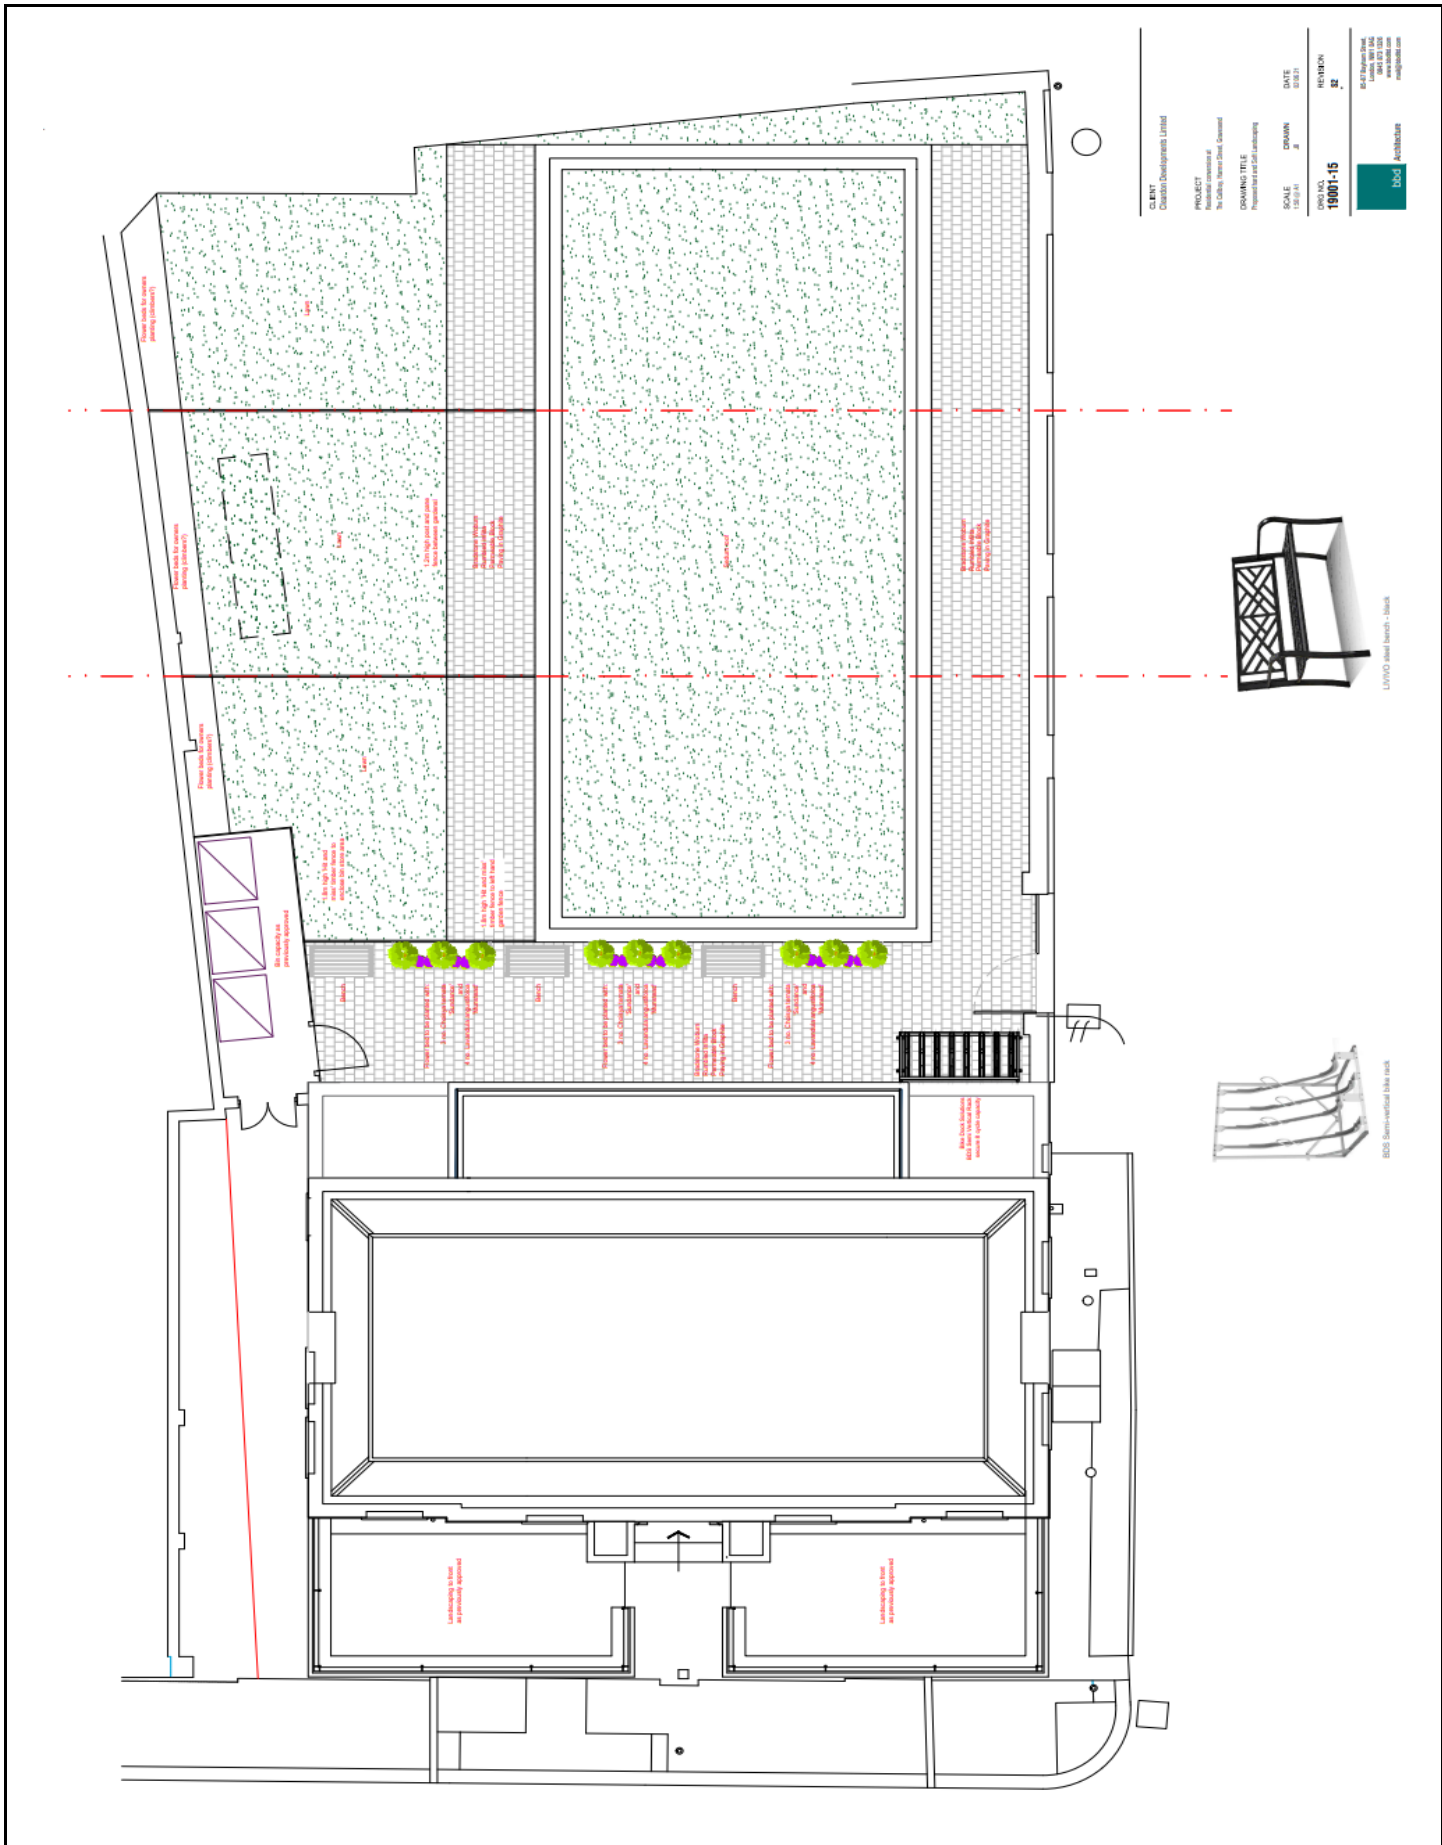
We understand that it is proposed to convert the existing Former Public House into a residential dwelling comprising flats and construct a two storey detached mews block comprising three houses to the rear with associated garden areas, as shown on Figure 3. It should be noted that the proposed landscaping arrangement has been amended since the time of our previous report (Ref. SE1540A), an updated plan is given on Figure 4.
