**Former Tollgate Hotel, Gravesend, Kent**

**Road Safety Audit Stage 1**

August 2025

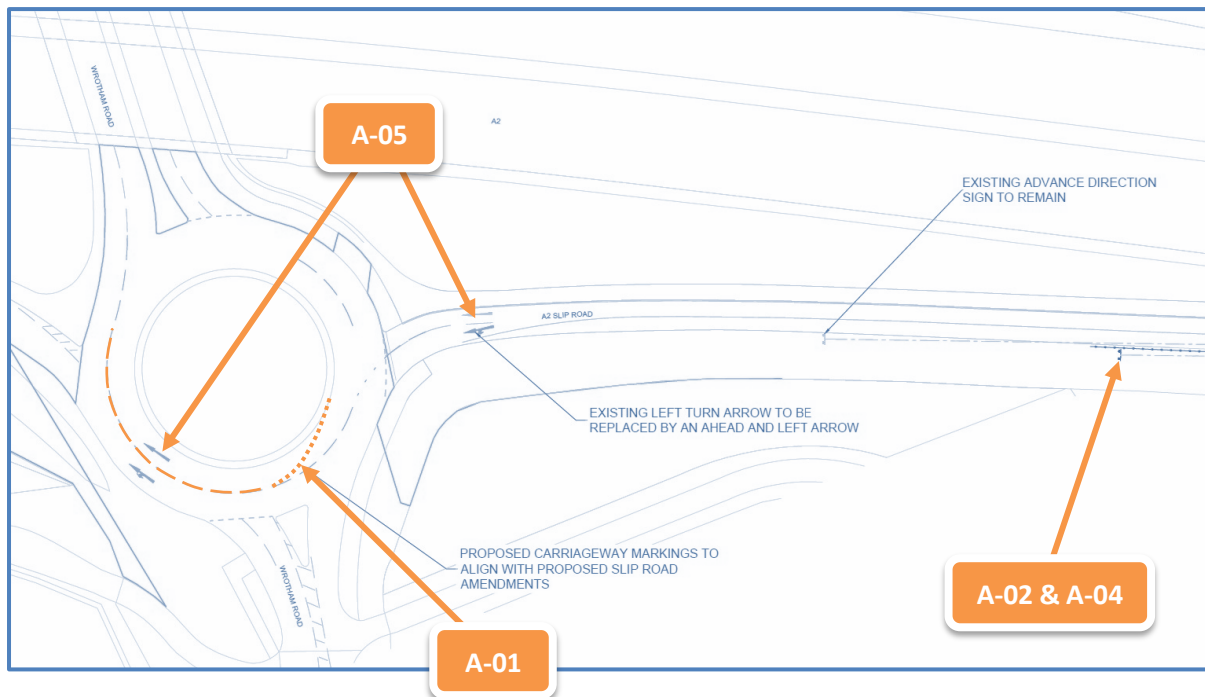
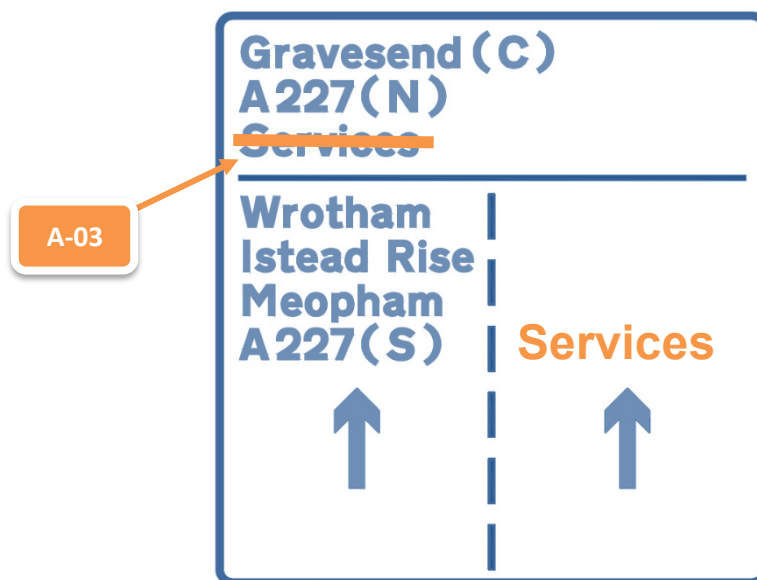
## Problem Location Plan

Each of the auditors' responses is classified as a 'Problem' that is likely to result in a significant road safety hazard. All comments and recommendations are referenced to the detailed design drawings and the locations have been indicated on the plan at the end of the report.
