# STRUCTURAL INSPECTION REPORT

## Imperial Wharf Flood Defence Inspection

File Reference:  
317181-FCG-SW-XX-RP-C-3101-S2-P03

**ON:** IMPERIAL WHARF FLOOD DEFENCE INSPECTION  
**FOR:** FM CONWAY  
**FRANKHAM PROJECT NO.:** 317181

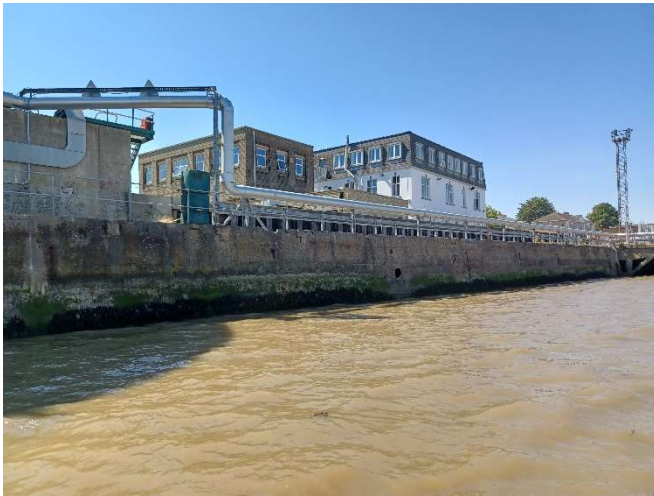
**Photo 1 - General photo of wall 1**

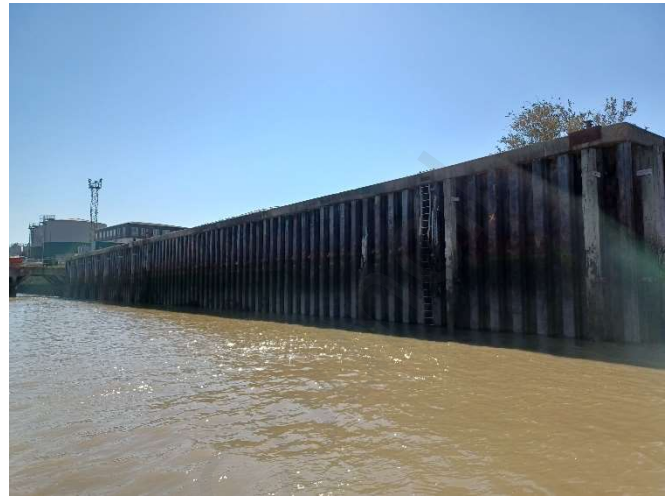
**Photo 2 - General photo of wall 2**

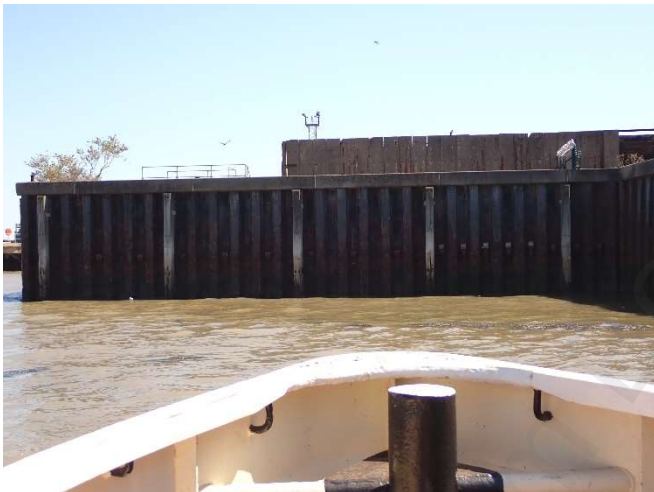
**Photo 3 - General photo of wall 3**

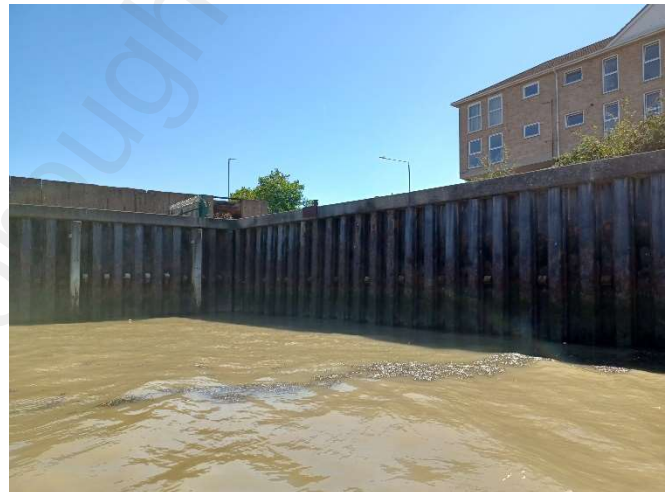
**Photo 4 - General photo of wall 4**

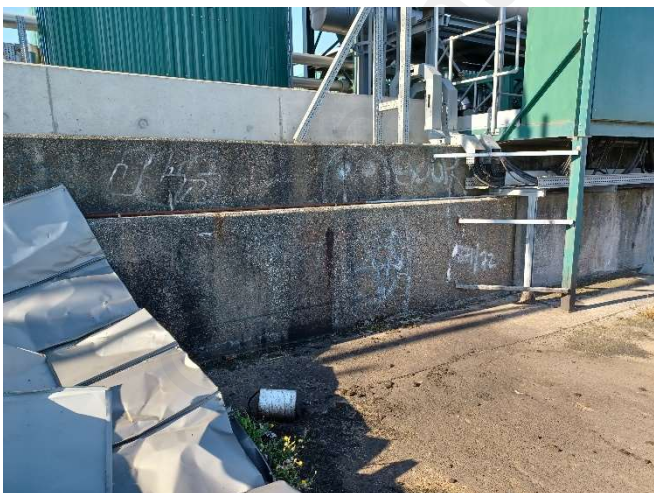
**Photo 5 - General photo of wall 5**

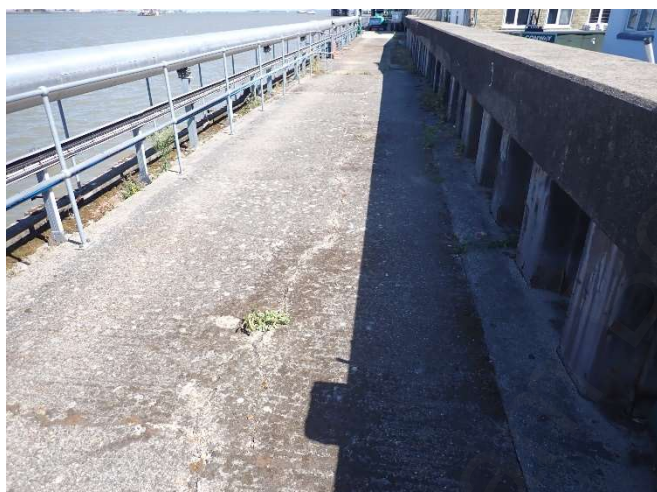
**Photo 19 – View of slope upriver next to wall 7**

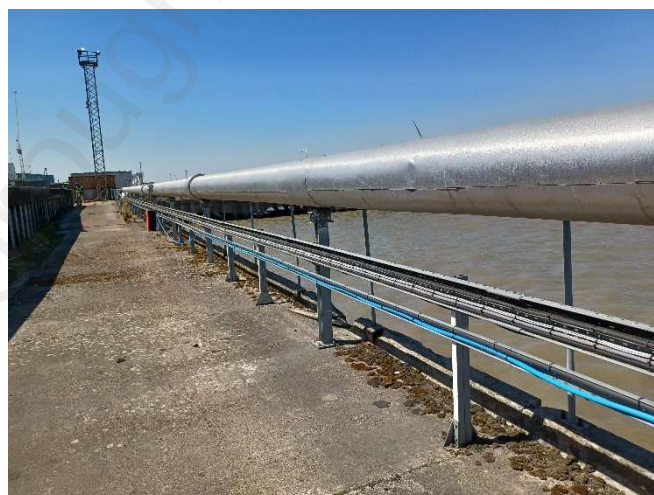
**Photo 20 – View of slope downriver next to wall 7**
