Convent of Mercy Phase 3,  
Hillside Drive,  
Gravesend  
DA12 1NY

Flood Risk Assessment and  
Drainage Strategy Report

C1477 / November 2024

| Document Status | | |
|---|---|---|
| Document Reference: B2240-FRA & Drainage Strategy | | |

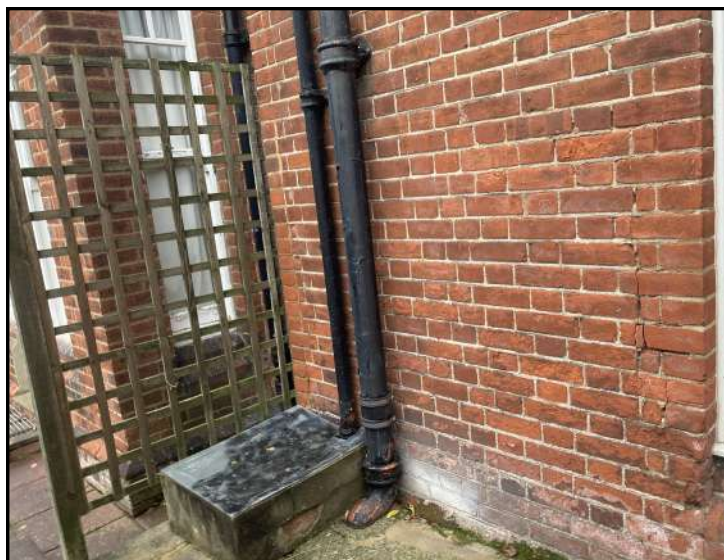
LOCATION OF SVP 2

SVP 2.  
UNABLE TO CCTV

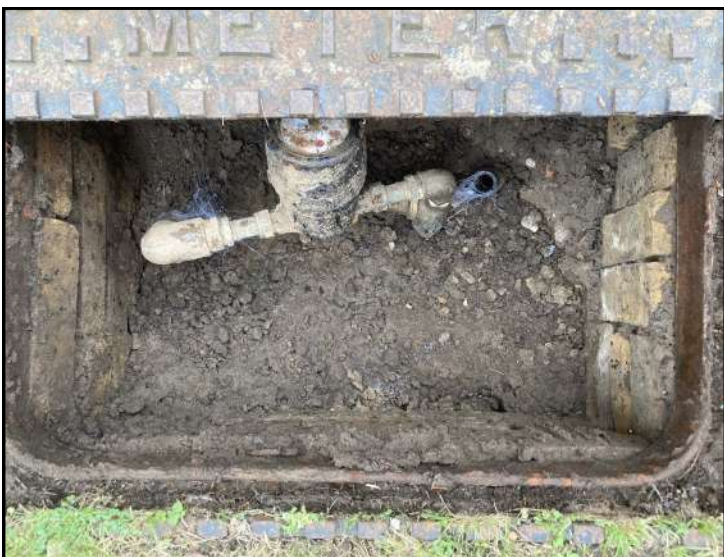
MH2.  
SERVICES

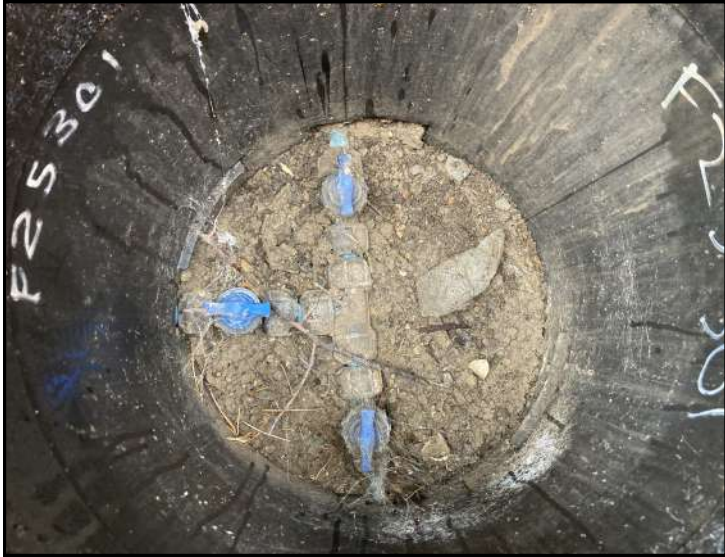
MH3.  
SERVICES

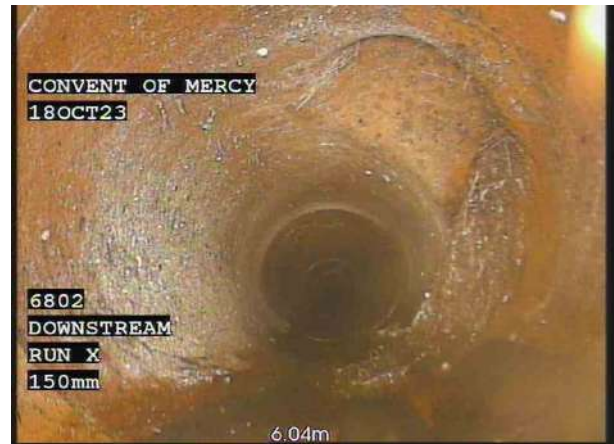
2, 00:01:13, 6.04 m  
Roots, mass, 5% cross-sectional area loss

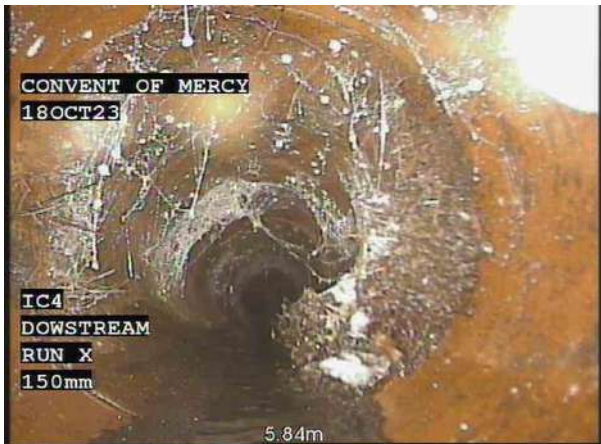
1, 00:00:53, 5.84 m  
Roots, mass at joint, 10% cross-sectional area loss
