CASCADES LEISURE CENTRE  
7313-FUR-XX-XX-RP-0001  
STRUCTURAL SURVEY  
NOVEMBER 2022

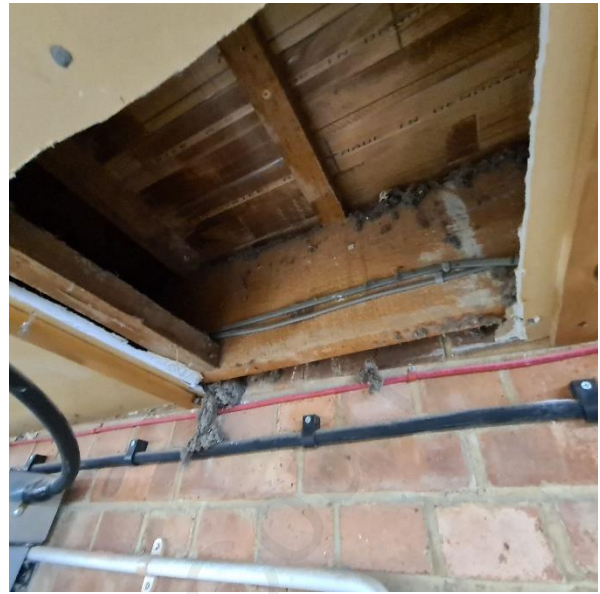
- 3.2.8 The lower ground floor area below the squash courts contains store rooms. The suspended ground floor construction is typically enclosed above the boarded soffit but was locally inspected above a missing section of boarding. The inspected area of floor construction comprises of timber joists with timber battens and boards over.

Figure 29: Suspended ground floor construction to squash courts 1 & 2

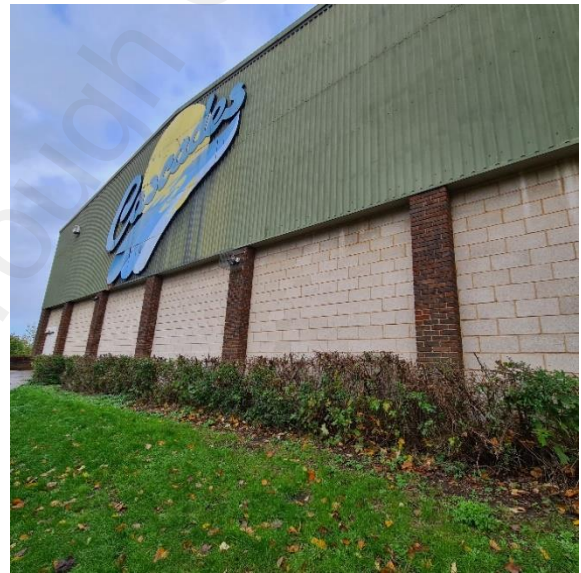
Figure 71: South elevation of original building and sports hall

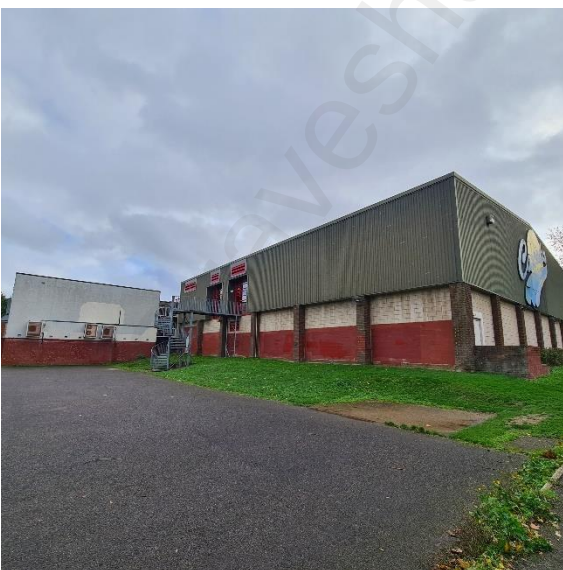
Figure 72: West elevation of sports hall

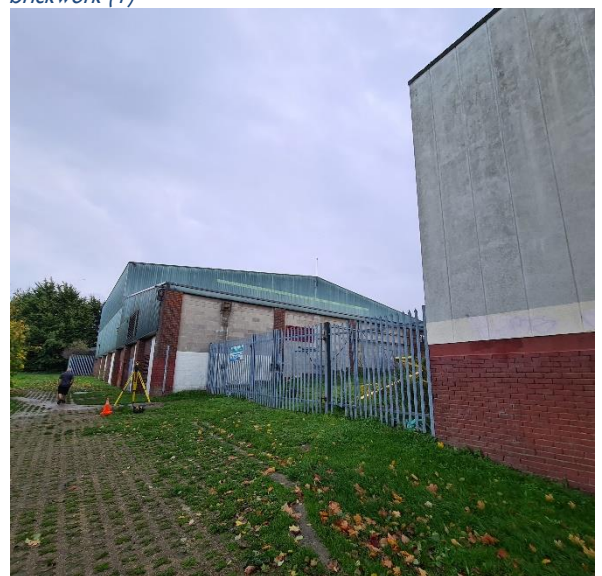
Figure 79: Mortar bed joint loss to squash court external brickwork (2)

- 4.2.4 Methodology for repair of damaged external brickwork is as follows;
- Repointing of masonry bed joints in areas subject to excessive mortar loss
